UNIVERSITY OF NORTH CAROLINA at CHARLOTTE

Burson Building Feasibility Study

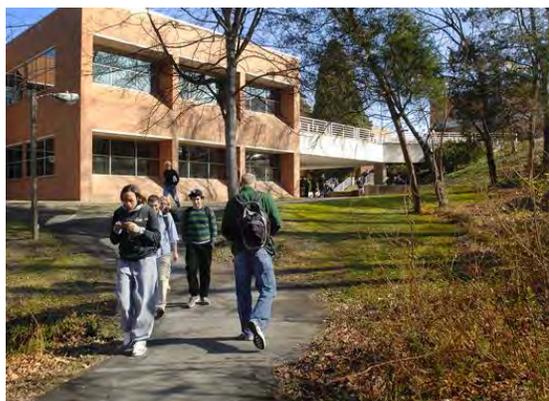
This feasibility study for the potential renovation and/or addition project includes a facility program of requirements (PoR) that outlines the requirements for the existing and new chemistry laboratories, research spaces and support spaces, including but not limited to, chemical fume hoods, laboratory casework, process piping, HVAC, infrastructure, lighting and sprinkler coverage. This feasibility study for potential renovation includes the evaluation of existing infrastructure and energy efficient solutions proposed. Based on a review and analysis of the existing building and infrastructure, graphic layouts for proposed alternate recommendations that accommodate the Chemistry Department's needs are included in this study. The graphic layouts include recommended phasing and budgets for each alternate layout.

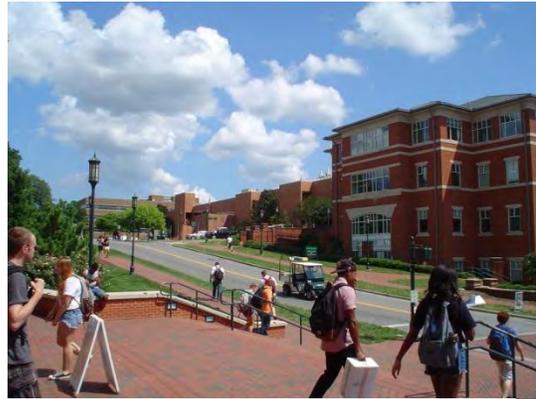
Burson Building from Craver Road

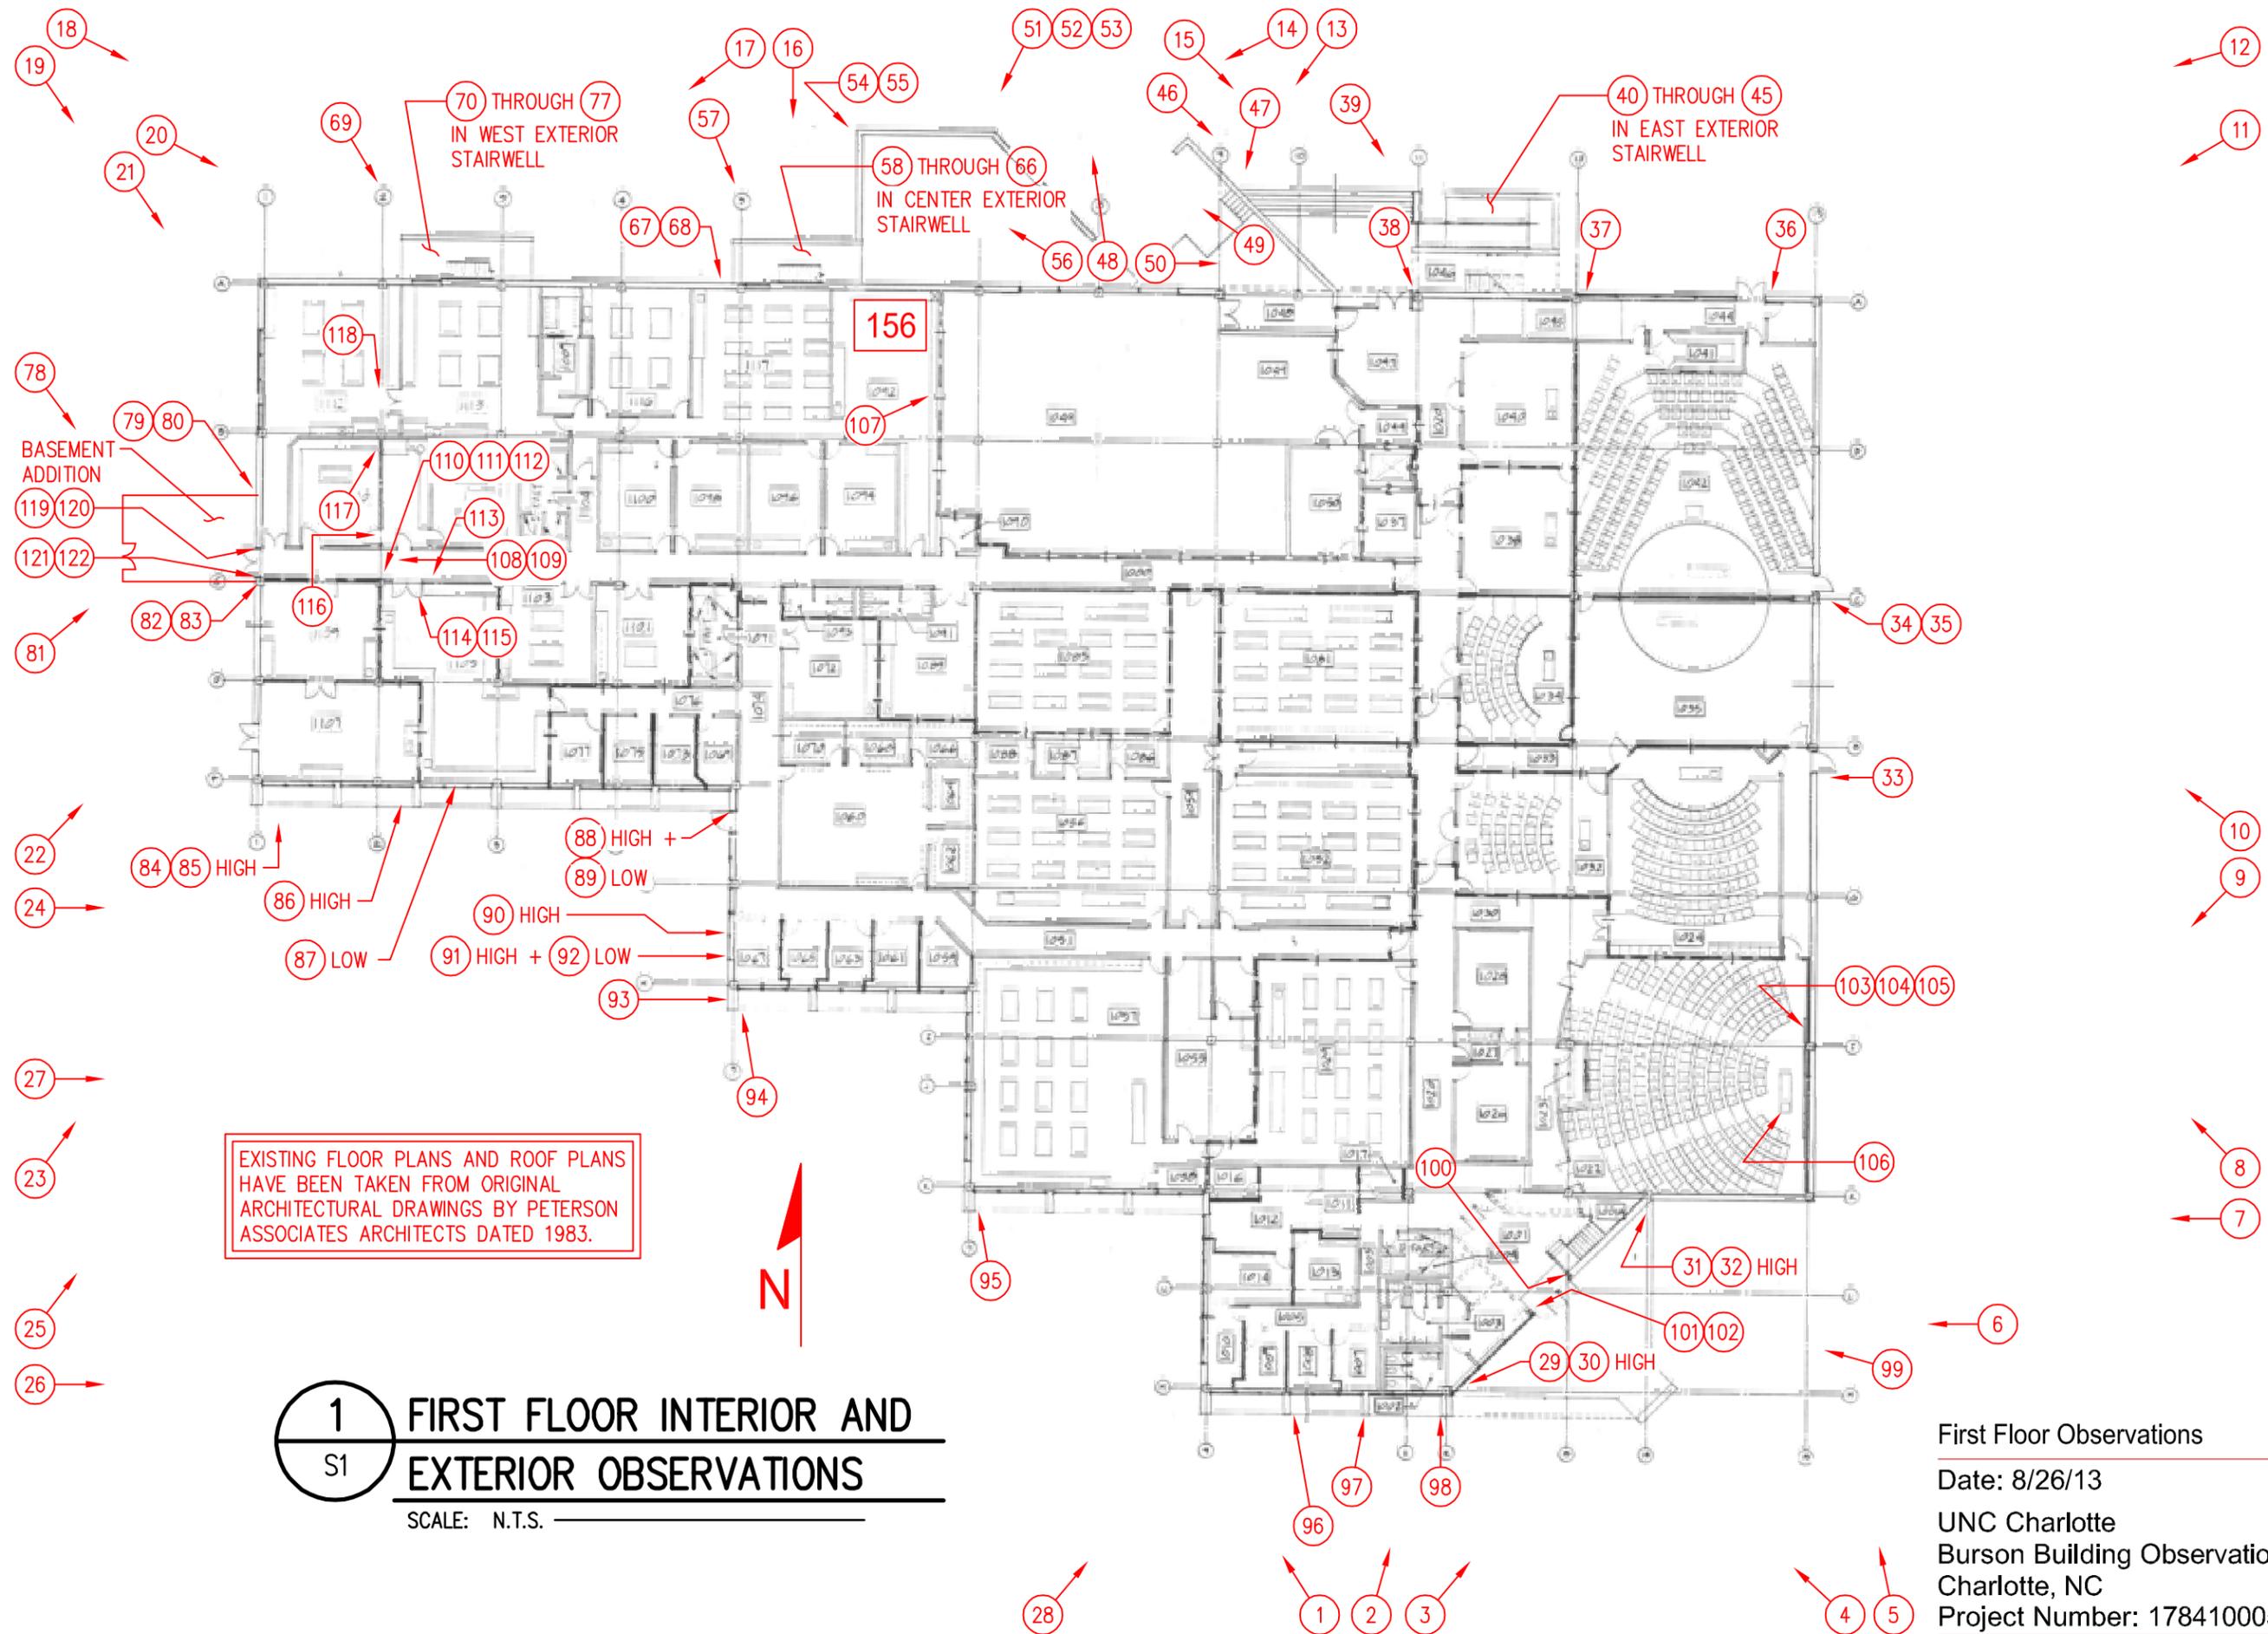
1
S1
FIRST FLOOR INTERIOR AND EXTERIOR OBSERVATIONS
SCALE: N.T.S.

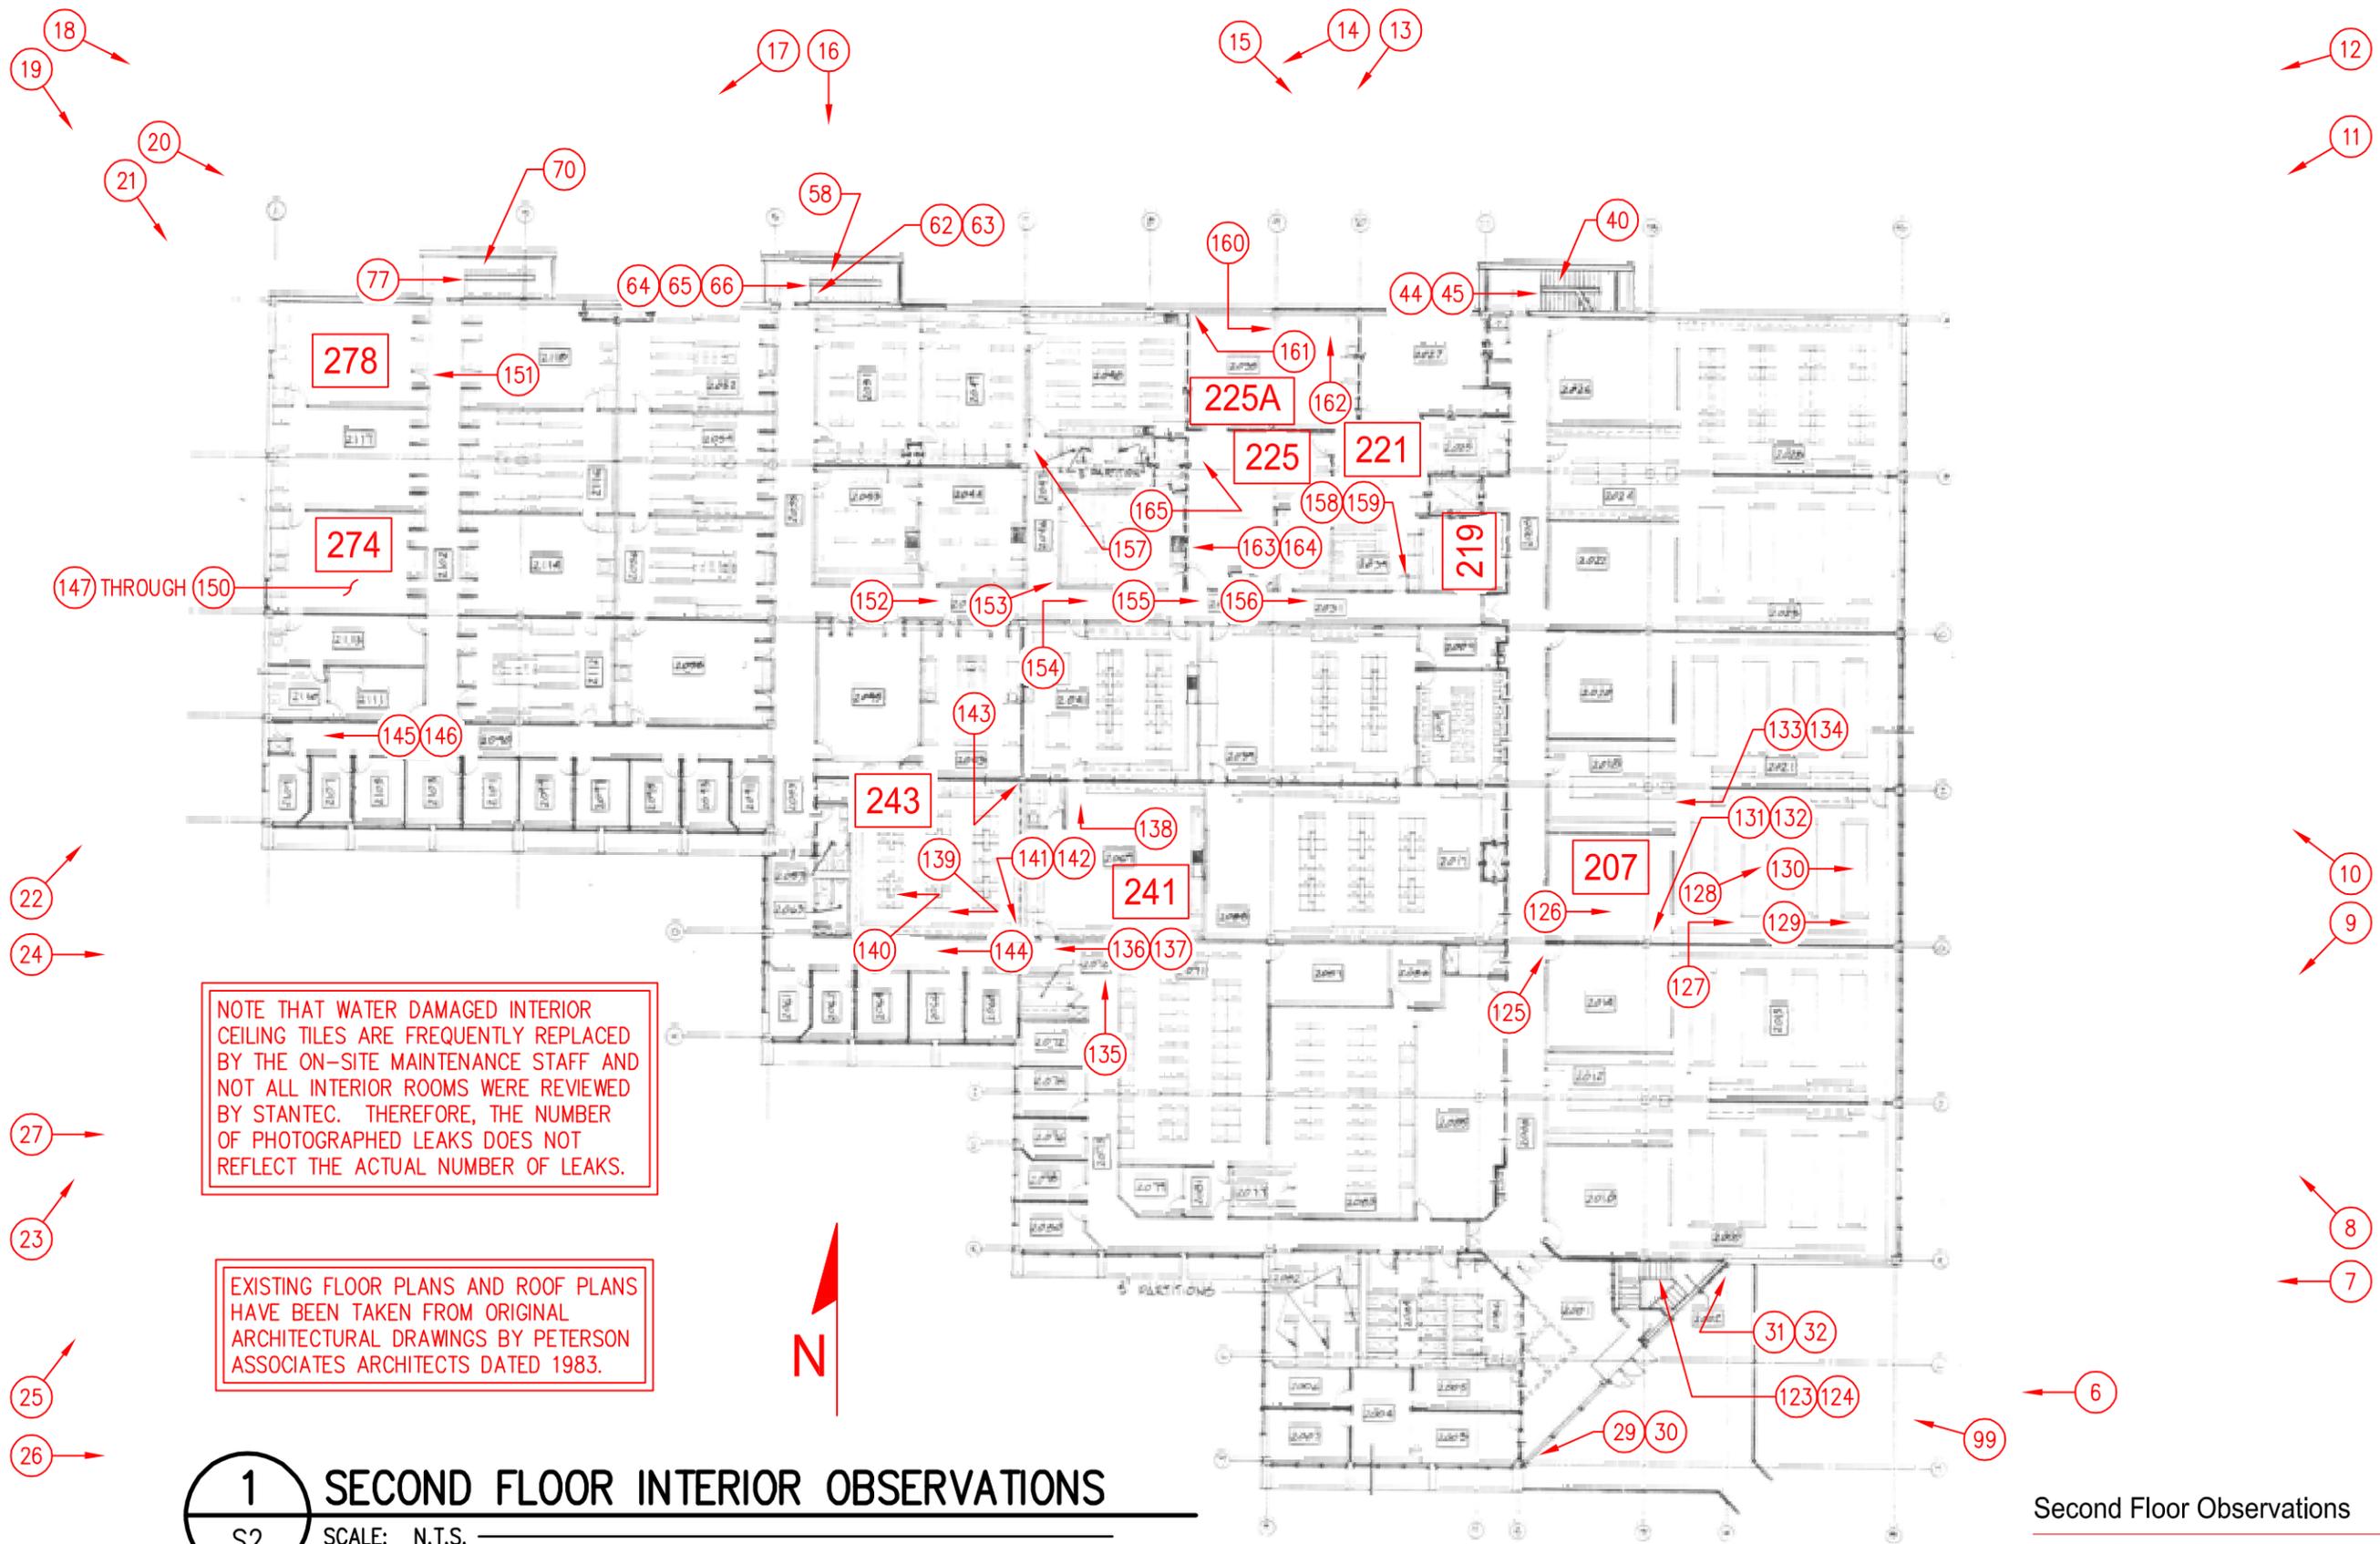
NOTE THAT WATER DAMAGED INTERIOR CEILING TILES ARE FREQUENTLY REPLACED BY THE ON-SITE MAINTENANCE STAFF AND NOT ALL INTERIOR ROOMS WERE REVIEWED BY STANTEC. THEREFORE, THE NUMBER OF PHOTOGRAPHED LEAKS DOES NOT REFLECT THE ACTUAL NUMBER OF LEAKS.

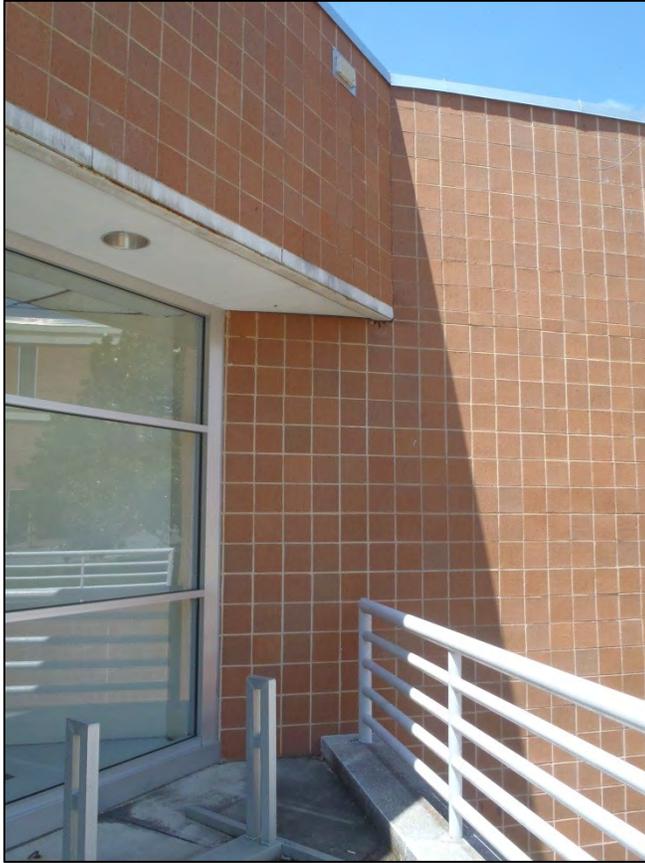
NO. 31 – SOUTHEAST ELEVATION AT MAIN
ENTRANCE – CRACKED BRICK VENEER AT GIRDER
BEARING

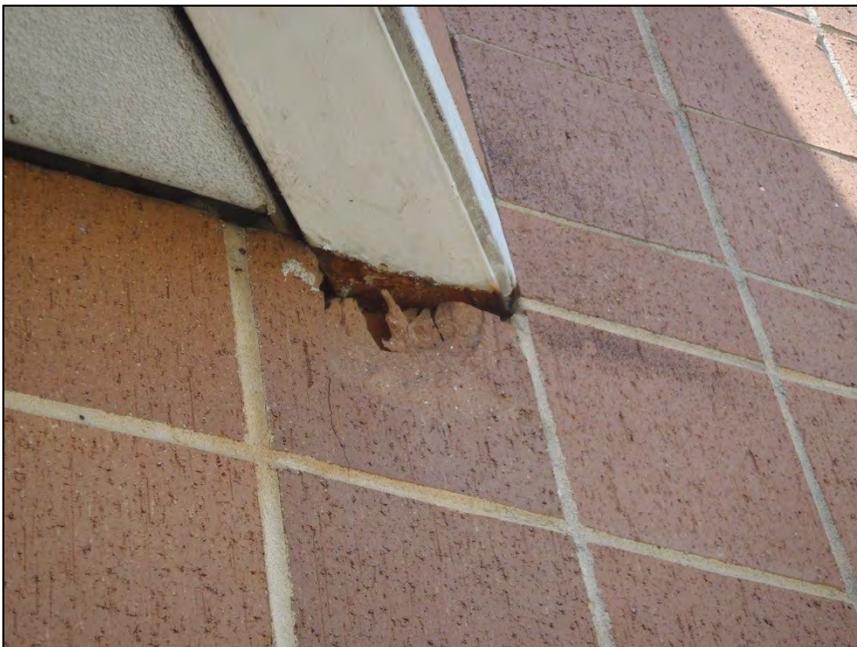
NO. 32 – SOUTHEAST ELEVATION
AT MAIN ENTRANCE – CRACKED
BRICK VENEER AT GIRDER
BEARING

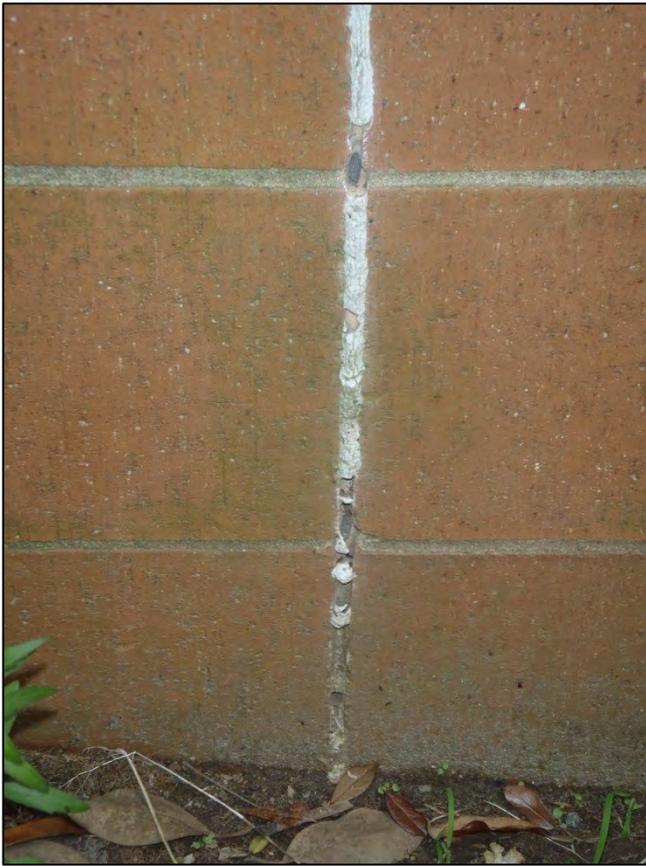
NO. 33 – EAST ELEVATION – DETERIORATED JOINT SEALANT

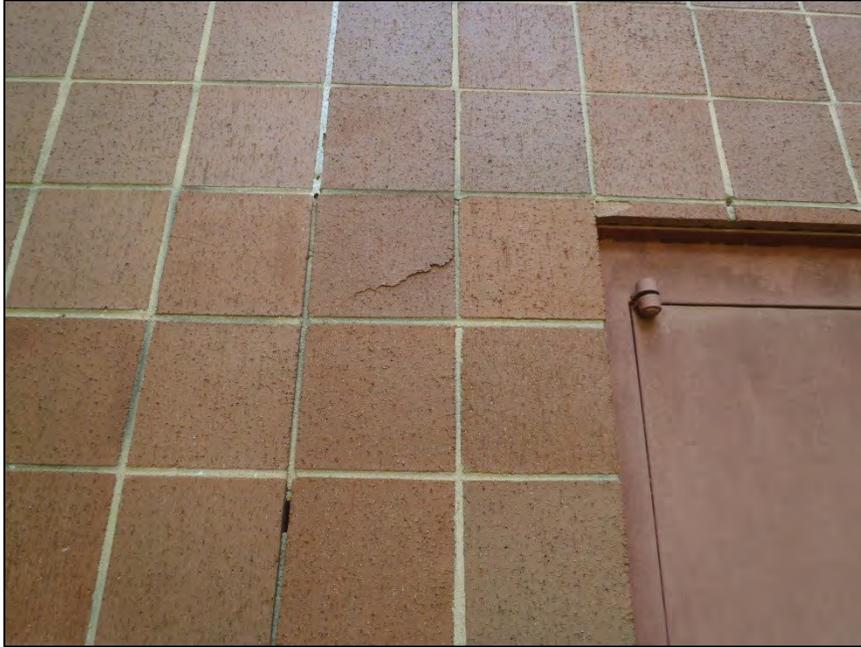
NO. 34 – EAST ELEVATION –
CRACKED INDIVIDUAL MASONRY
UNIT

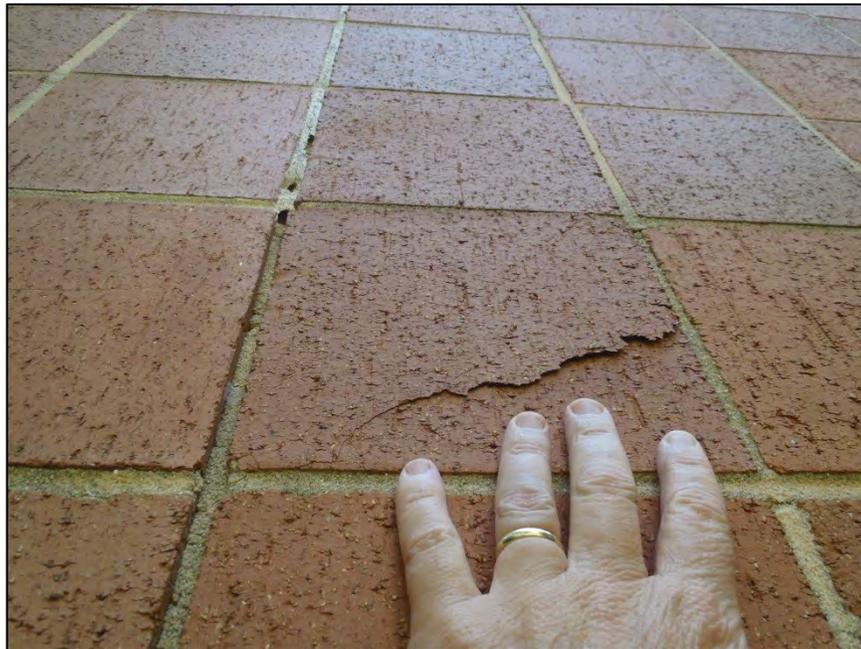
NO. 35 – EAST ELEVATION –
CRACKED INDIVIDUAL MASONRY
UNIT

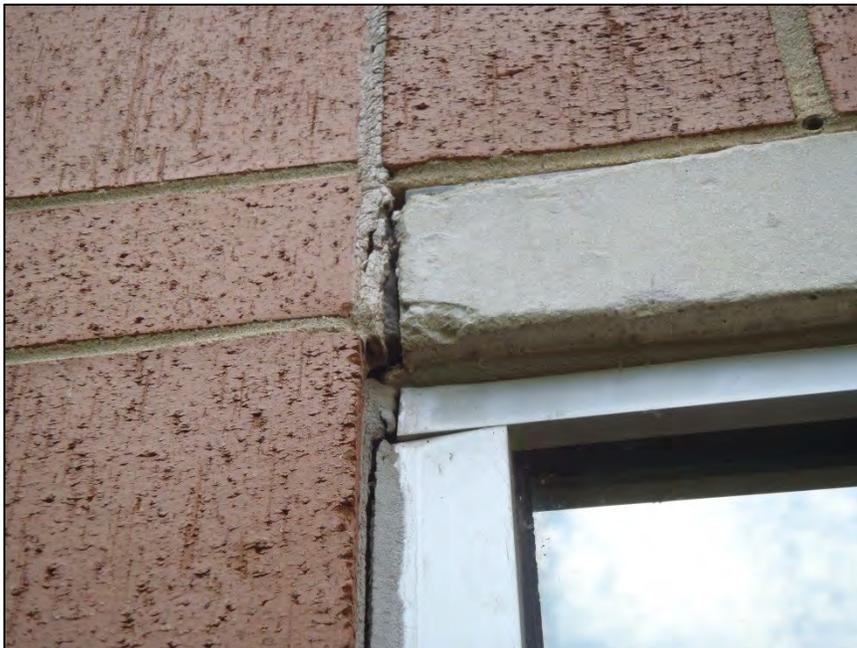
NO. 36 – NORTH ELEVATION –
DETERIORATED EXTERIOR JOINT
REQUIRING JOINT SEALANT

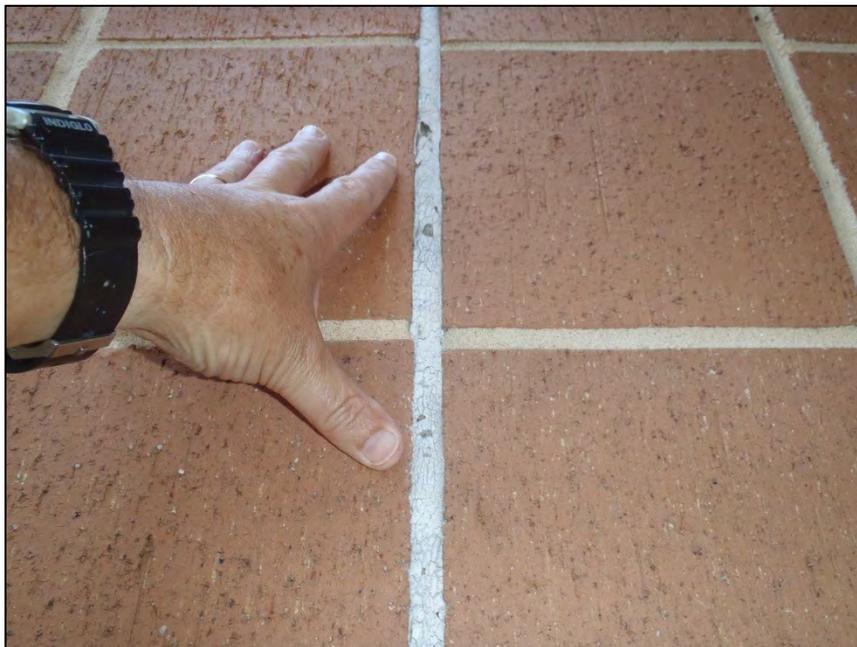
NO. 37 – NORTH ELEVATION –
DETERIORATED JOINT SEALANT

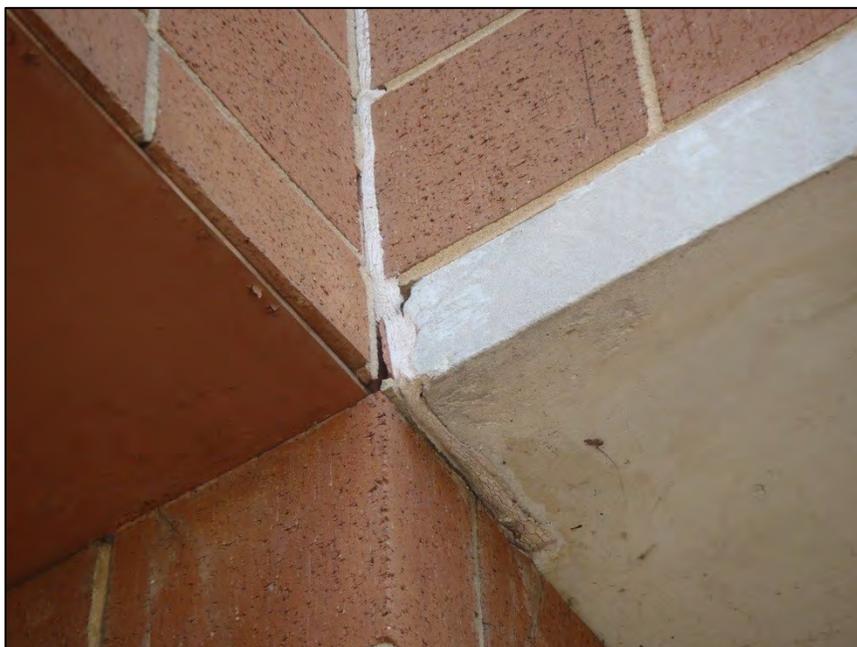
NO. 38 – NORTH ELEVATION –
DETERIORATED JOINT SEALANT

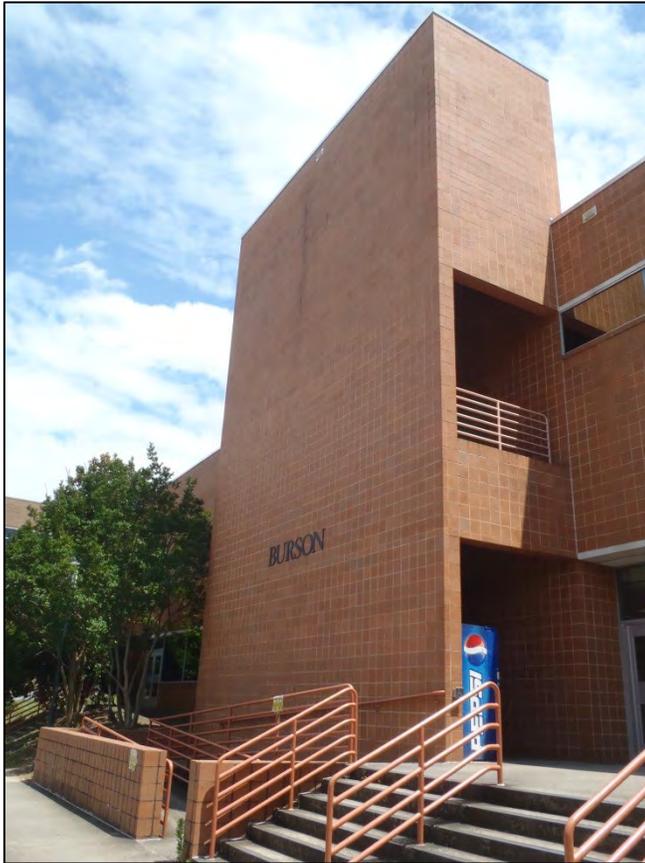
NO. 39 – NORTH ELEVATION – EAST EXTERIOR STAIRWELL

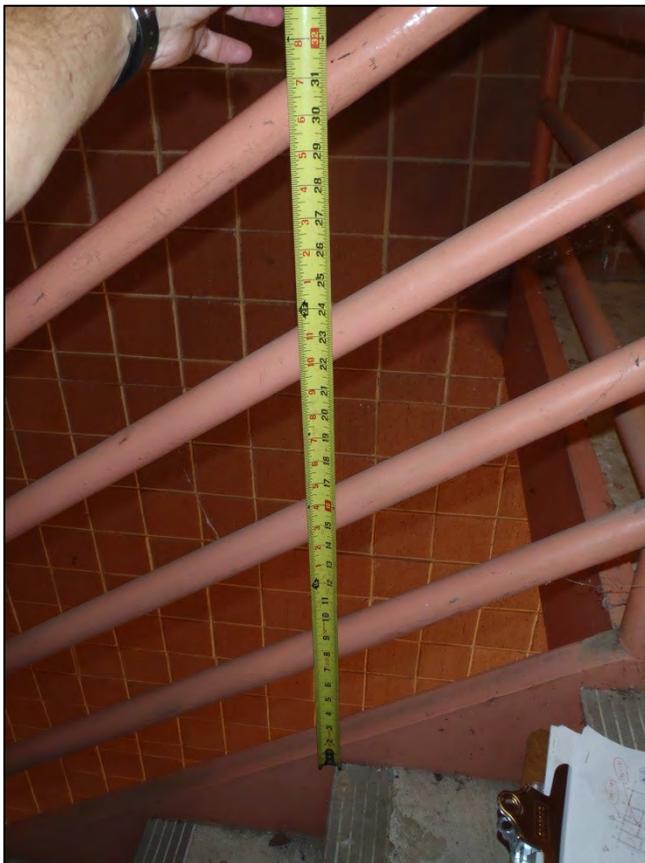
NO. 40 – NORTH ELEVATION AT EAST EXTERIOR STAIRWELL – INADEQUATE GUARDRAIL HEIGHT AT STAIRS

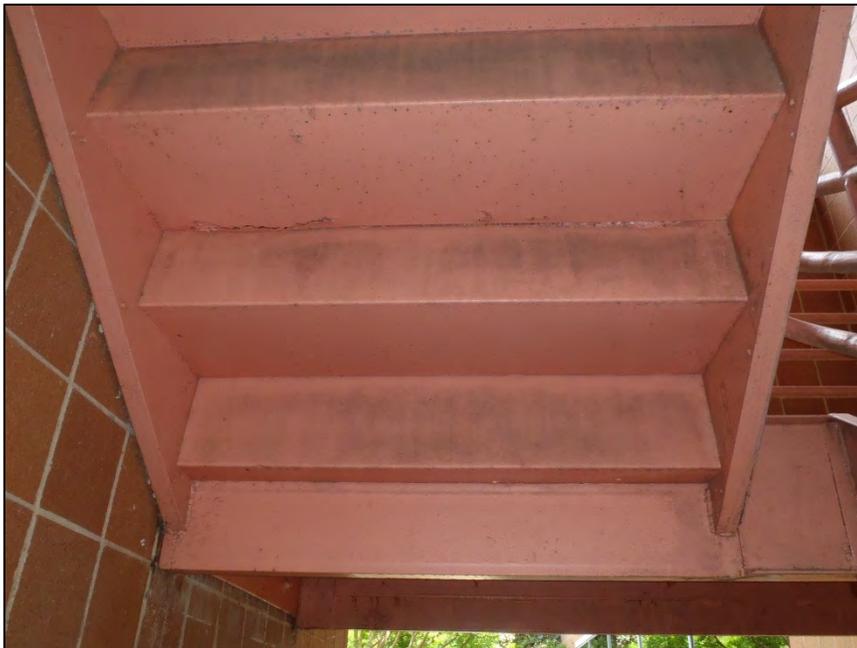
NO. 41 – NORTH ELEVATION AT EAST EXTERIOR STAIRWELL – DETERIORATED STAIR FRAMING

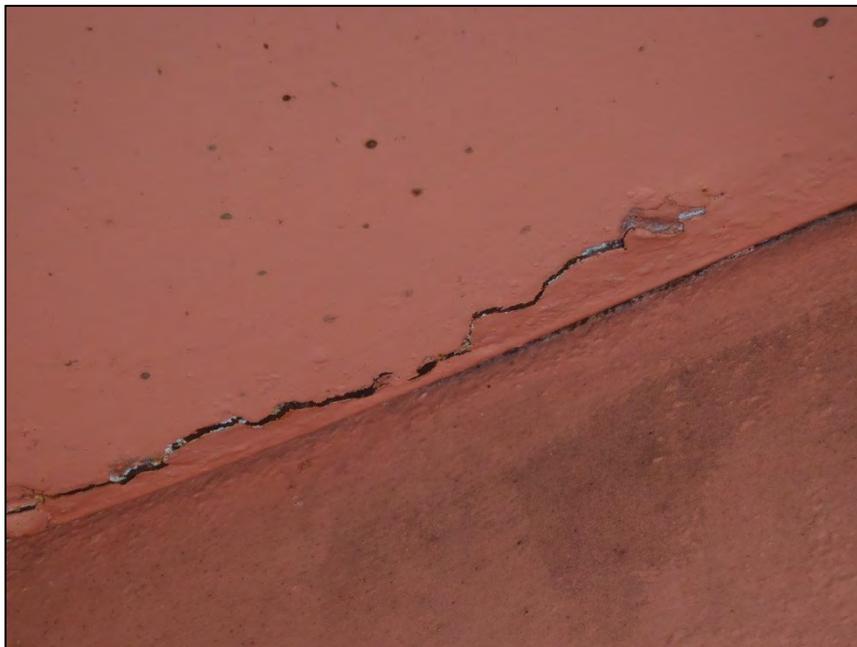
NO. 42 – NORTH ELEVATION AT EAST EXTERIOR STAIRWELL – DETERIORATED STAIR FRAMING

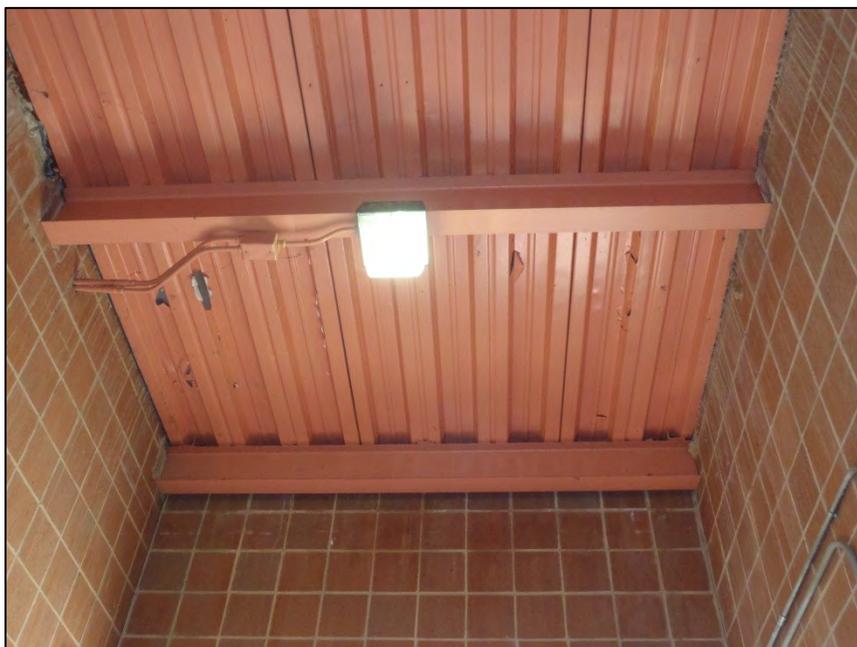
NO. 43 – NORTH ELEVATION AT EAST EXTERIOR STAIRWELL – DETERIORATED LANDING FRAMING

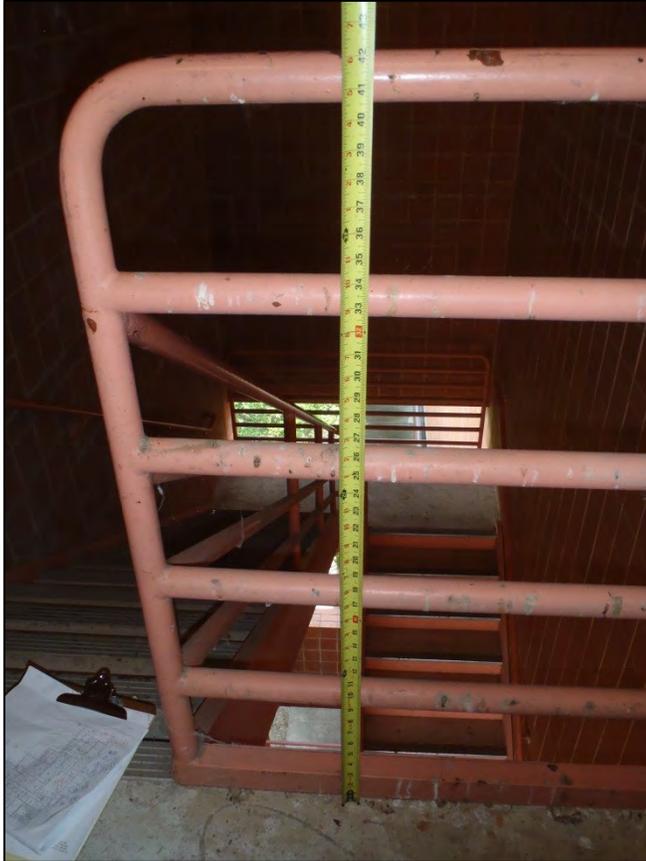
NO. 44 – NORTH ELEVATION AT EAST EXTERIOR STAIRWELL – INADEQUATE GUARDRAIL PICKET SPACINGS

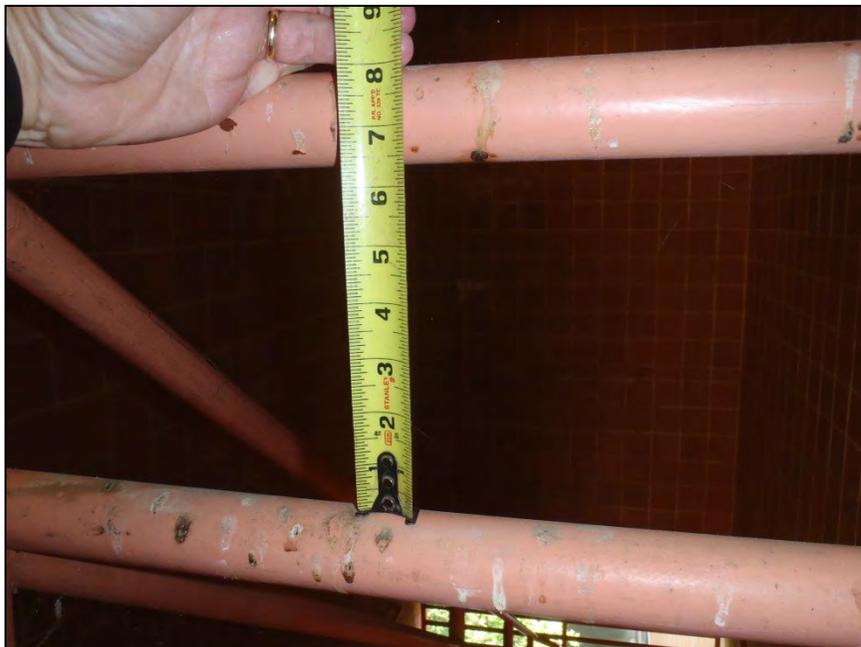
NO. 45 – NORTH ELEVATION AT EAST EXTERIOR STAIRWELL – INADEQUATE GUARDRAIL PICKET SPACINGS

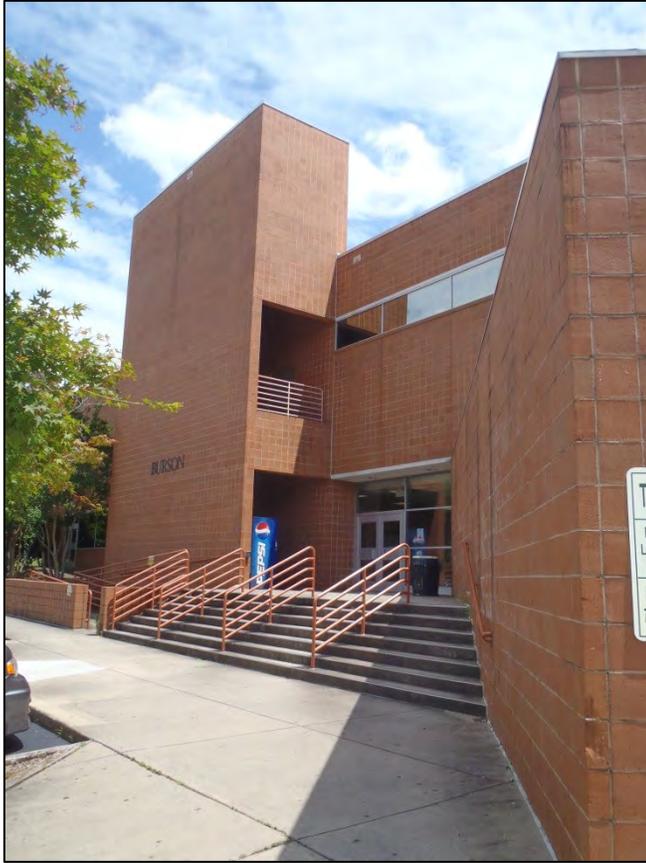
NO. 46 – NORTH ELEVATION AT EXTERIOR SCREEN WALL

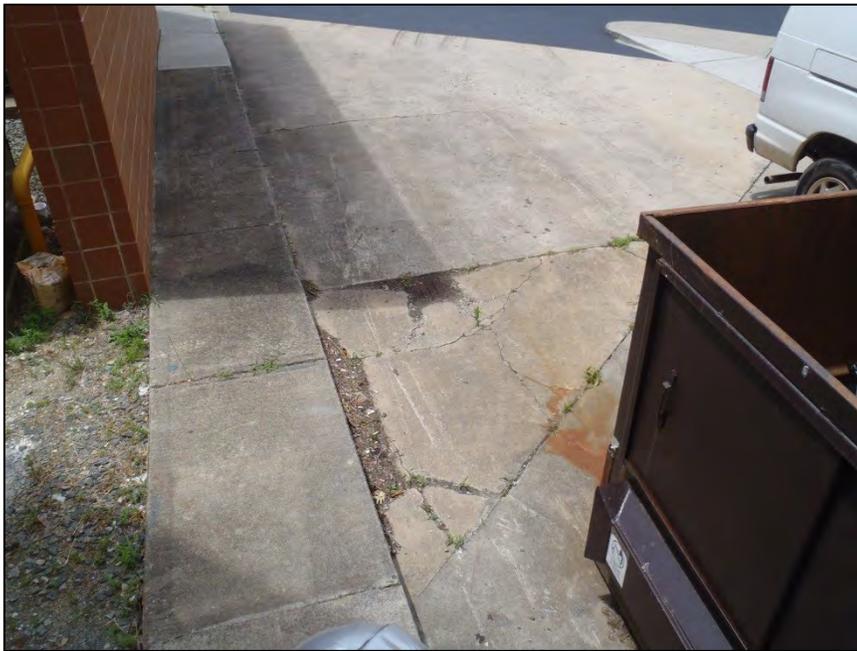
NO. 48 – NORTH ELEVATION AT
LOADING DOCK – DETERIORATED
EXTERIOR CONCRETE SLAB

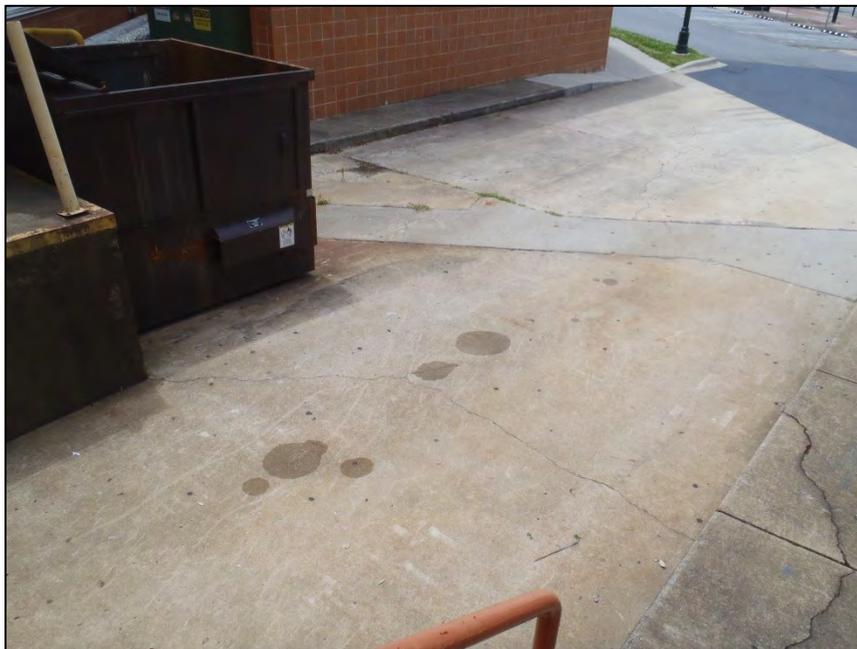
NO. 49 – NORTH ELEVATION AT
LOADING DOCK – DETERIORATED
EXTERIOR CONCRETE SLAB

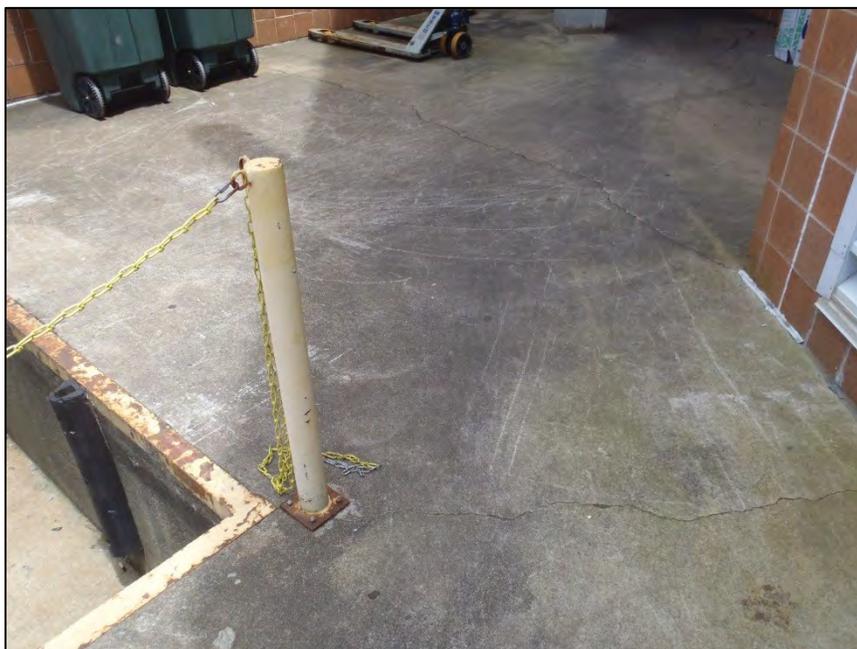
NO. 50 – NORTH ELEVATION AT
LOADING DOCK – DETERIORATED
EXTERIOR CONCRETE SLAB

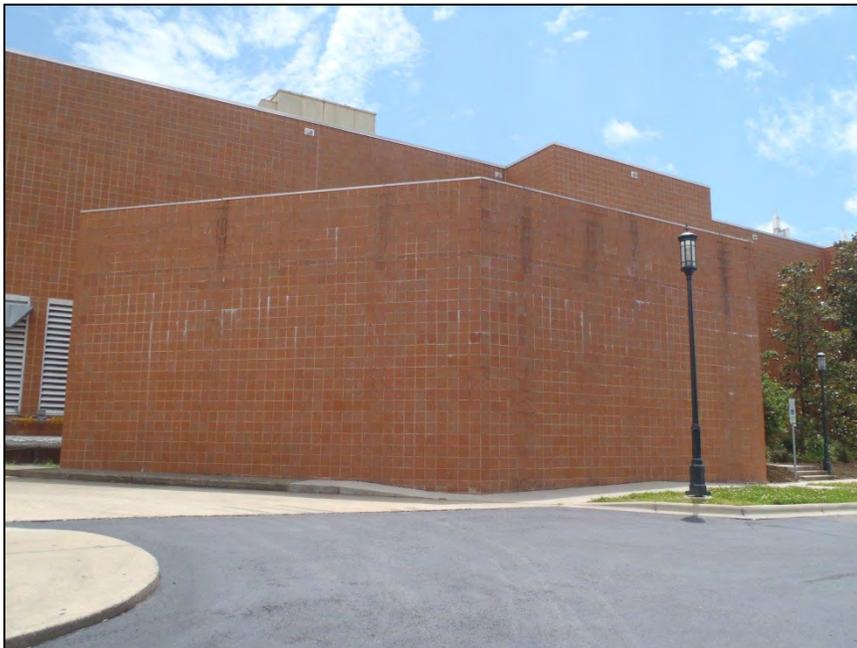
NO. 51 – NORTH ELEVATION AT
EXTERIOR SCREEN WALL –
EFFLORESCENCE AT EXTERIOR
BRICK VENEER

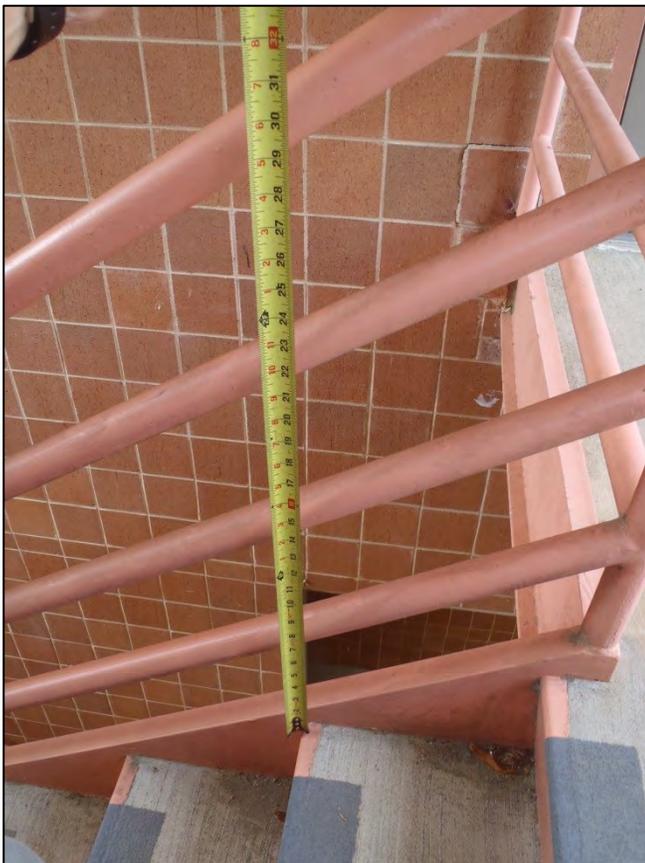
NO. 58 – NORTH ELEVATION AT CENTER EXTERIOR STAIRWELL – INADEQUATE GUARDRAIL HEIGHT AT STAIRS

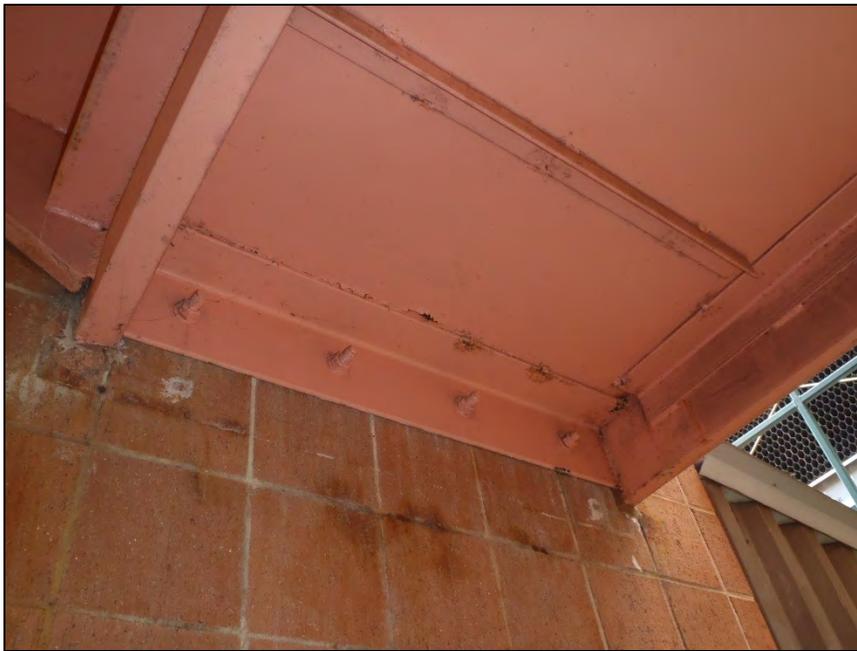
NO. 59 – NORTH ELEVATION AT
CENTER EXTERIOR STAIRWELL –
DETERIORATED LANDING
FRAMING

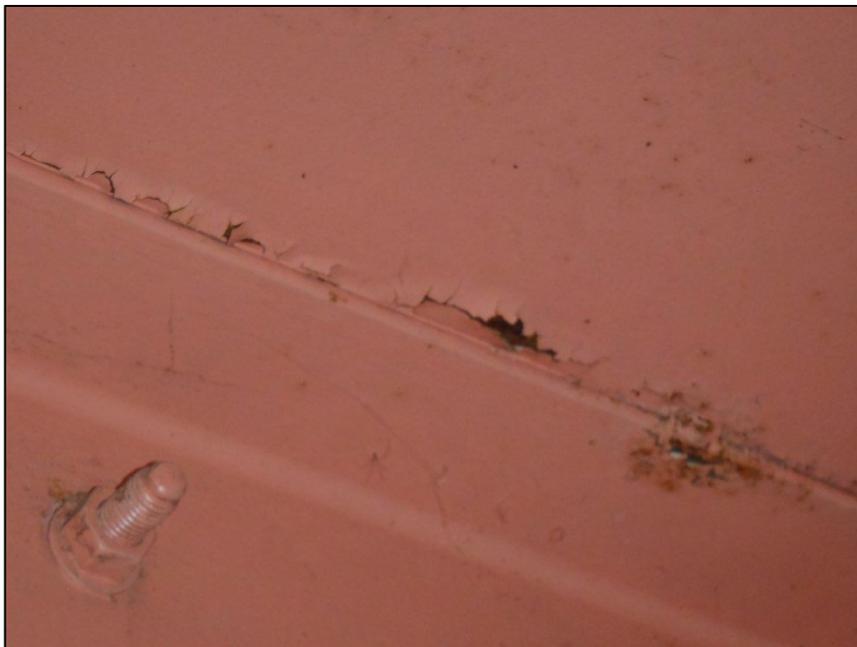
NO. 60 – NORTH ELEVATION AT
CENTER EXTERIOR STAIRWELL –
DETERIORATED LANDING
FRAMING

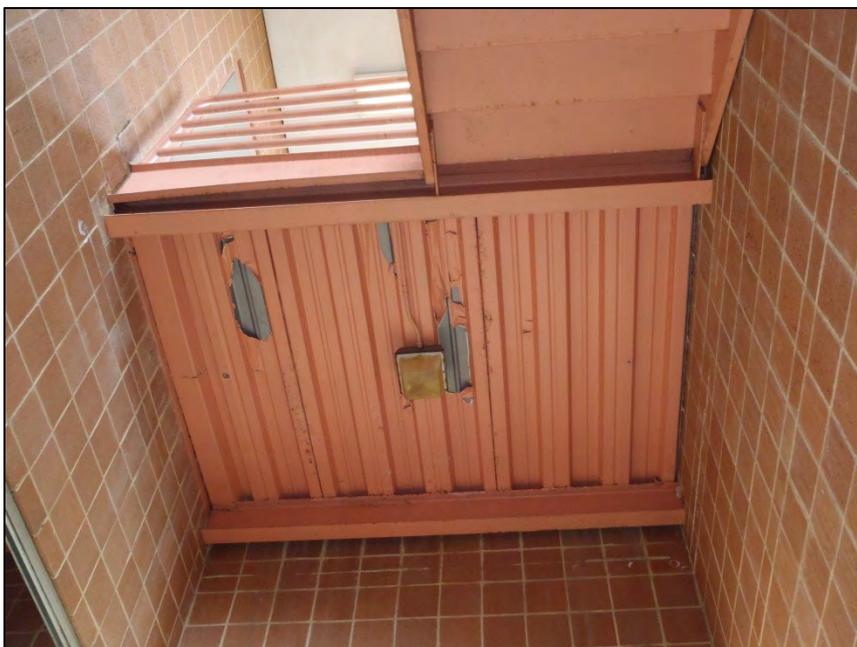
NO. 61 – NORTH ELEVATION AT
CENTER EXTERIOR STAIRWELL –
DETERIORATED LANDING
FRAMING

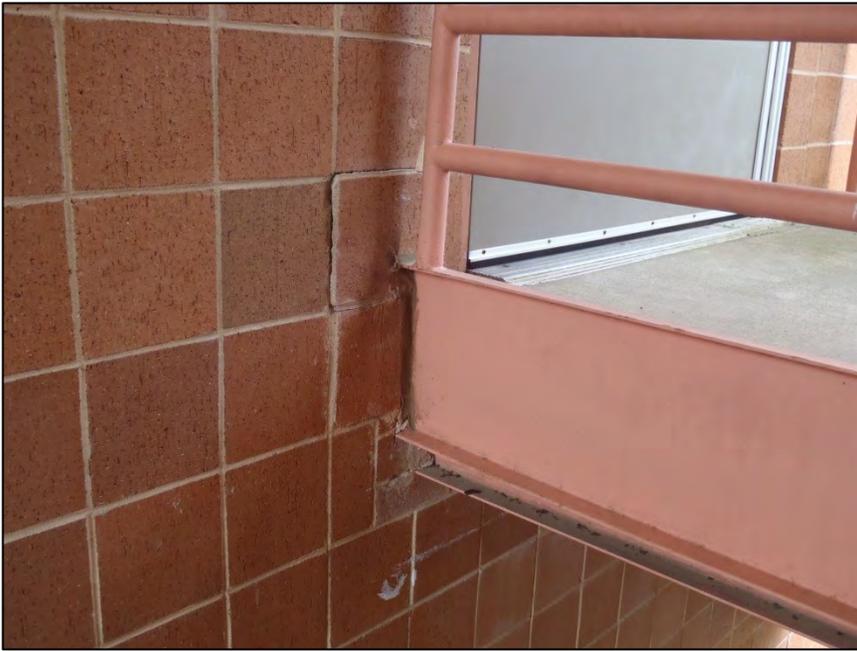
NO. 62 – NORTH ELEVATION AT CENTER EXTERIOR STAIRWELL – DETERIORATED STEEL GIRDER AND SPALLED BRICK VENEER AT BEAM BEARING LOCATION

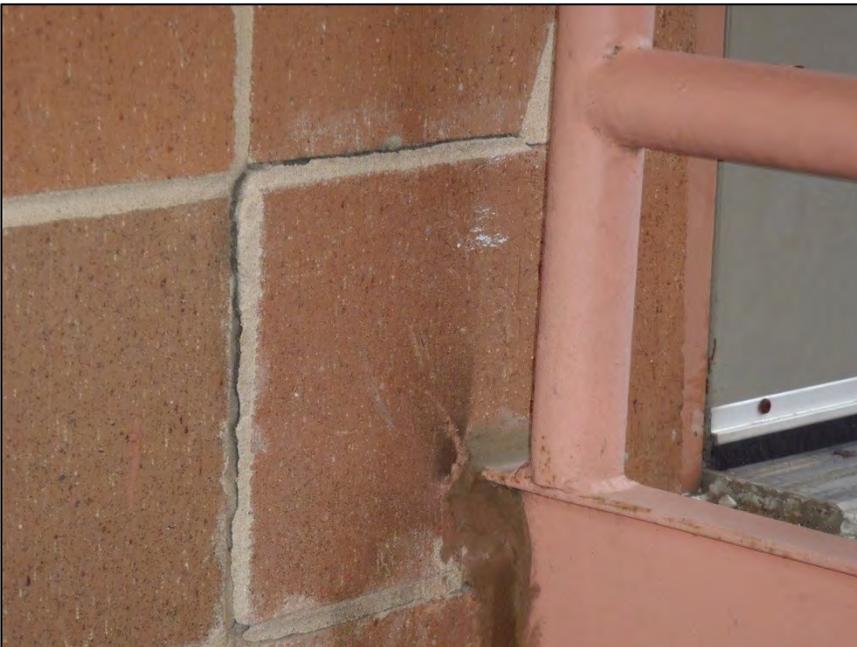
NO. 63 – NORTH ELEVATION AT CENTER EXTERIOR STAIRWELL – DETERIORATED STEEL GIRDER AND SPALLED BRICK VENEER AT BEAM BEARING LOCATION
