UNIVERSITY OF NORTH CAROLINA at CHARLOTTE

Burson Building Feasibility Study

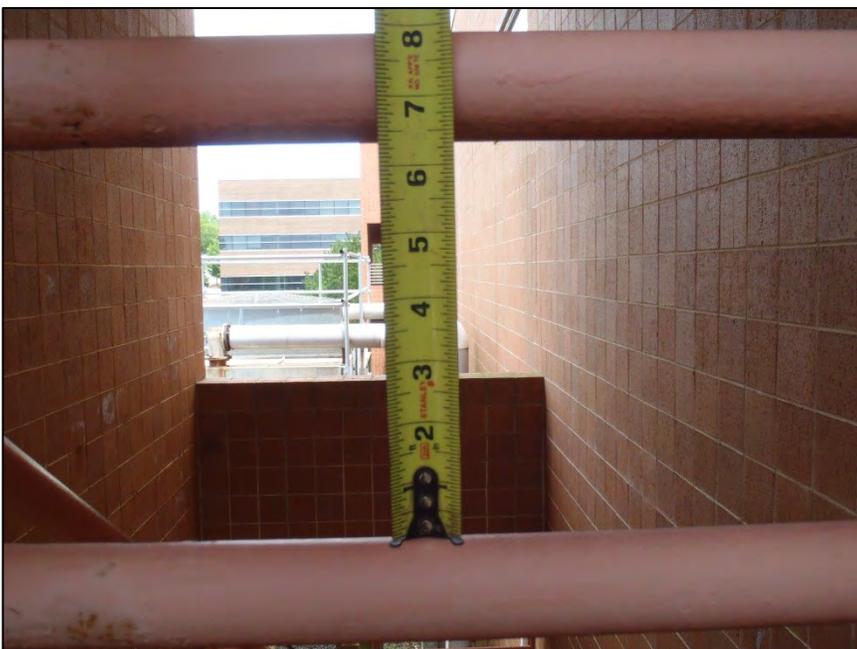
NO. 64 – NORTH ELEVATION AT CENTER EXTERIOR STAIRWELL – INADEQUATE GUARDRAIL PICKET SPACINGS

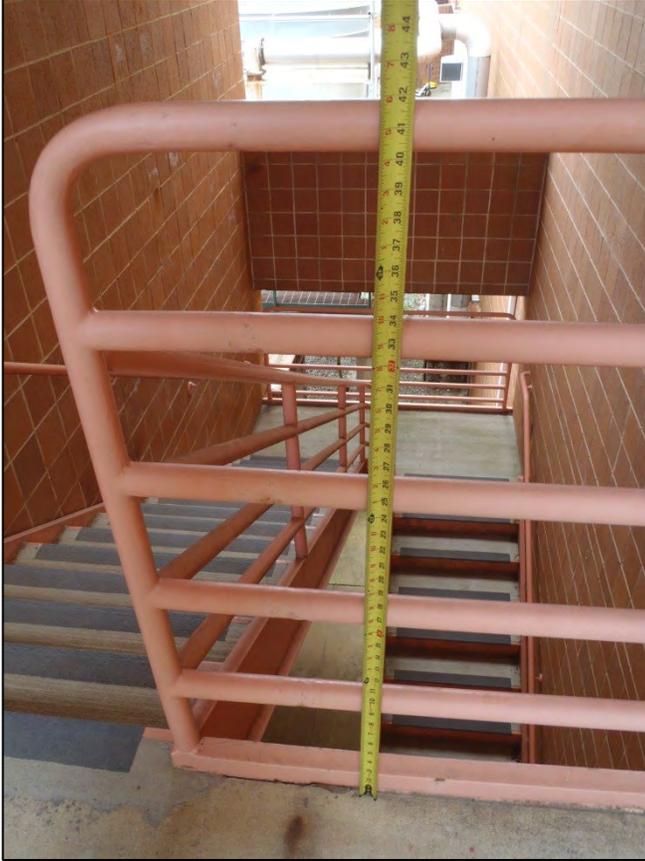
NO. 65 – NORTH ELEVATION AT CENTER EXTERIOR STAIRWELL – INADEQUATE GUARDRAIL HEIGHT

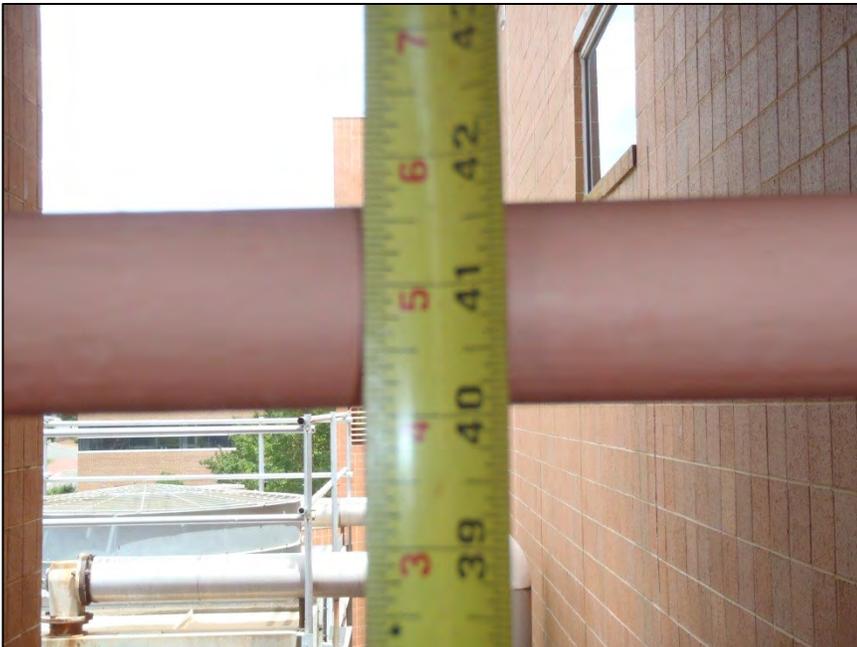
NO. 66 – NORTH ELEVATION AT CENTER EXTERIOR STAIRWELL – INADEQUATE GUARDRAIL HEIGHT

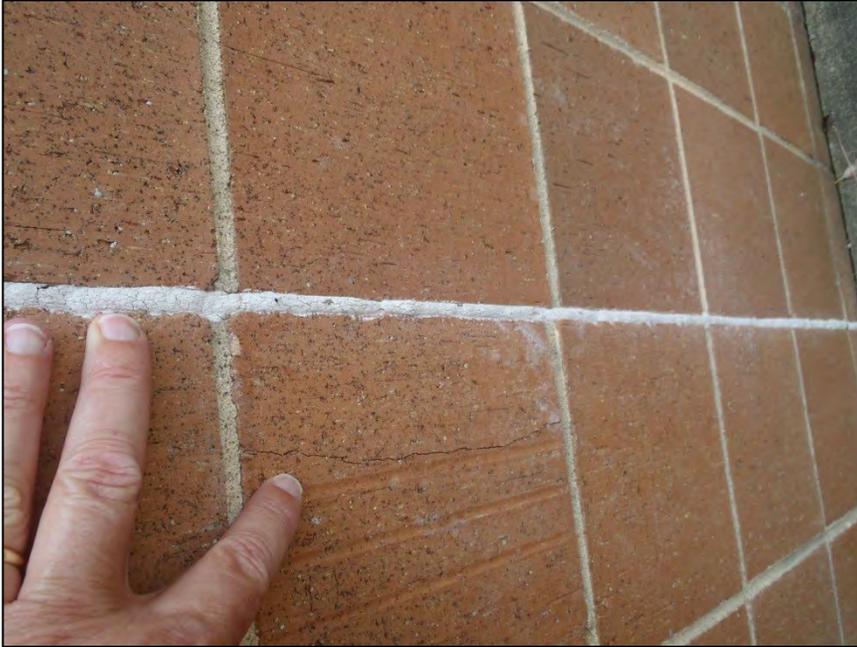
NO. 67 – NORTH ELEVATION
ADJACENT TO THE CENTER
EXTERIOR STAIRWELL –
DETERIORATED JOINT SEALANT
AND CRACKED INDIVIDUAL BRICK
MASONRY UNIT

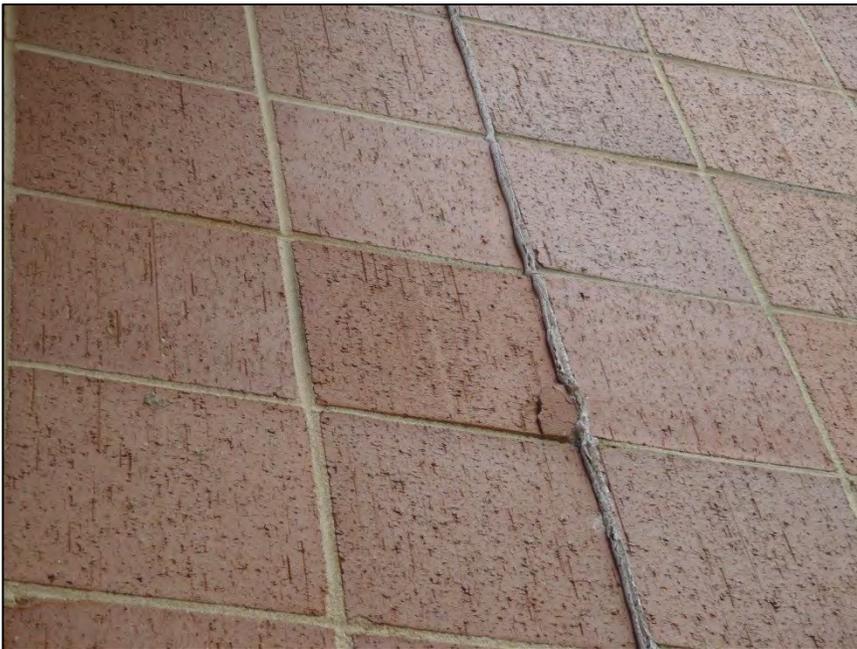
NO. 68 – NORTH ELEVATION
ADJACENT TO THE CENTER
EXTERIOR STAIRWELL –
DETERIORATED JOINT SEALANT

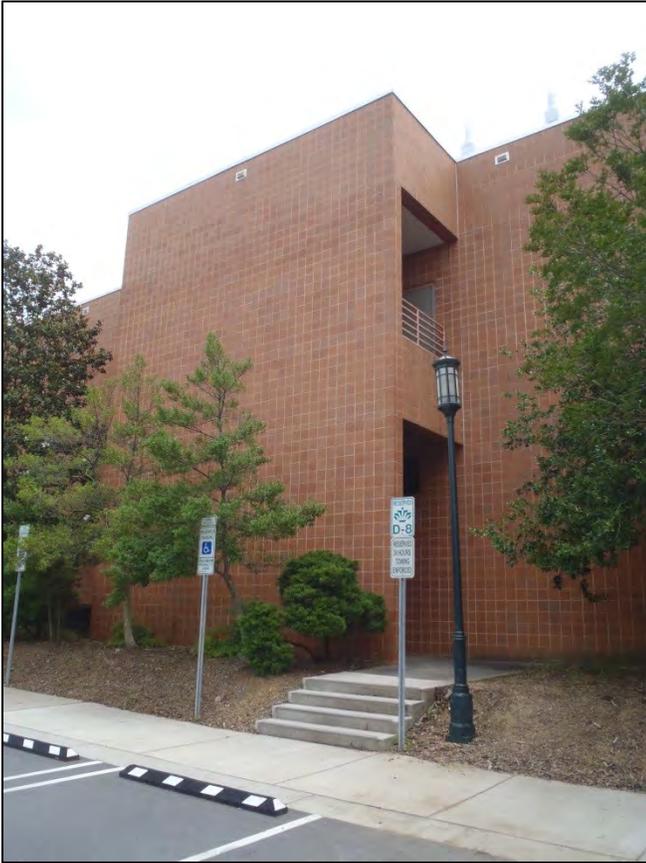
NO. 69 – NORTH ELEVATION – WEST EXTERIOR STAIRWELL

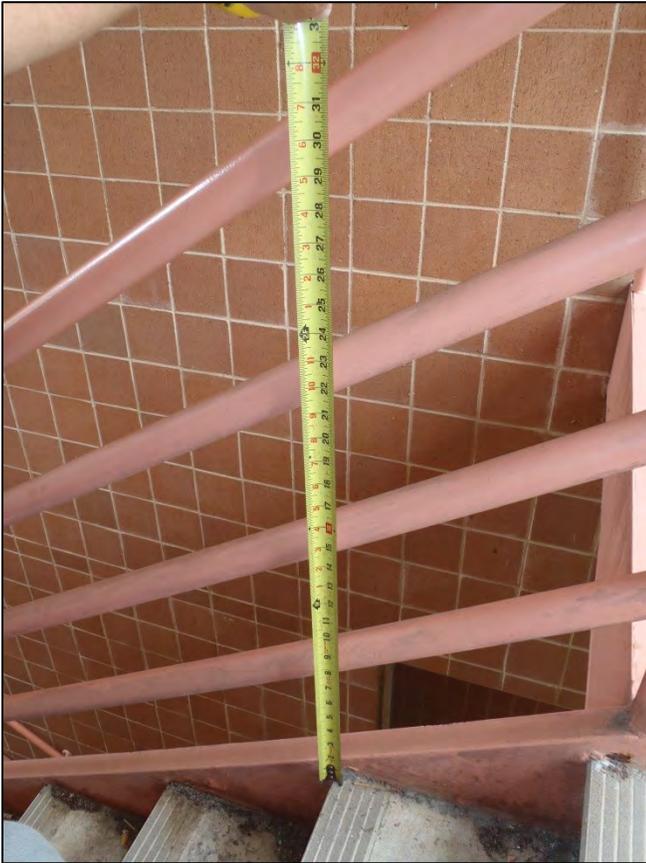
NO. 70 – NORTH ELEVATION AT WEST EXTERIOR STAIRWELL – INADEQUATE GUARDRAIL HEIGHT AT STAIRS

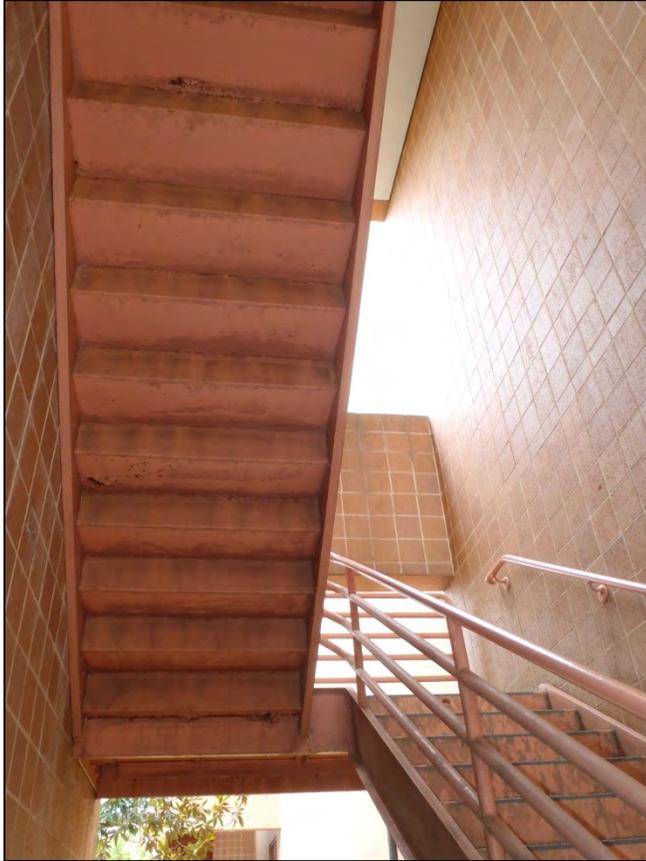
NO. 71 – NORTH ELEVATION AT WEST EXTERIOR STAIRWELL – DETERIORATED STAIR FRAMING

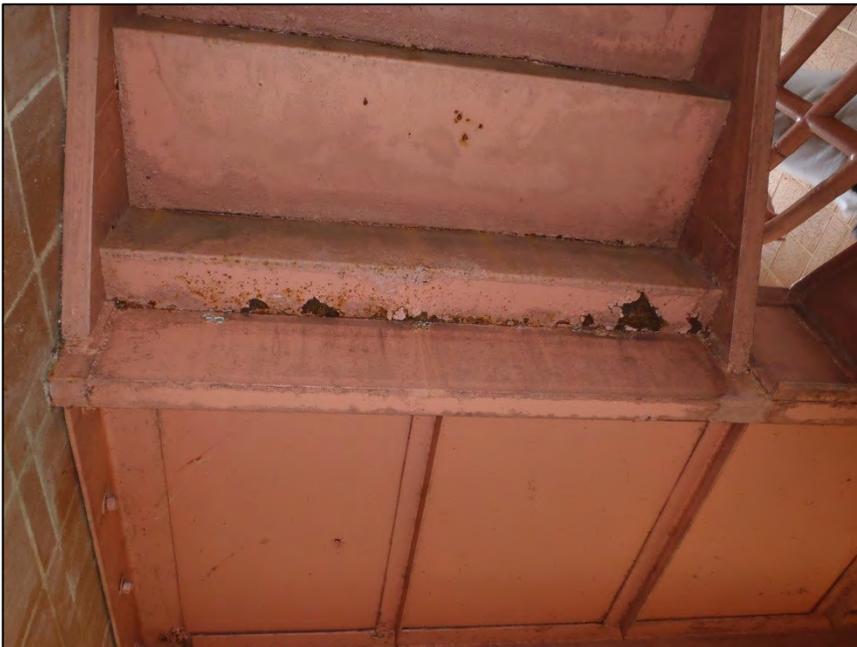
NO. 72 – NORTH ELEVATION AT WEST EXTERIOR STAIRWELL – DETERIORATED STAIR FRAMING

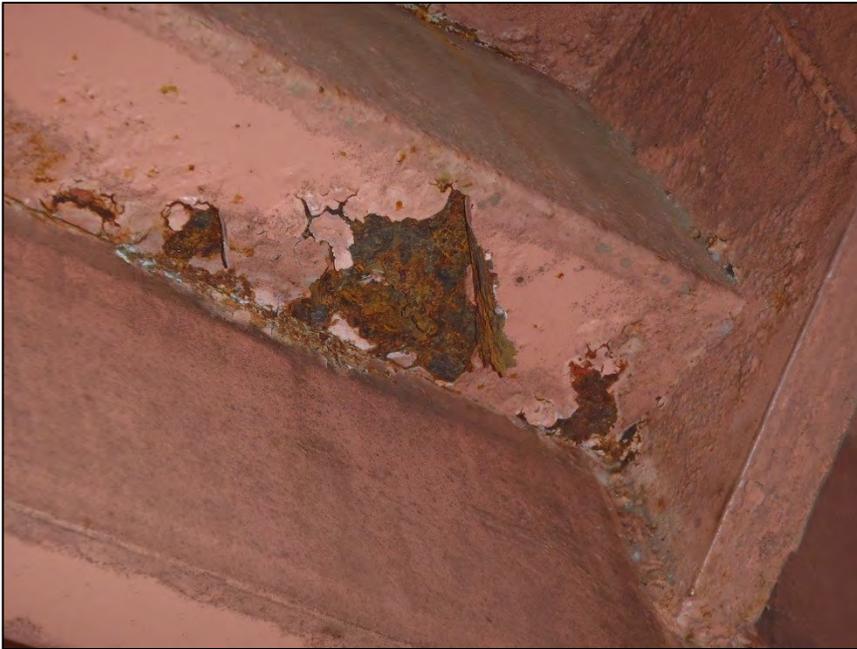
NO. 73 – NORTH ELEVATION AT WEST EXTERIOR STAIRWELL – DETERIORATED STAIR FRAMING

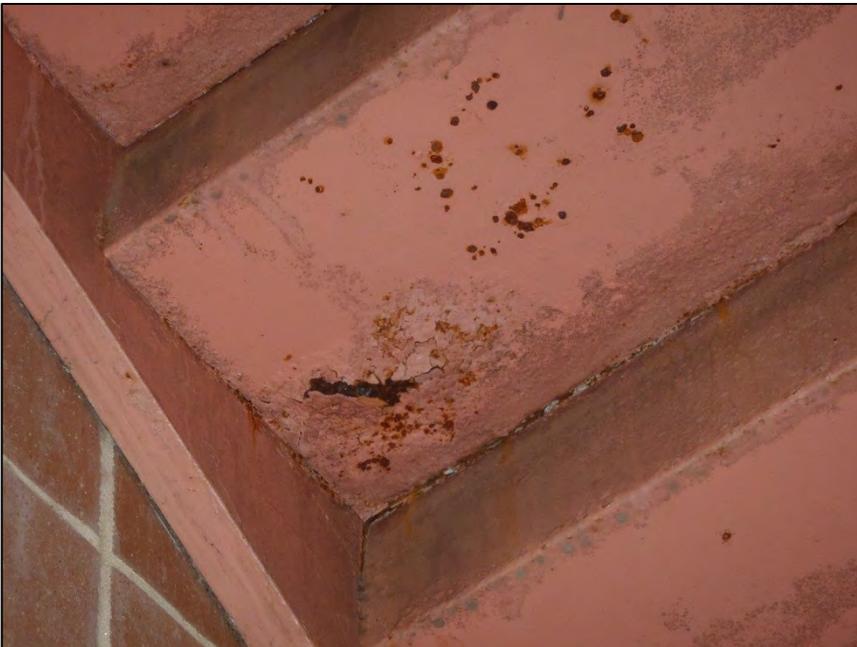
NO. 74 – NORTH ELEVATION AT WEST EXTERIOR STAIRWELL – DETERIORATED STAIR FRAMING

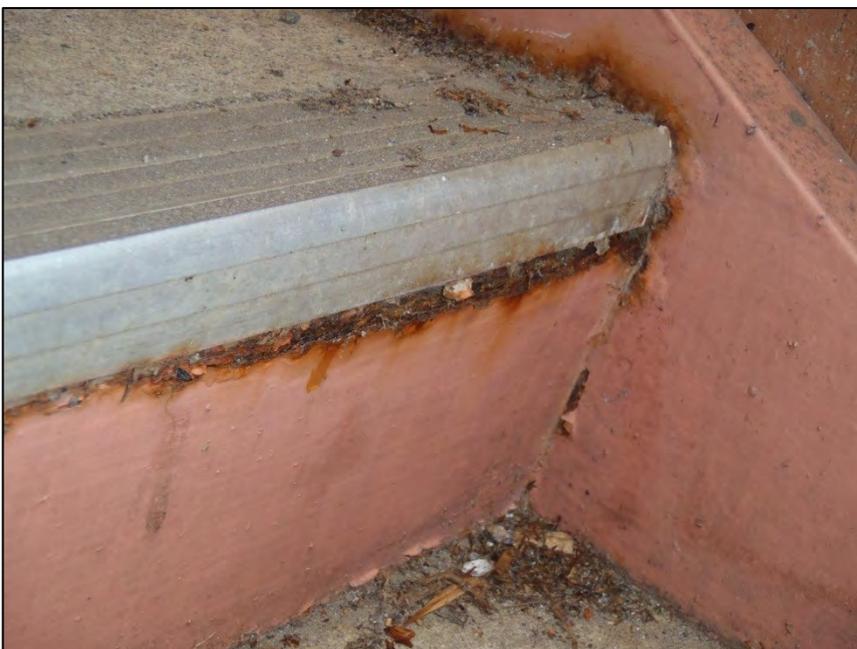
NO. 75 – NORTH ELEVATION AT WEST EXTERIOR STAIRWELL – DETERIORATED STAIR FRAMING

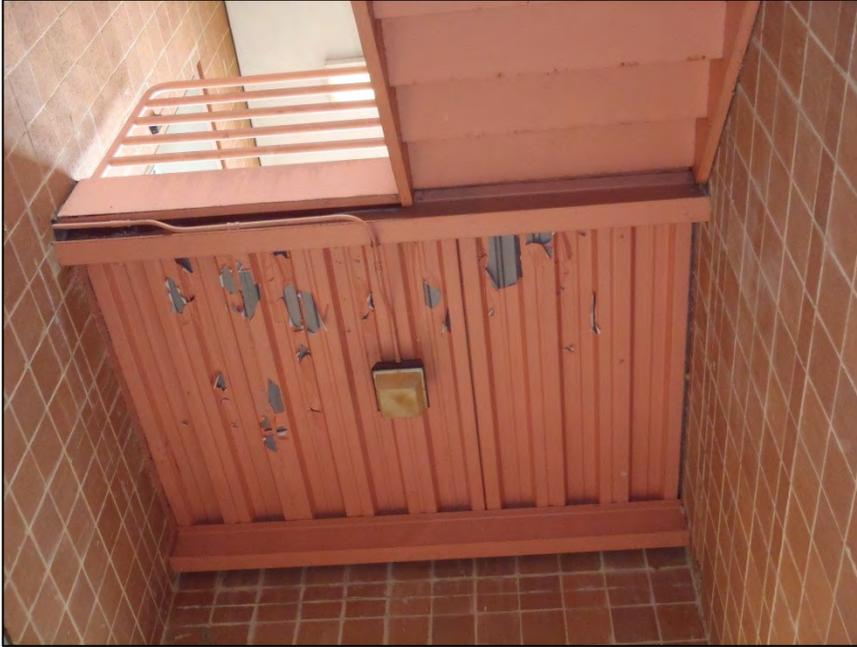
NO. 76 – NORTH ELEVATION AT WEST EXTERIOR STAIRWELL – DETERIORATED LANDING FRAMING

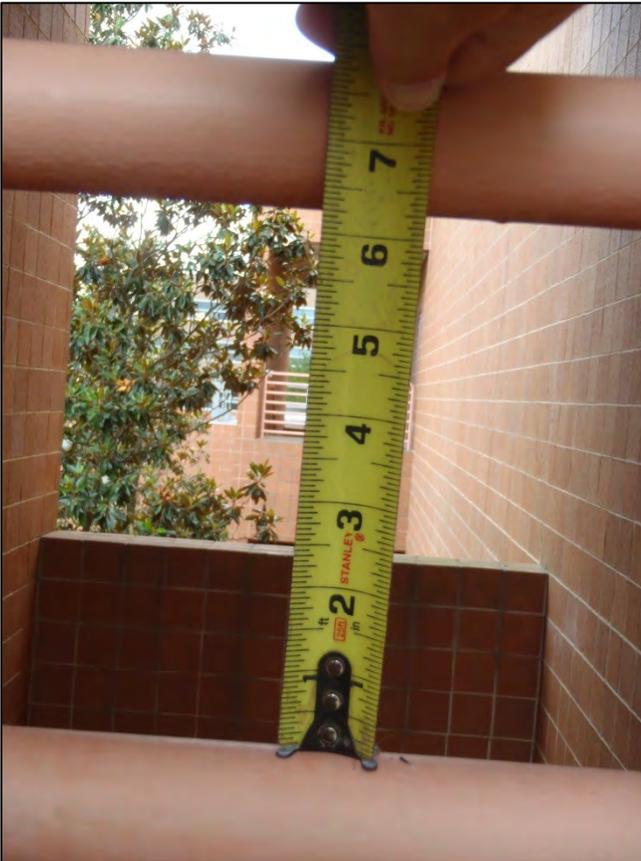
NO. 77 – NORTH ELEVATION AT WEST EXTERIOR STAIRWELL – INADEQUATE GUARDRAIL PICKET SPACINGS

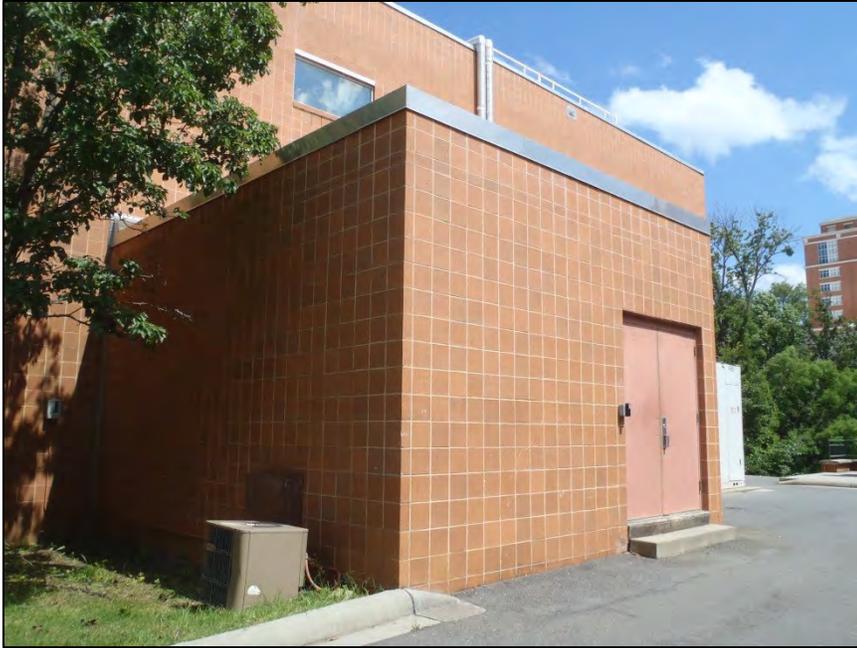
NO. 78 – WEST ELEVATION –
BASEMENT ADDITION

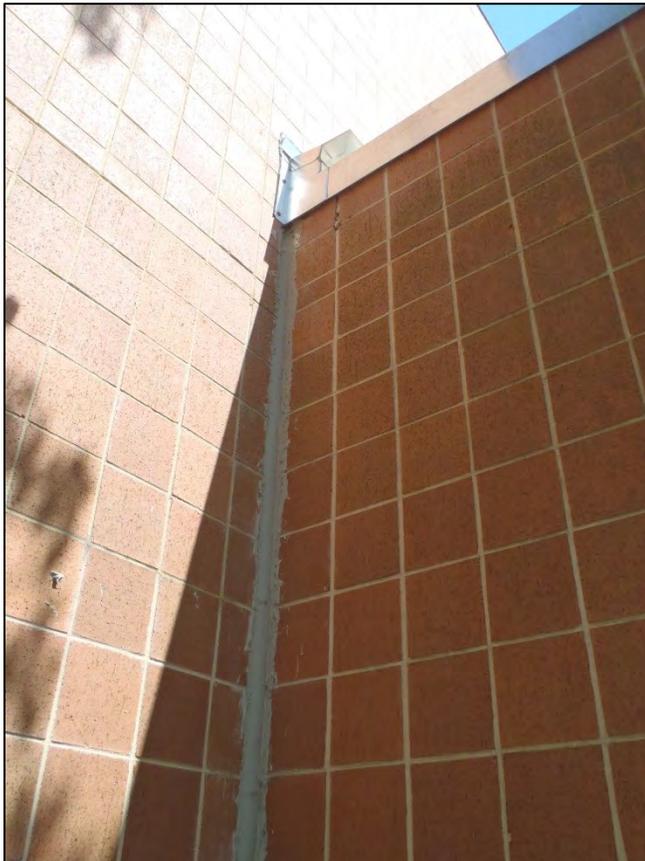
NO. 79 – WEST ELEVATION AT BASEMENT ADDITION
– DETERIORATED JOINT SEALANT

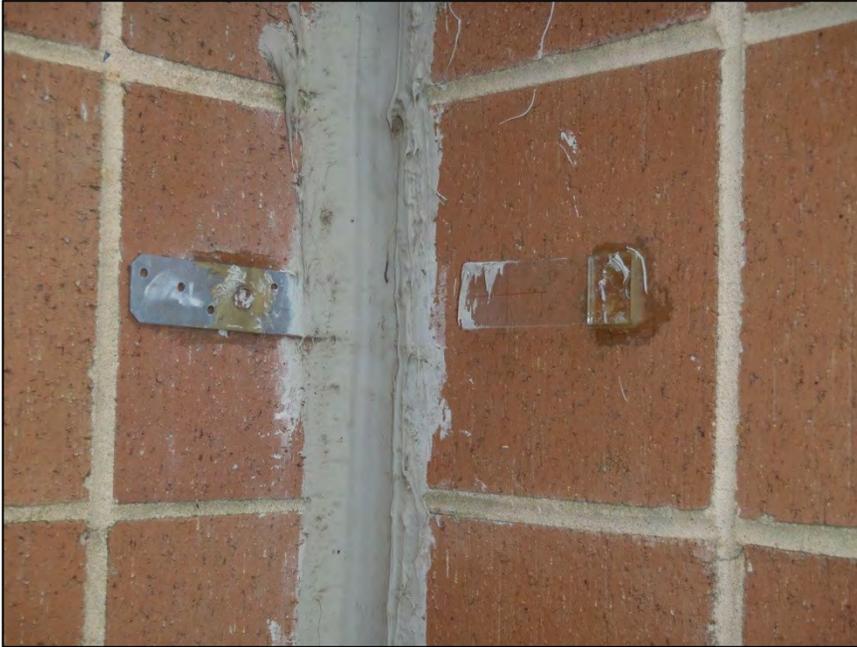
NO. 80 – WEST ELEVATION AT
BASEMENT ADDITION –
DETERIORATED JOINT SEALANT

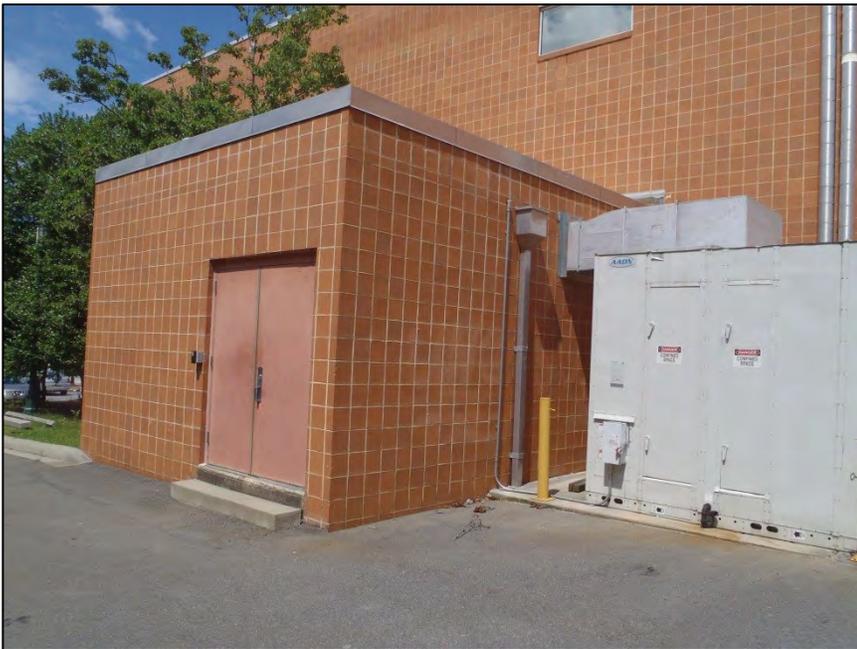
NO. 81 – WEST ELEVATION –
BASEMENT ADDITION

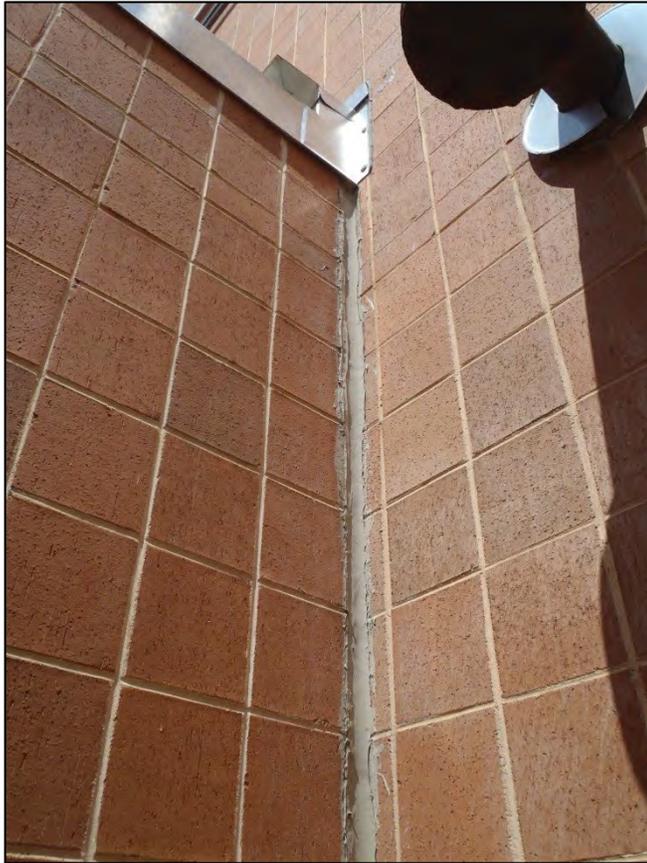
NO. 82 – WEST ELEVATION AT BASEMENT ADDITION
– DETERIORATED JOINT SEALANT

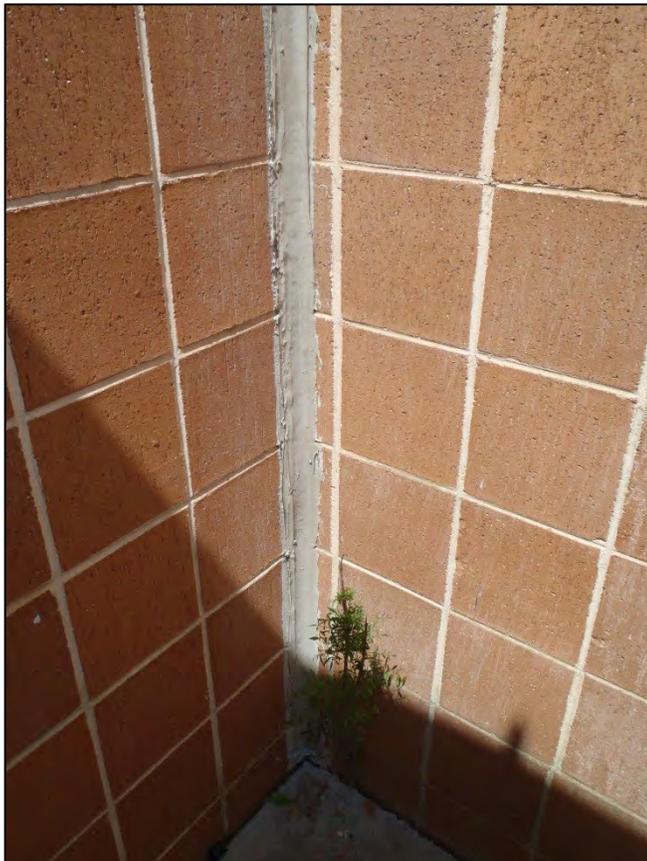
NO. 83 – WEST ELEVATION AT BASEMENT ADDITION
– DETERIORATED JOINT SEALANT

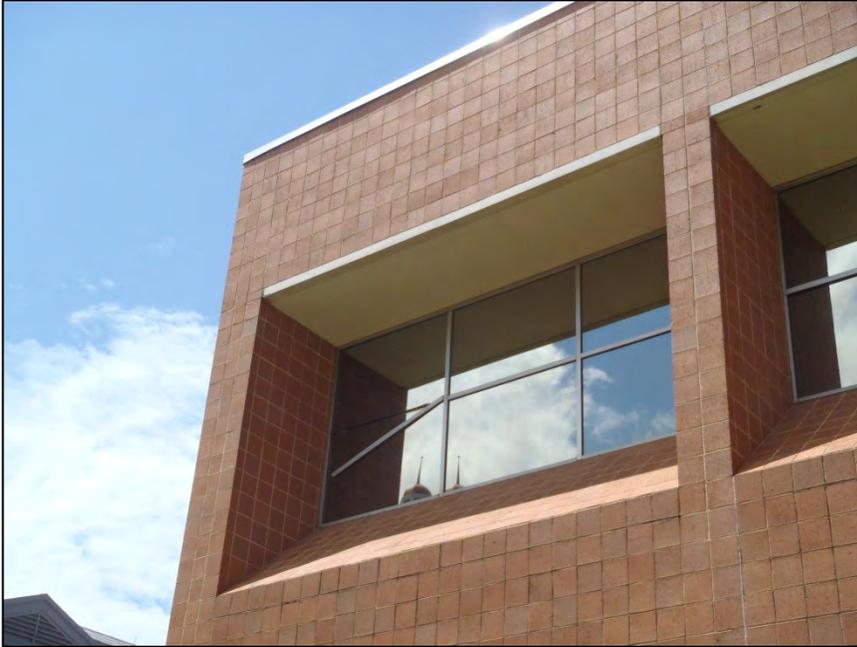
NO. 84 – SOUTH ELEVATION –
DISPLACED WINDOW FRAMING

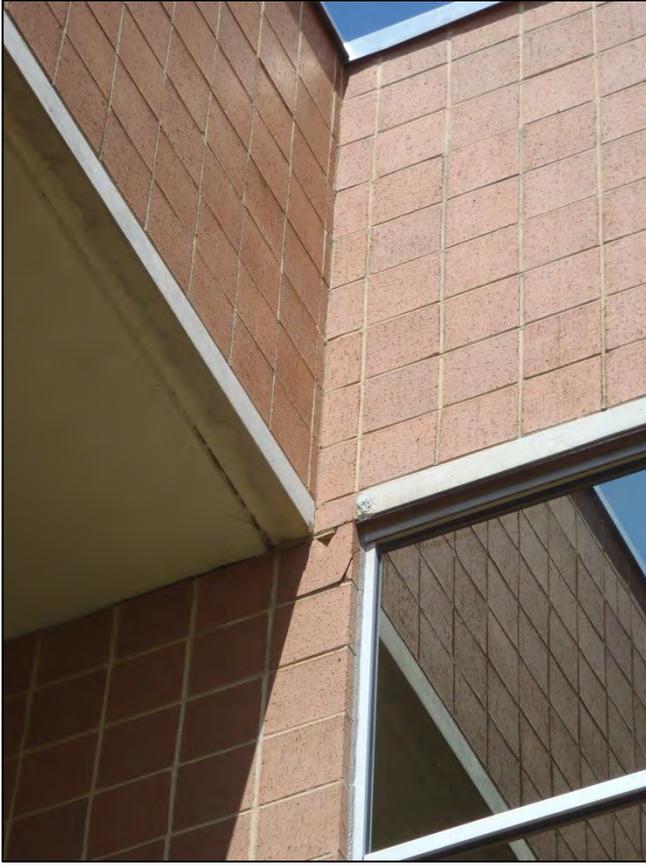
NO. 88 – SOUTHWEST ELEVATION – CRACKED
INDIVIDUAL BRICK MASONRY UNITS

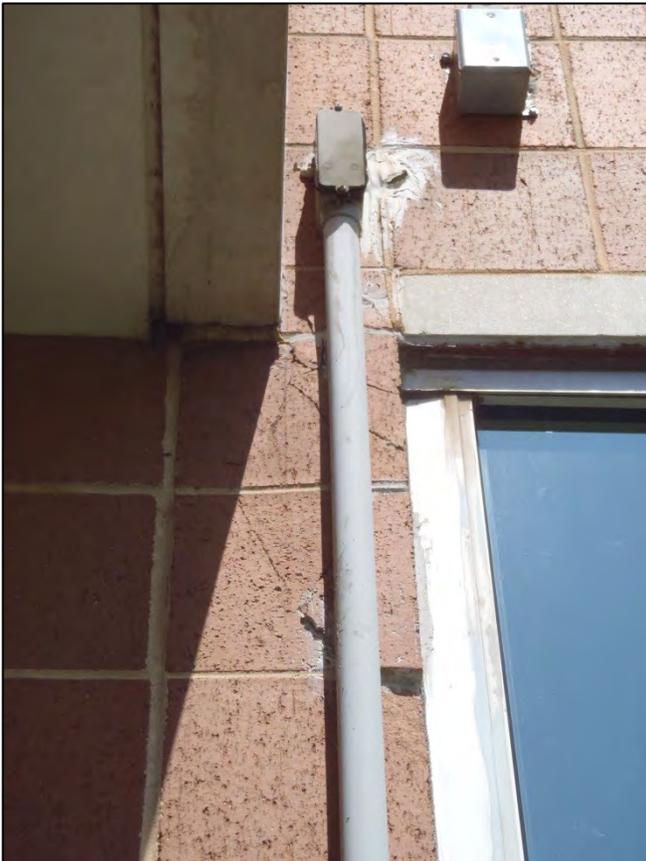
NO. 89 – SOUTHWEST ELEVATION – CRACKED
INDIVIDUAL BRICK MASONRY UNITS

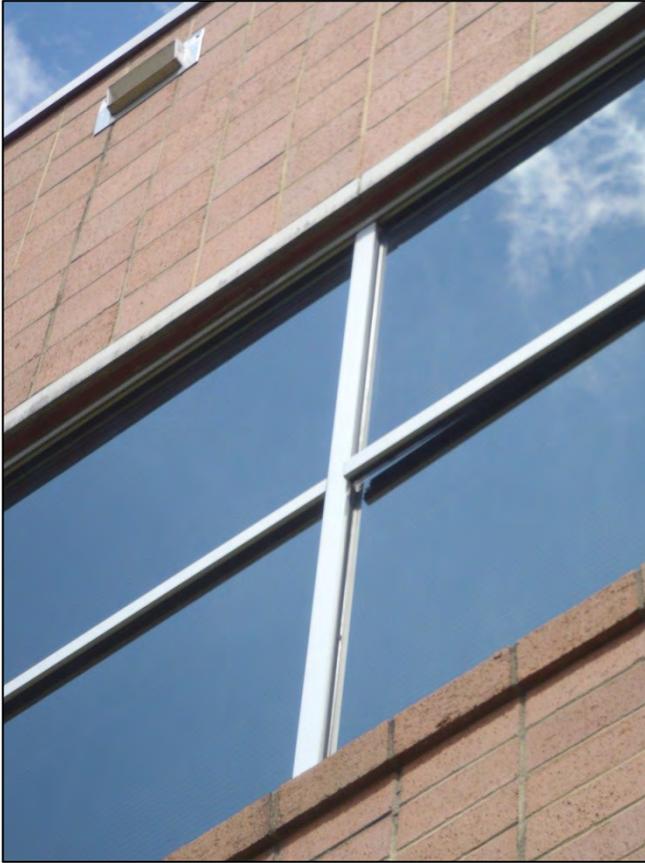
NO. 90 – SOUTHWEST ELEVATION – DISPLACED WINDOW FRAMING

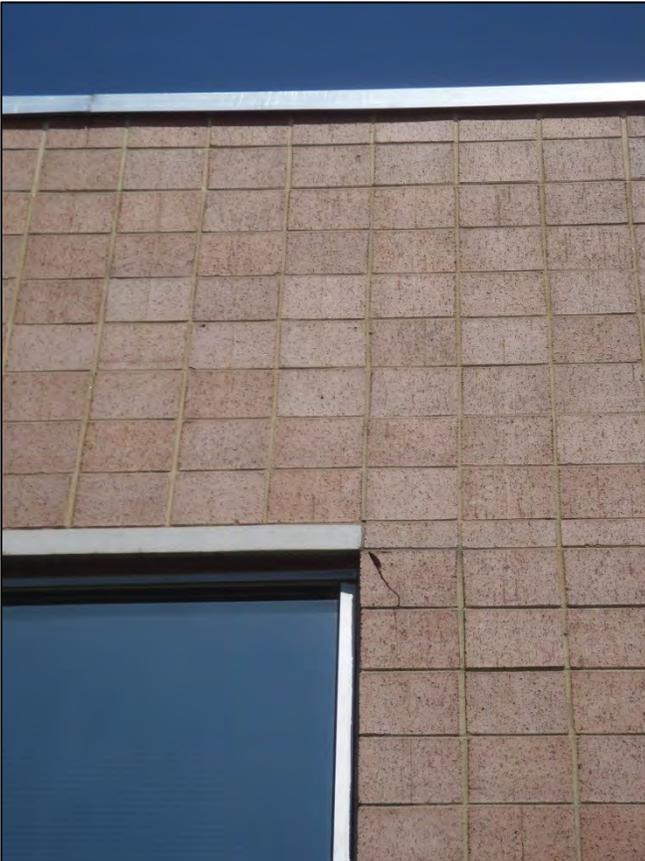
NO. 91 – SOUTHWEST ELEVATION – CRACKED INDIVIDUAL BRICK MASONRY UNITS

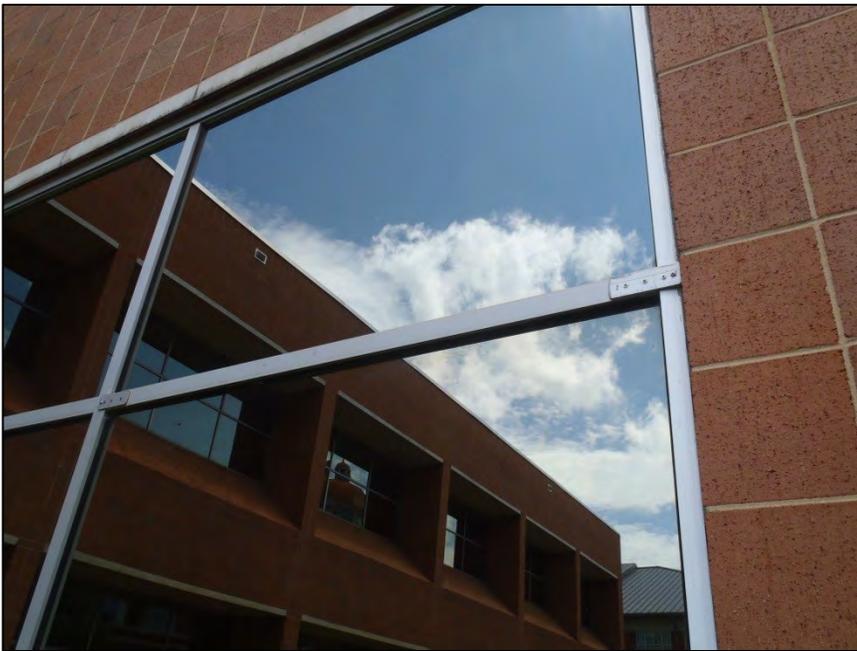
NO. 92 – SOUTHWEST ELEVATION
– DISPLACED WINDOW FRAMING

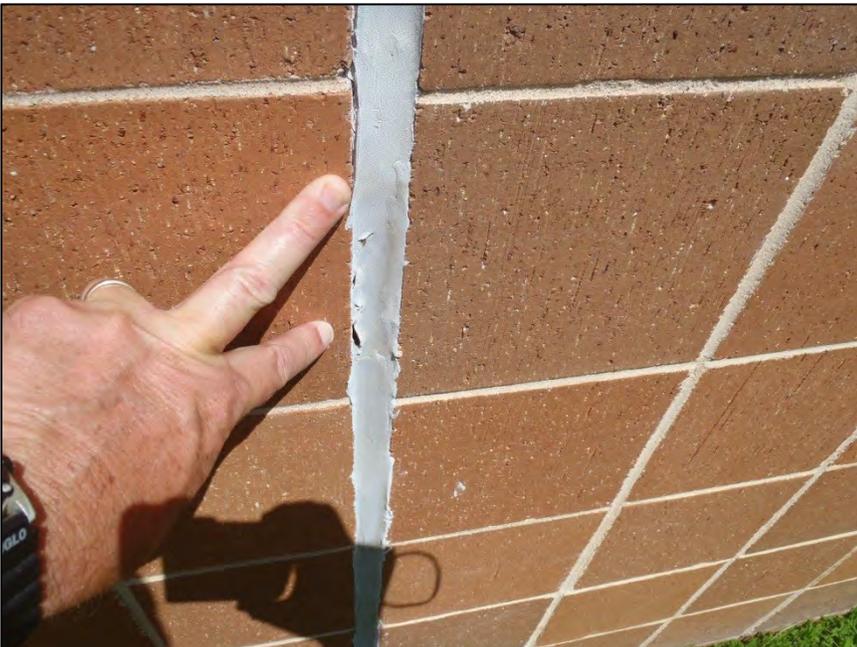
NO. 93 – SOUTHWEST ELEVATION
– DETERIORATED JOINT SEALANT

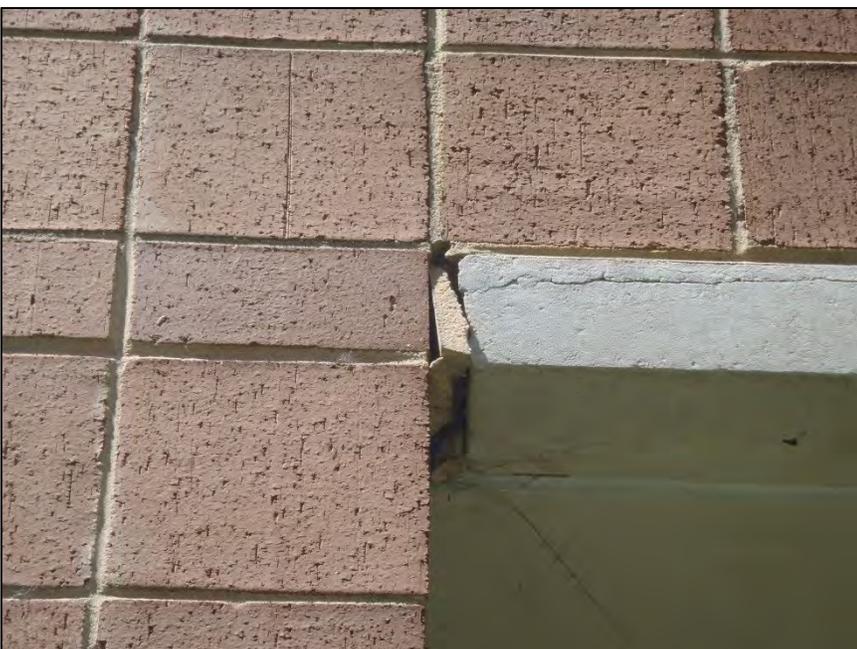
NO. 94 – SOUTH ELEVATION –
DETERIORATED JOINT
REQUIRING JOINT SEALANT

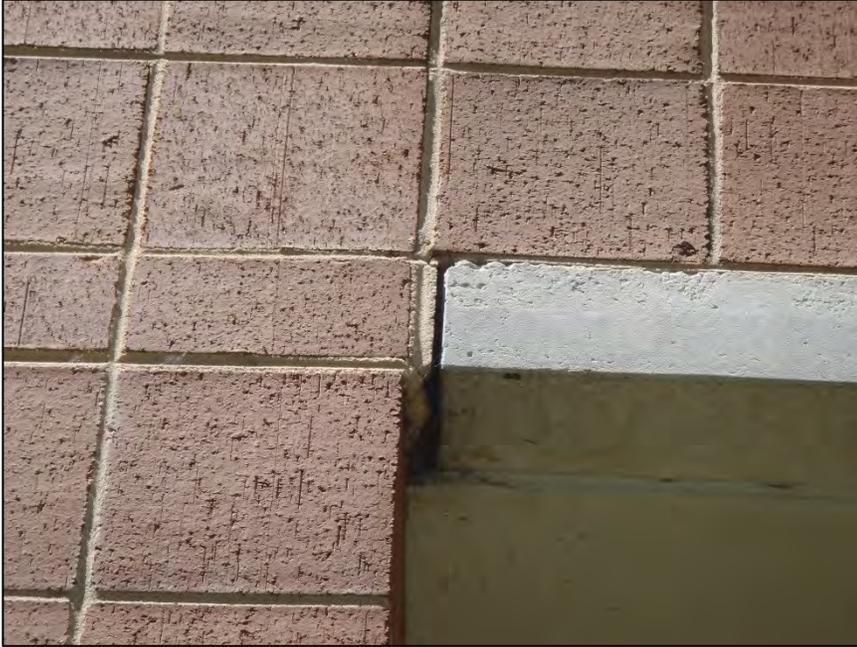
NO. 95 – SOUTH ELEVATION –
DETERIORATED JOINT
REQUIRING JOINT SEALANT

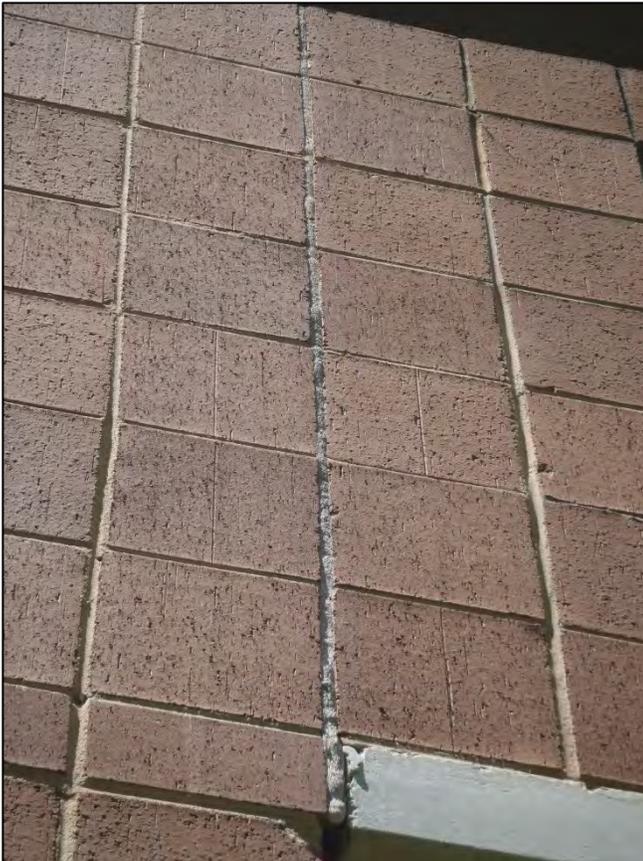
NO. 96 – SOUTH ELEVATION – DETERIORATED
JOINT SEALANT

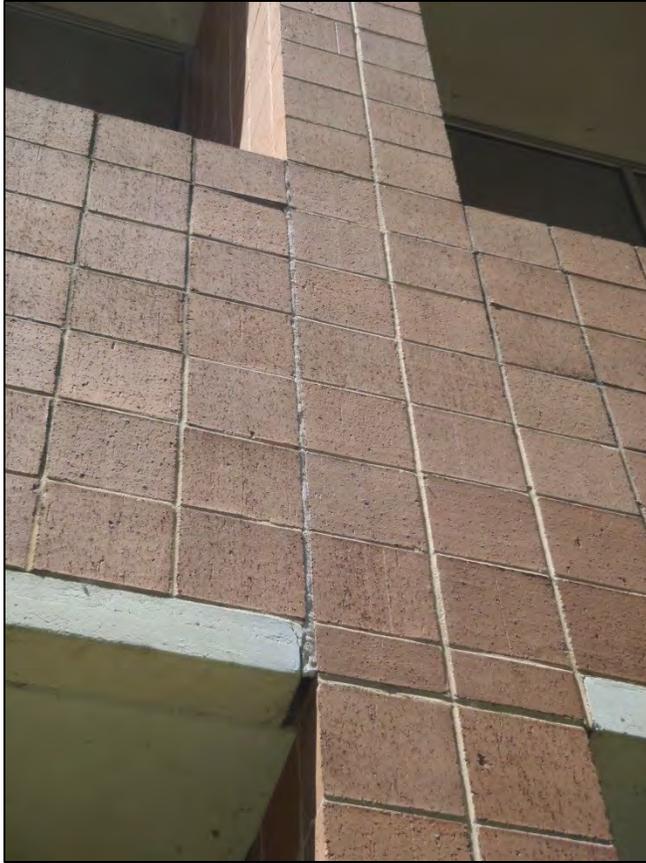
NO. 97 – SOUTH ELEVATION – DETERIORATED JOINT SEALANT

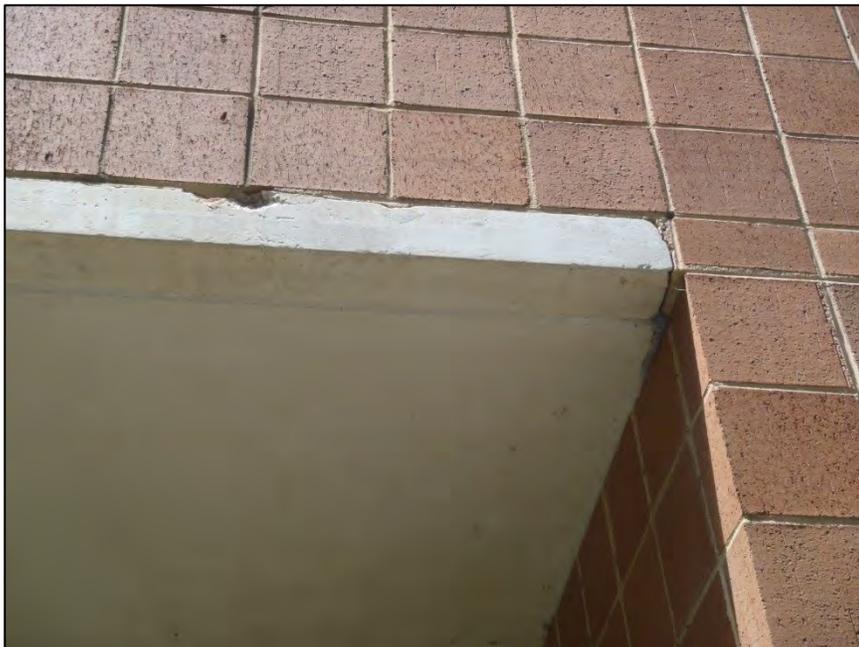
NO. 98 – SOUTH ELEVATION – CONCRETE SPALL AND DETERIORATED JOINT REQUIRING JOINT SEALANT

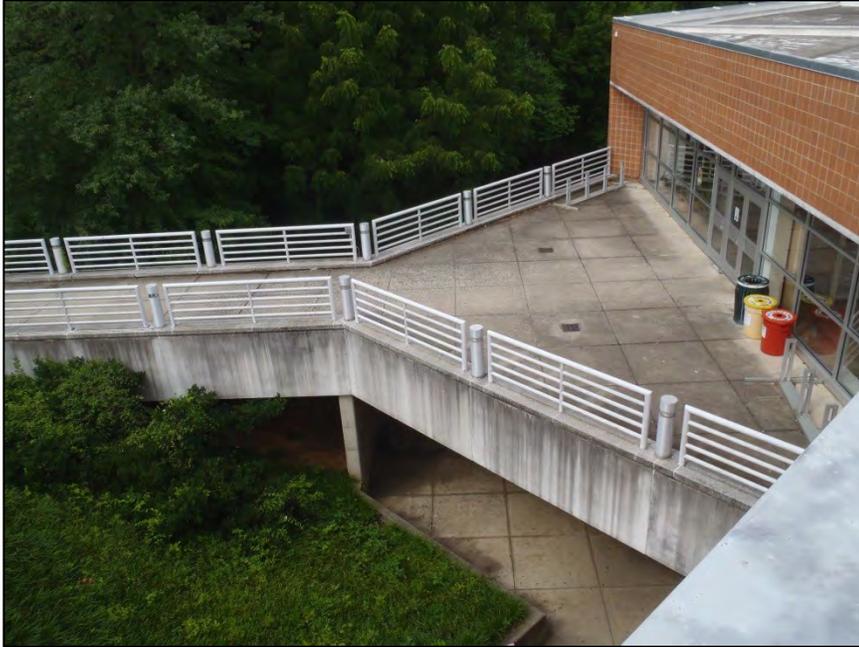
NO. 99 – SECOND FLOOR
SOUTHEAST ENTRY PLAZA

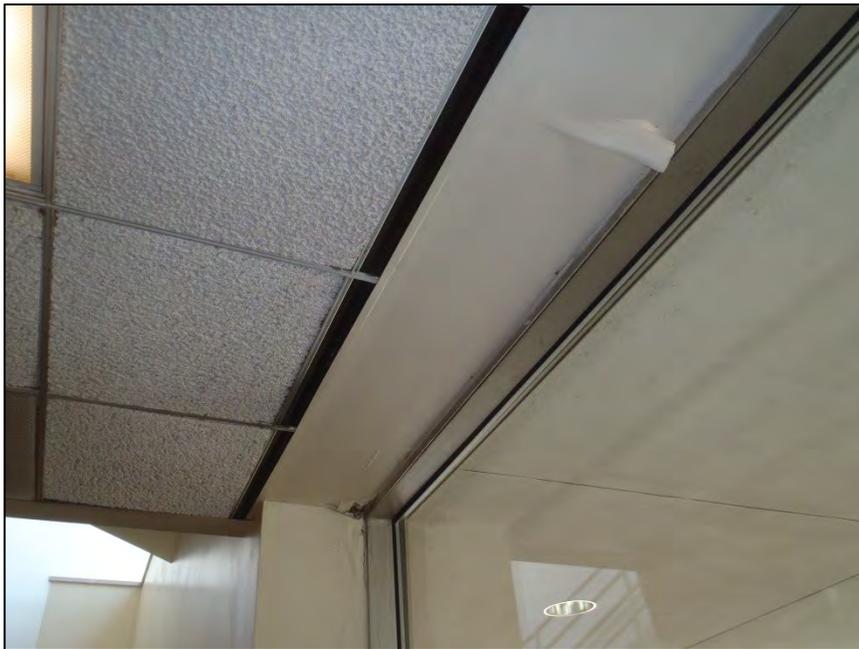
NO. 100 – FIRST FLOOR AT
SOUTHEAST ENTRY PLAZA –
WATER INFILTRATION

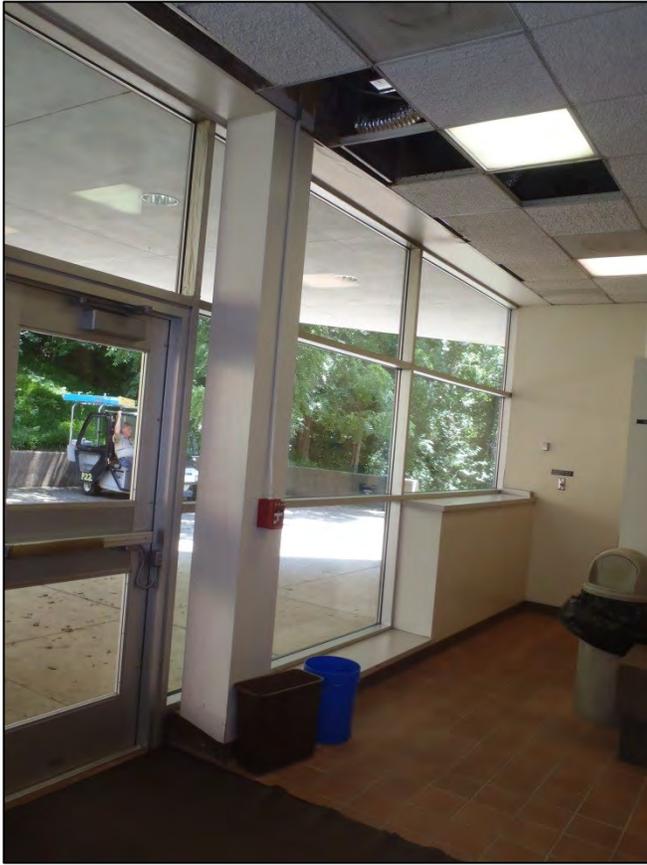
NO. 101 – FIRST FLOOR AT SOUTHEAST ENTRY PLAZA – WATER INFILTRATION

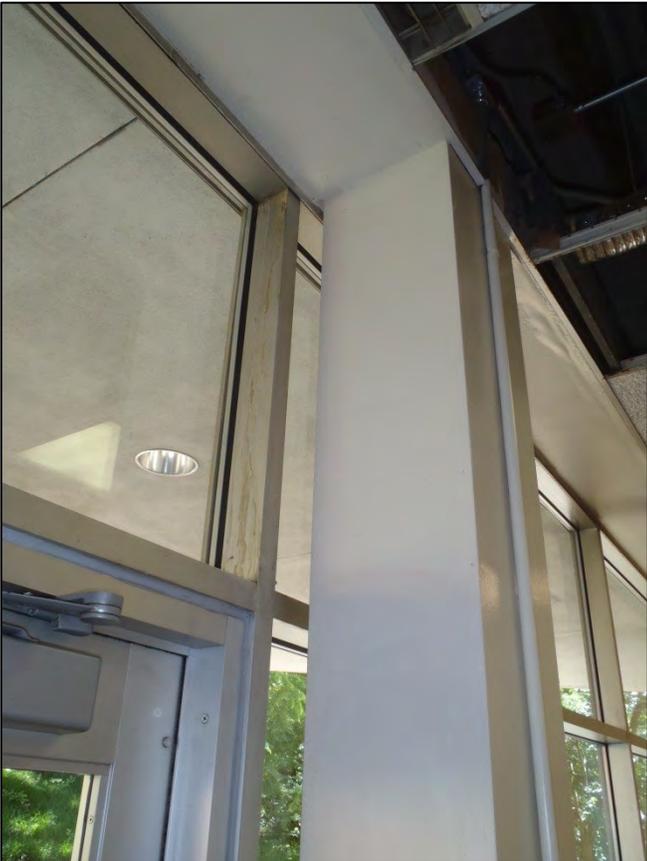
NO. 102 – FIRST FLOOR AT SOUTHEAST ENTRY PLAZA – WATER INFILTRATION

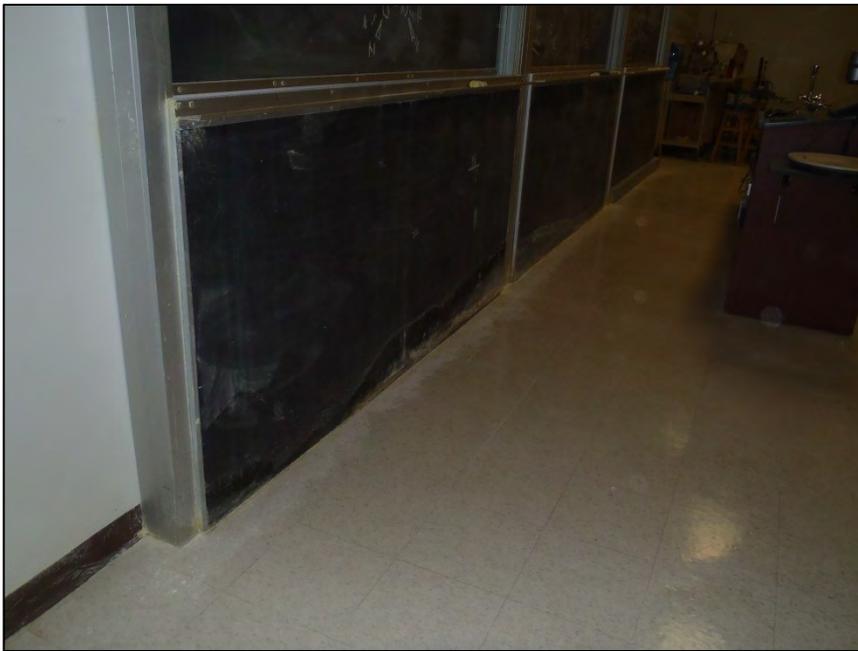
NO. 103 – SOUTHEAST FIRST FLOOR AUDITORIUM – WATER INFILTRATION AT BASE OF WALL

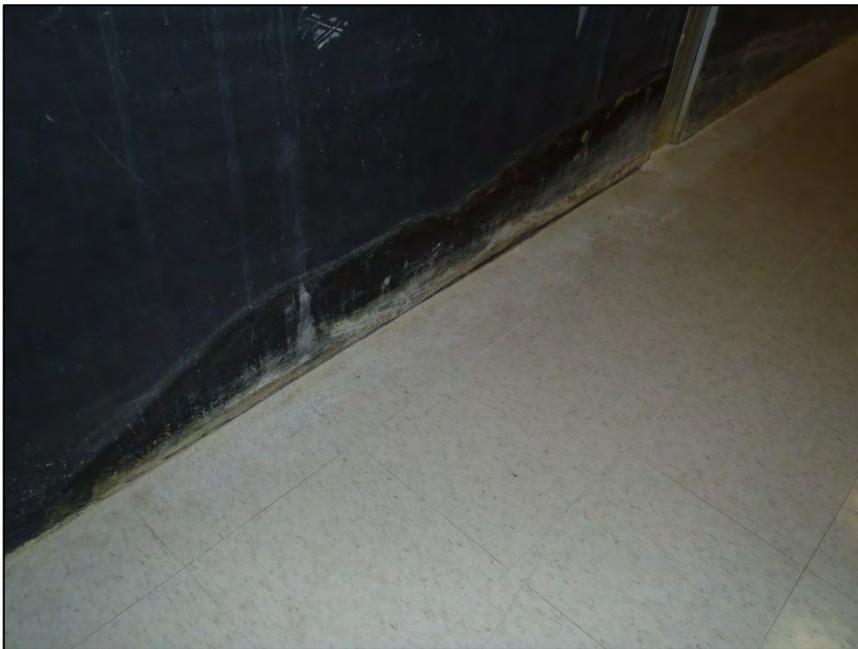
NO. 104 – SOUTHEAST FIRST FLOOR AUDITORIUM – WATER INFILTRATION AT BASE OF WALL

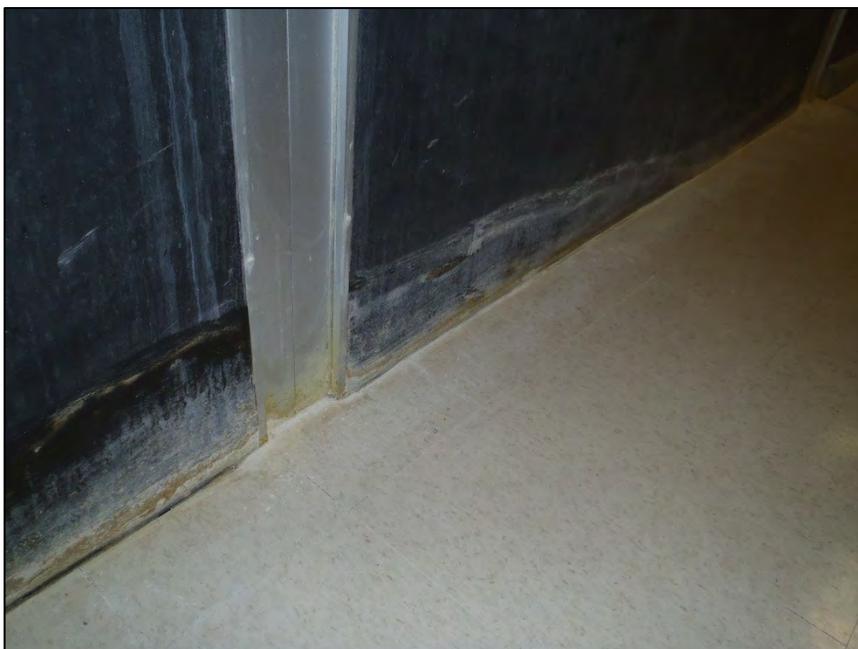
NO. 105 – SOUTHEAST FIRST FLOOR AUDITORIUM – WATER INFILTRATION AT BASE OF WALL

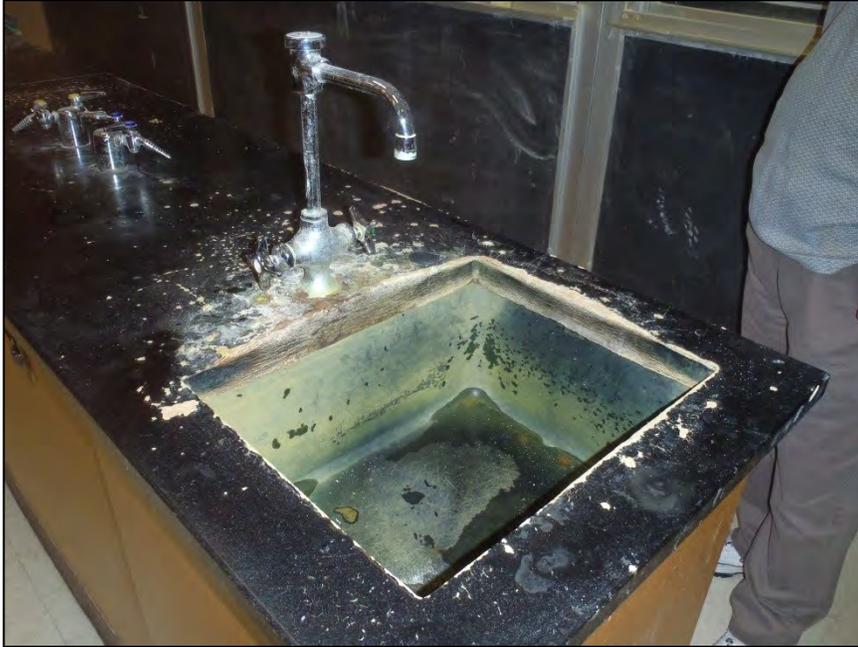
NO. 106 – SOUTHEAST FIRST FLOOR AUDITORIUM – SEVERELY DETERIORATED COUNTERTOP, SINK, AND PLUMBING FIXTURES
