UNIVERSITY OF NORTH CAROLINA at CHARLOTTE

Burson Building Feasibility Study

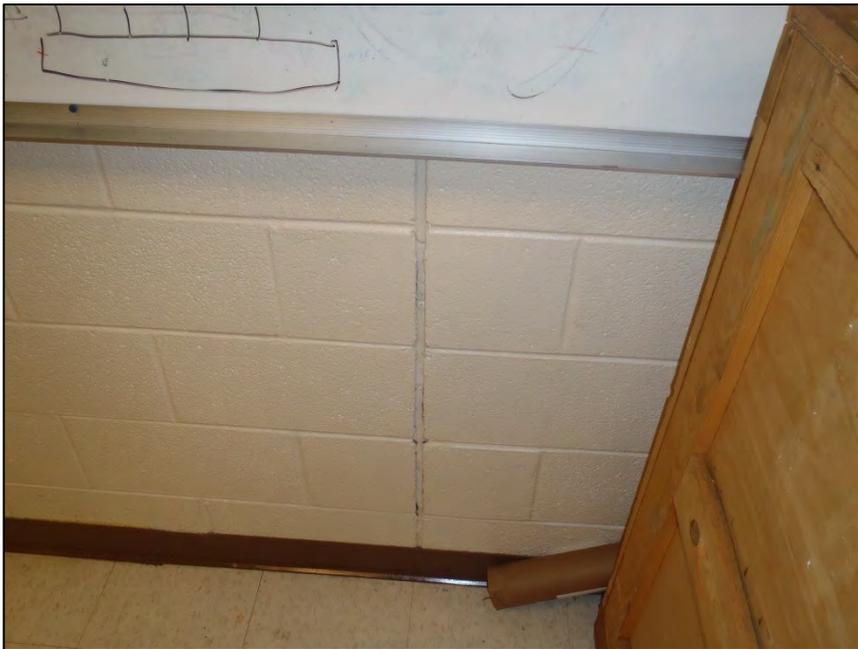
NO. 107 – FIRST FLOOR RESEARCH LABORATORY – DETERIORATED INTERIOR JOINT SEALANT

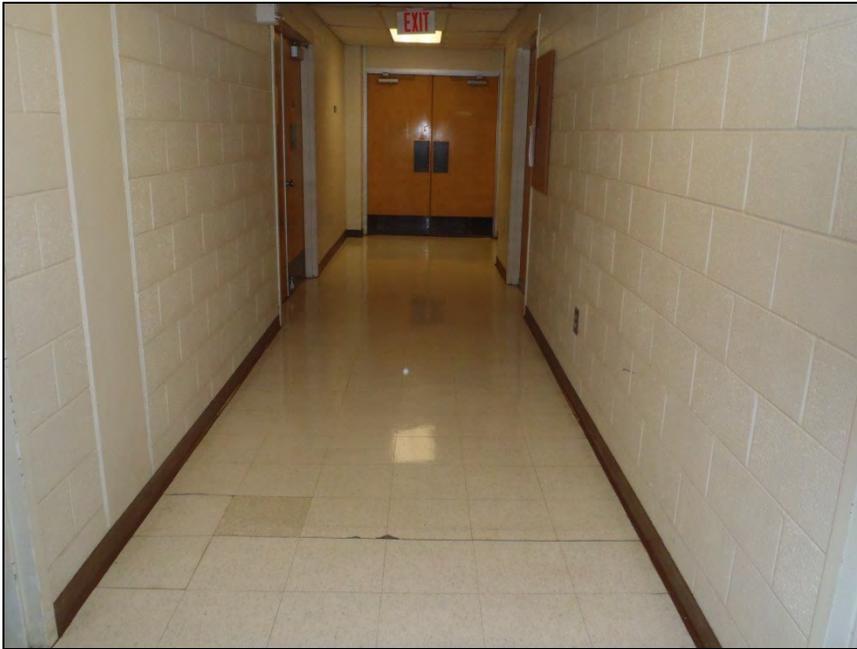
NO. 108 – FIRST FLOOR INTERIOR
HALLWAY – CRACKED FLOOR
FINISHES

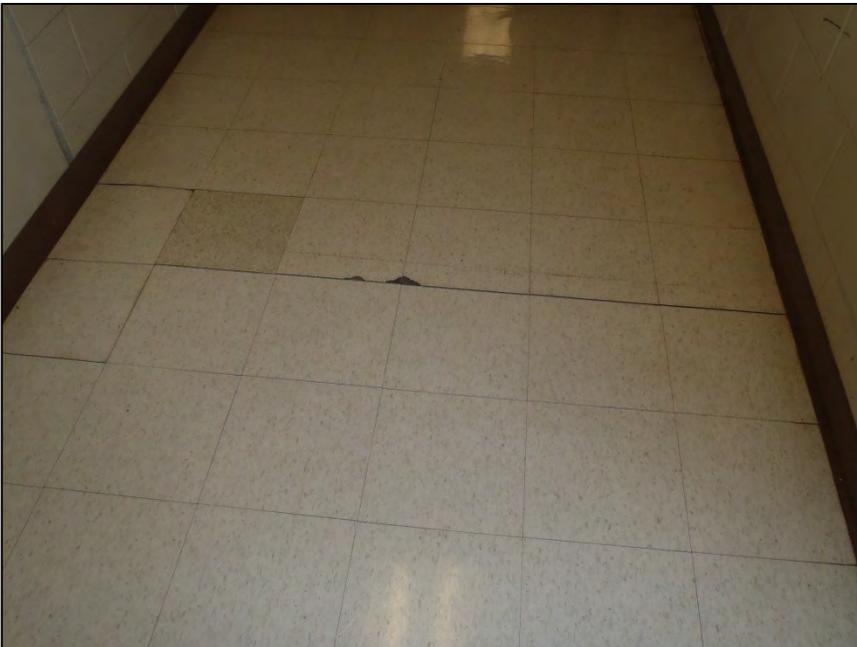
NO. 109 – FIRST FLOOR INTERIOR
HALLWAY – CRACKED FLOOR
FINISHES

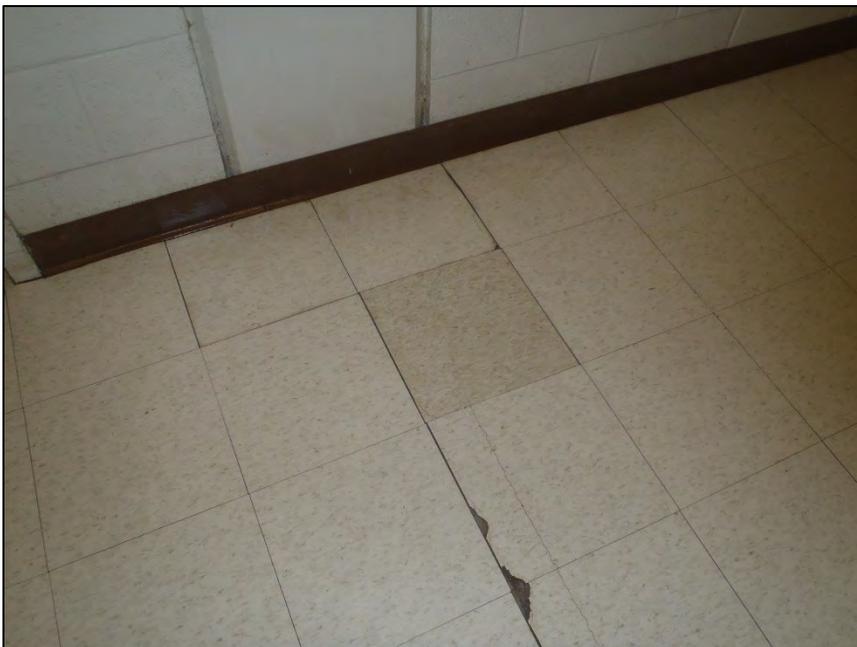
NO. 110 – FIRST FLOOR INTERIOR
HALLWAY – CRACKED FLOOR
FINISHES

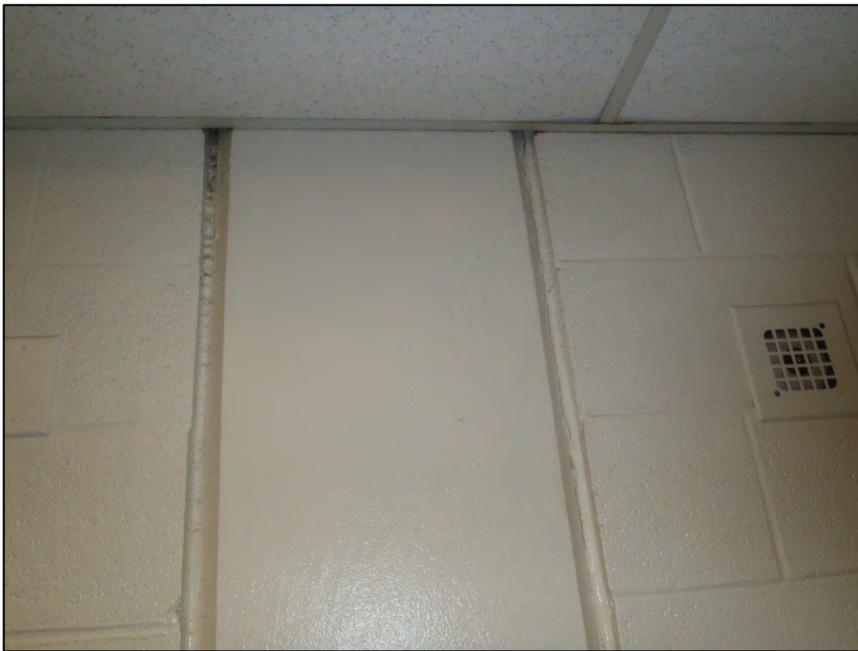
NO. 111 – FIRST FLOOR INTERIOR HALLWAY – DETERIORATED INTERIOR JOINT SEALANTS

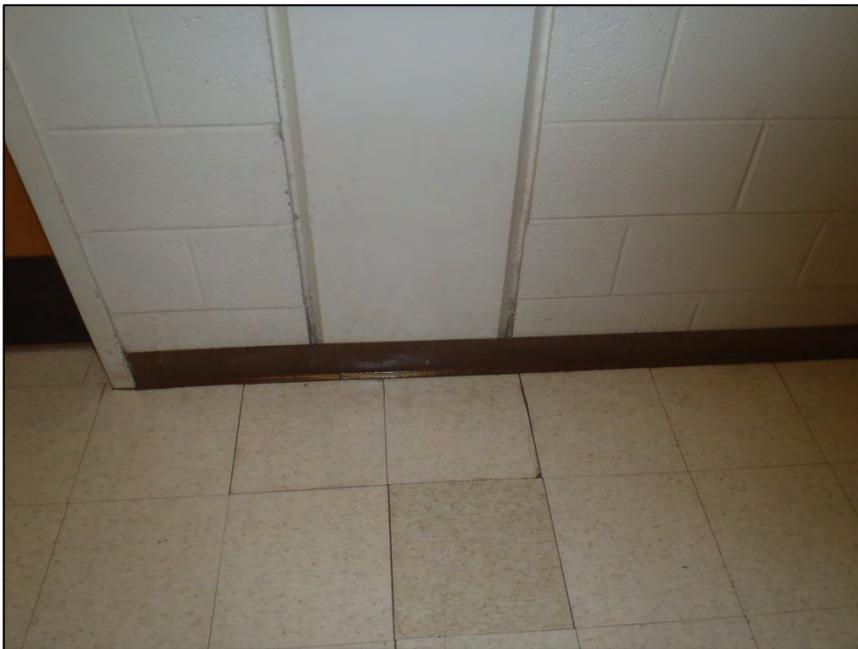
NO. 112 – FIRST FLOOR INTERIOR HALLWAY – DETERIORATED INTERIOR JOINT SEALANTS

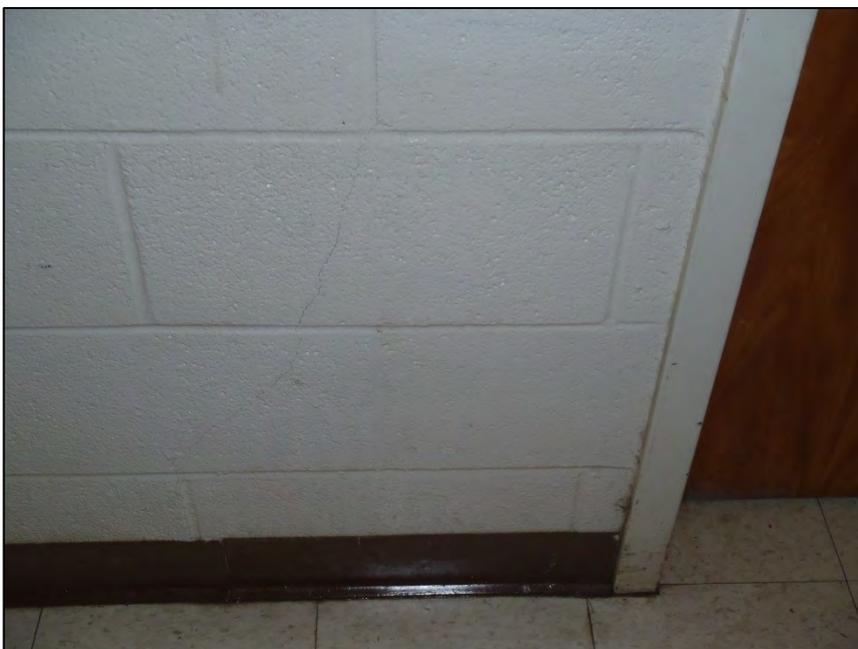
NO. 113 – FIRST FLOOR INTERIOR HALLWAY – CRACKED INDIVIDUAL CONCRETE MASONRY UNIT

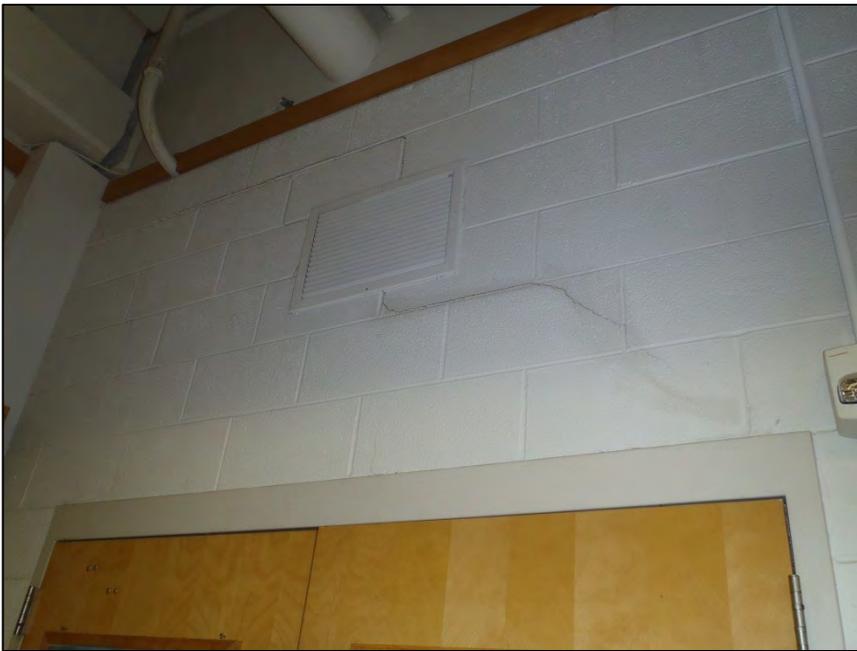
NO. 114 – FIRST FLOOR –
INTERIOR CRACKS IN A
CONCRETE MASONRY PARTITION
WALL

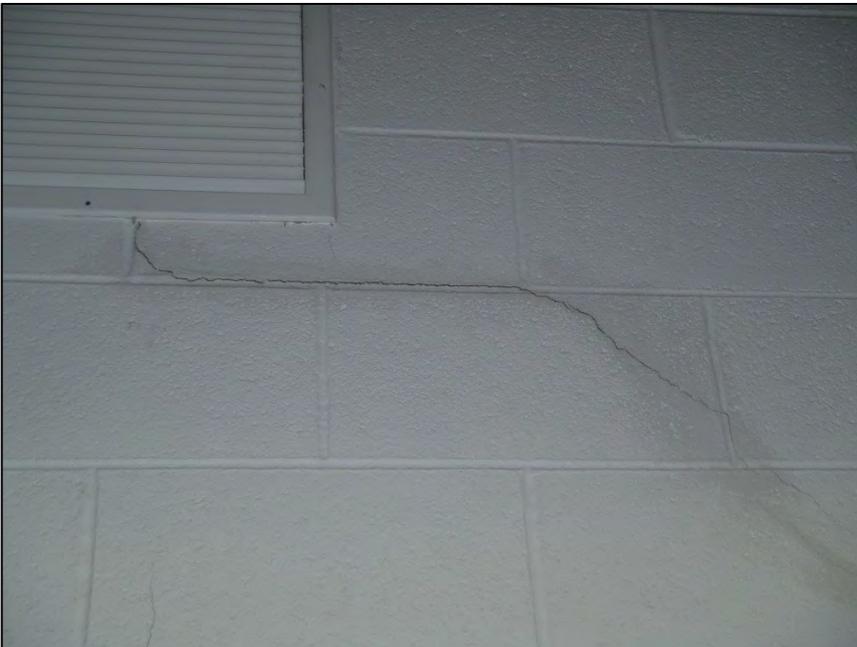
NO. 115 – FIRST FLOOR –
INTERIOR CRACKS IN A
CONCRETE MASONRY PARTITION
WALL

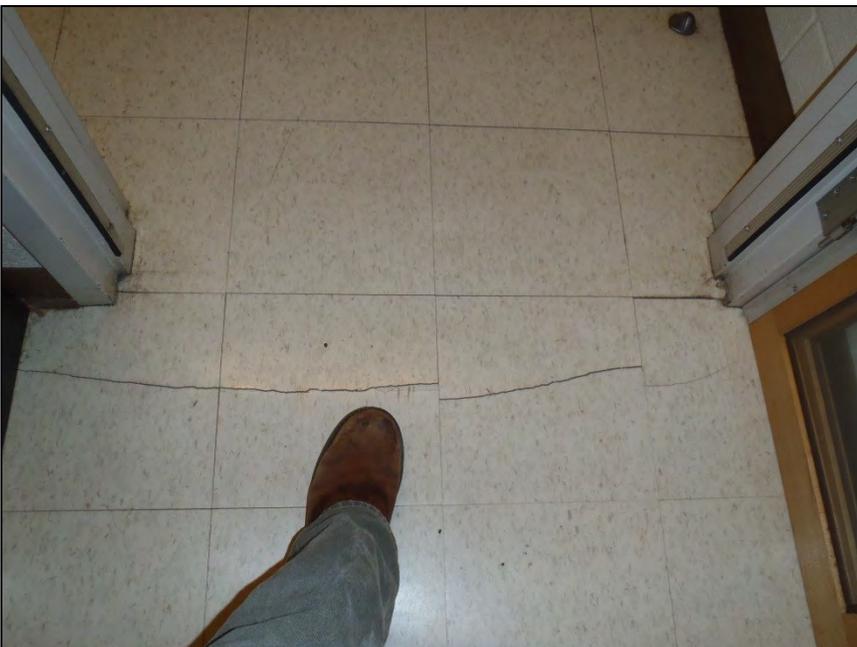
NO. 116 – FIRST FLOOR –
CRACKED INTERIOR FLOOR
FINISHES

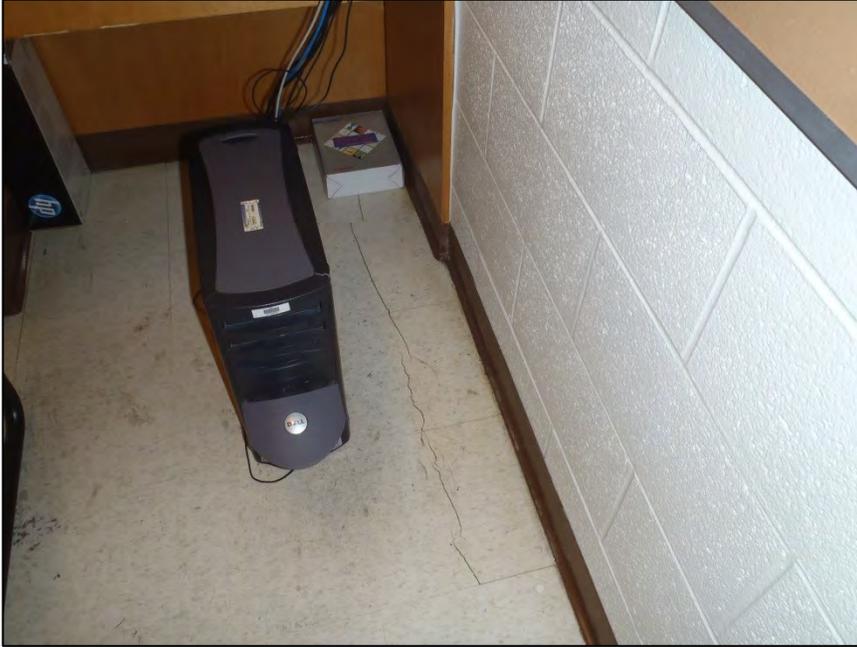
NO. 117 – FIRST FLOOR –
CRACKED INTERIOR FLOOR
FINISHES

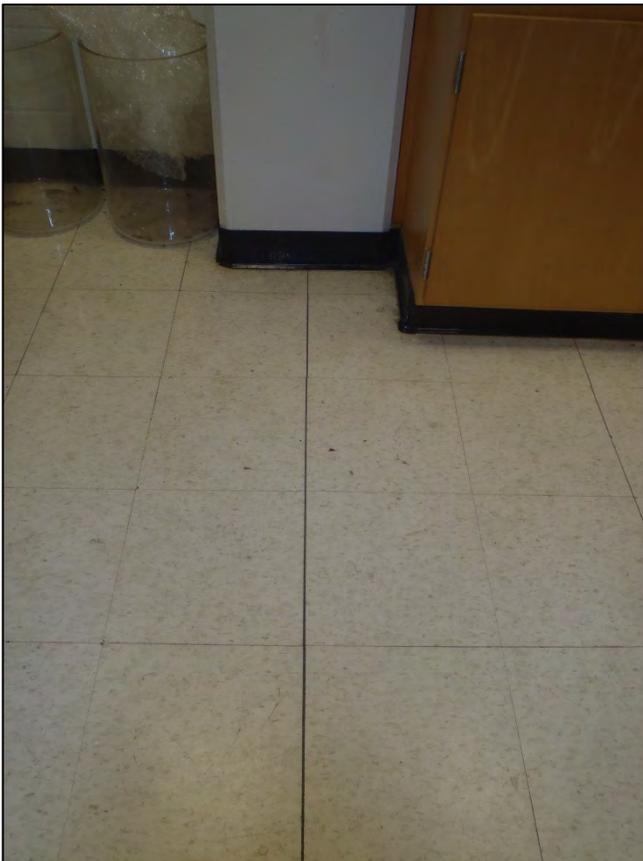
NO. 118 – FIRST FLOOR – DISPLACED INTERIOR
FLOOR FINISHES

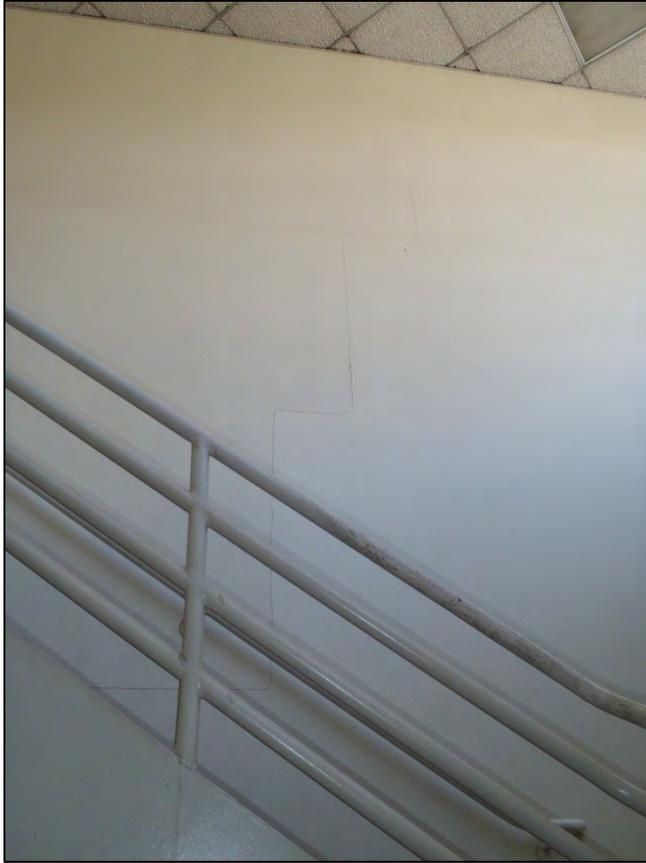
NO. 123 – SECOND FLOOR STAIRWELL AT MAIN ENTRANCE – CRACKED INTERIOR CONCRETE MASONRY

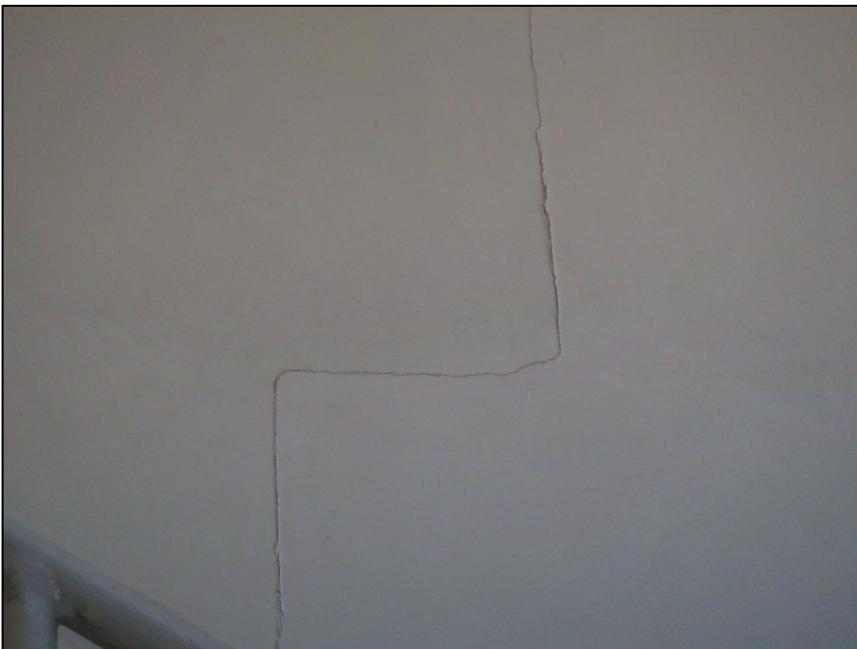
NO. 124 – SECOND FLOOR STAIRWELL AT MAIN ENTRANCE – CRACKED INTERIOR CONCRETE MASONRY

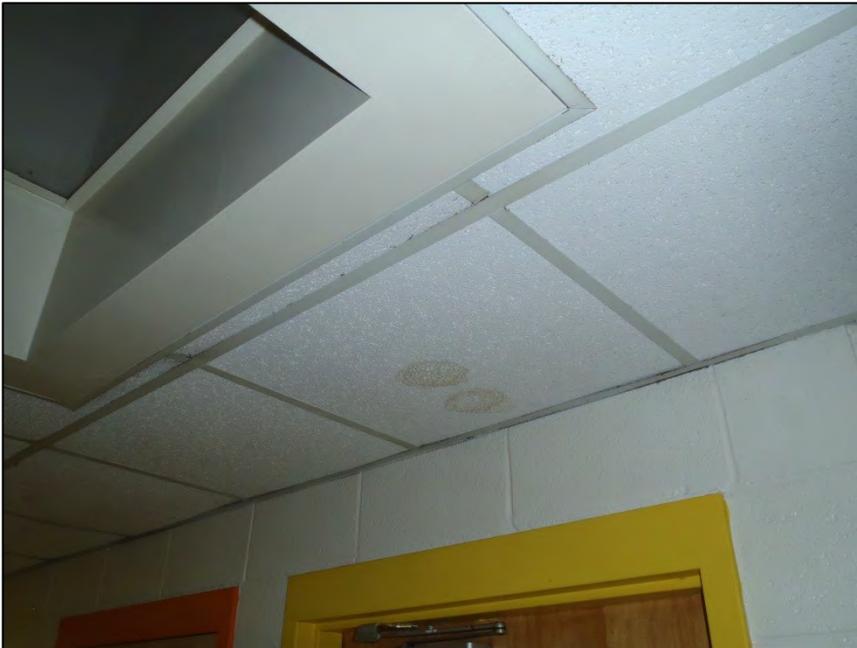
NO. 125 – SECOND FLOOR
CORRIDOR – DAMAGED CEILING
TILE FROM WATER INFILTRATION

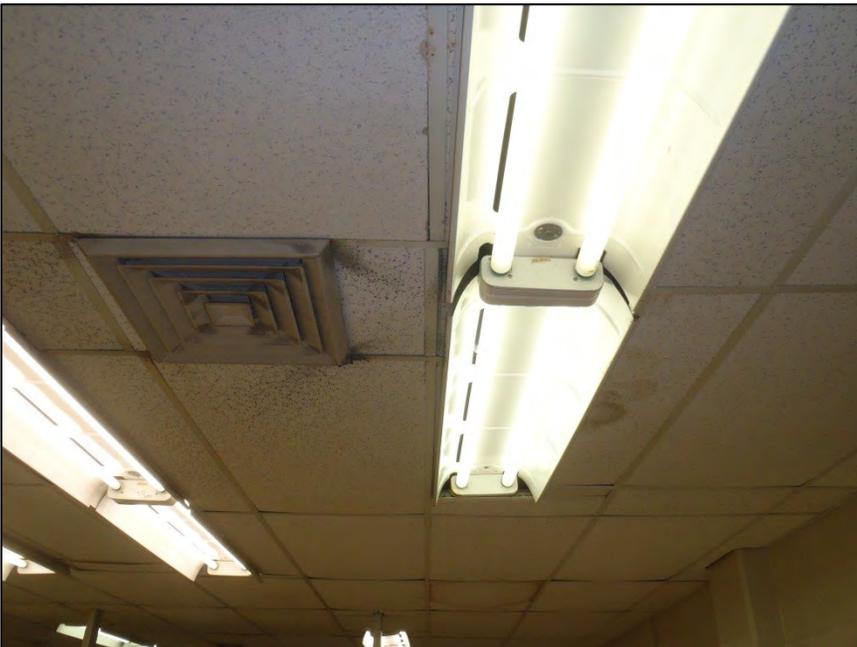
NO. 126 – SECOND FLOOR
GENERAL CHEMISTRY
LABORATORY 207 – DAMAGED
CEILING TILES FROM WATER
INFILTRATION

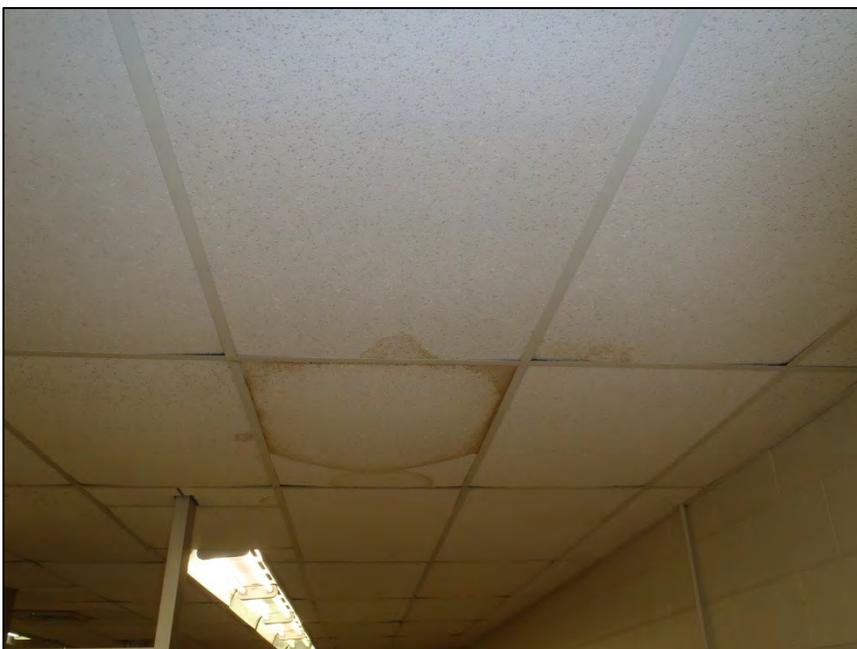
NO. 127 – SECOND FLOOR
GENERAL CHEMISTRY
LABORATORY 207 – DAMAGED
CEILING TILES FROM WATER
INFILTRATION

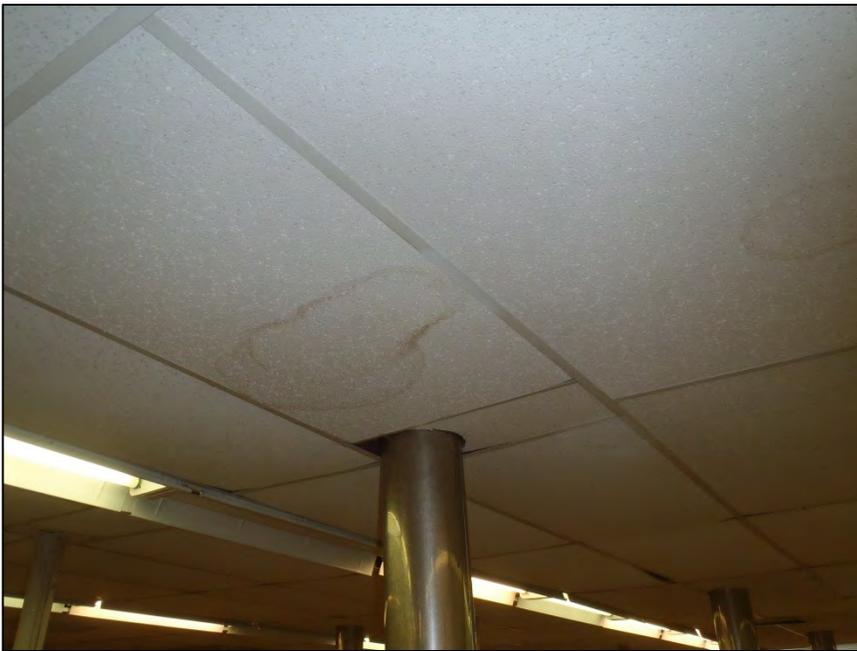
NO. 128 – SECOND FLOOR
GENERAL CHEMISTRY
LABORATORY 207 – DAMAGED
CEILING TILES FROM WATER
INFILTRATION

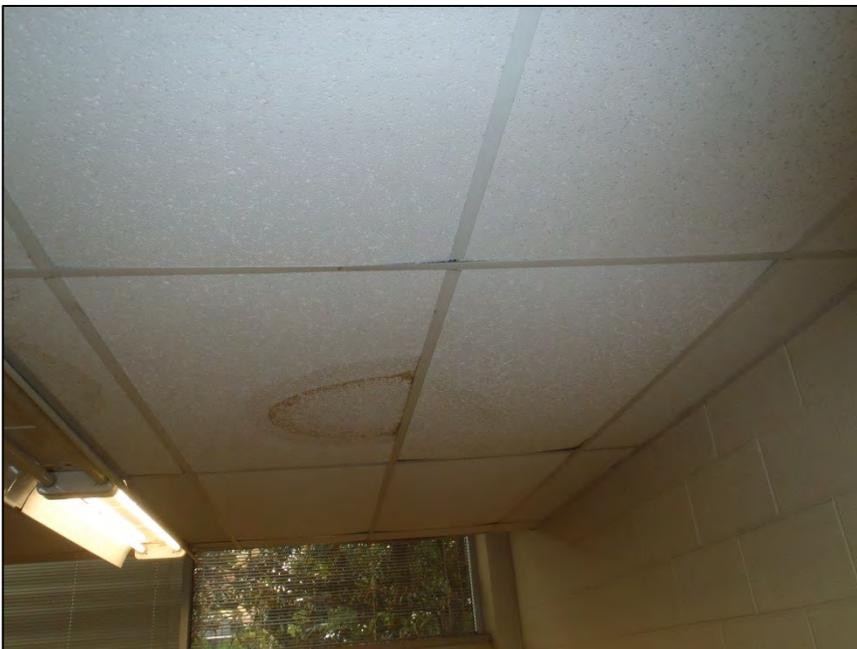
NO. 129 – SECOND FLOOR
GENERAL CHEMISTRY
LABORATORY 207 – DAMAGED
CEILING TILES FROM WATER
INFILTRATION

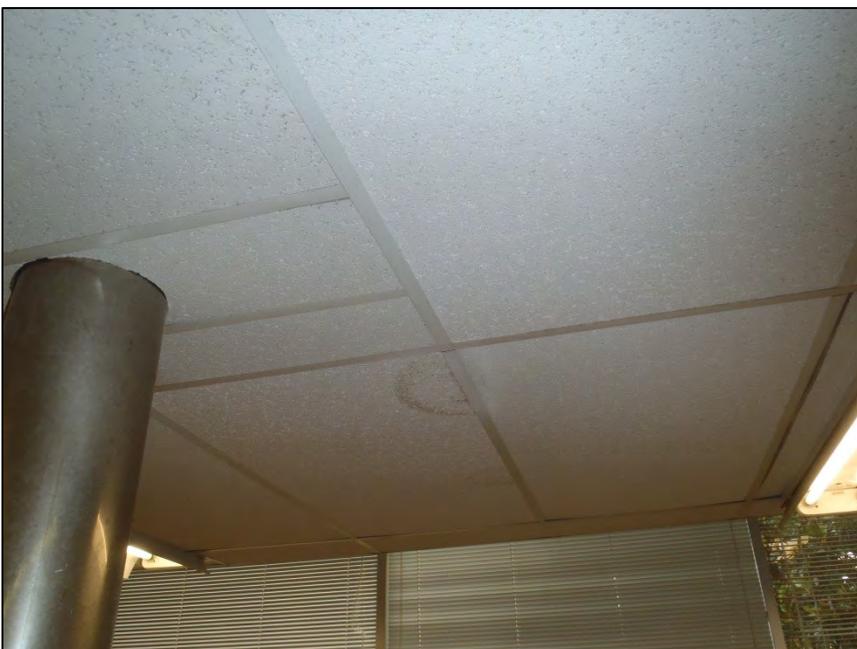
NO. 130 – SECOND FLOOR
GENERAL CHEMISTRY
LABORATORY 207 – DAMAGED
CEILING TILES FROM WATER
INFILTRATION

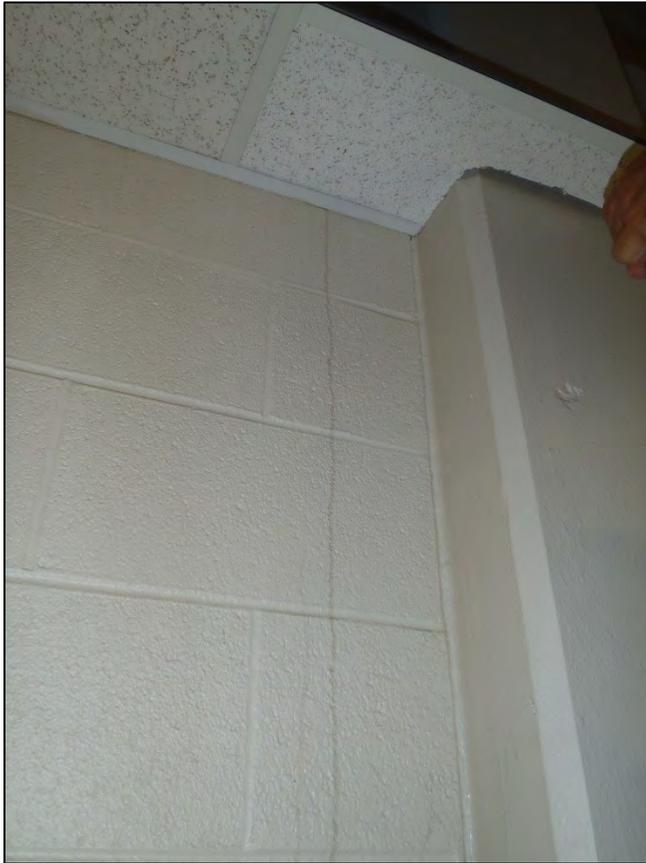
NO. 131 – SECOND FLOOR GENERAL CHEMISTRY
LABORATORY 207 – WATER STAINED INTERIOR
PARTITION WALL FROM WATER INFILTRATION

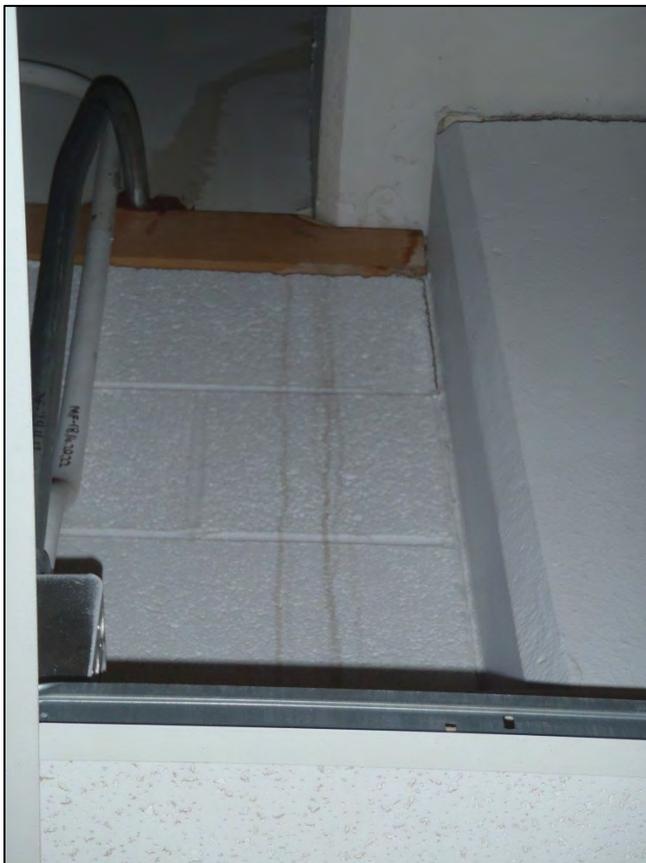
NO. 132 – SECOND FLOOR GENERAL CHEMISTRY
LABORATORY 207 – WATER STAINED INTERIOR
PARTITION WALL FROM WATER INFILTRATION

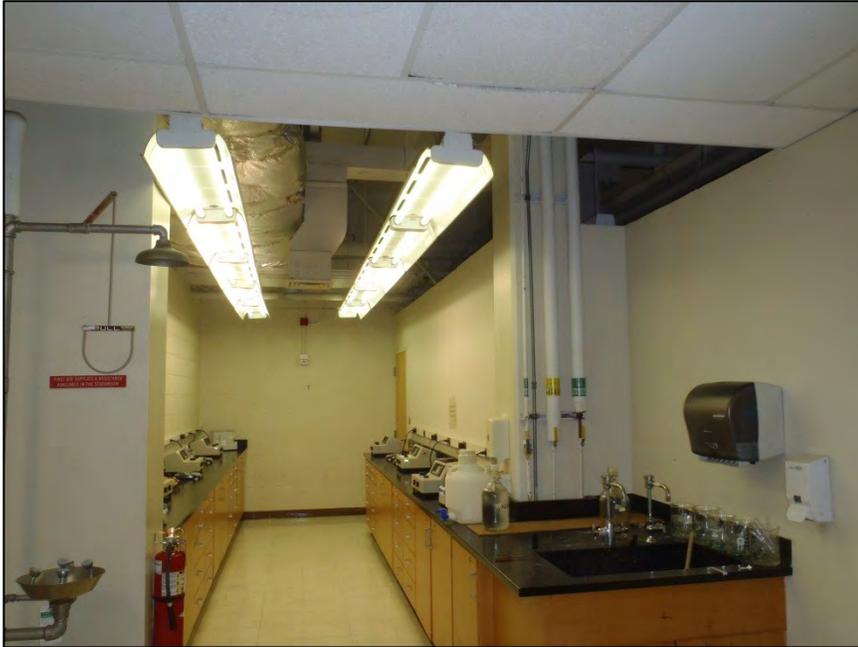
NO. 133 – SECOND FLOOR
GENERAL CHEMISTRY
LABORATORY 207 – MISSING
CEILING TILES

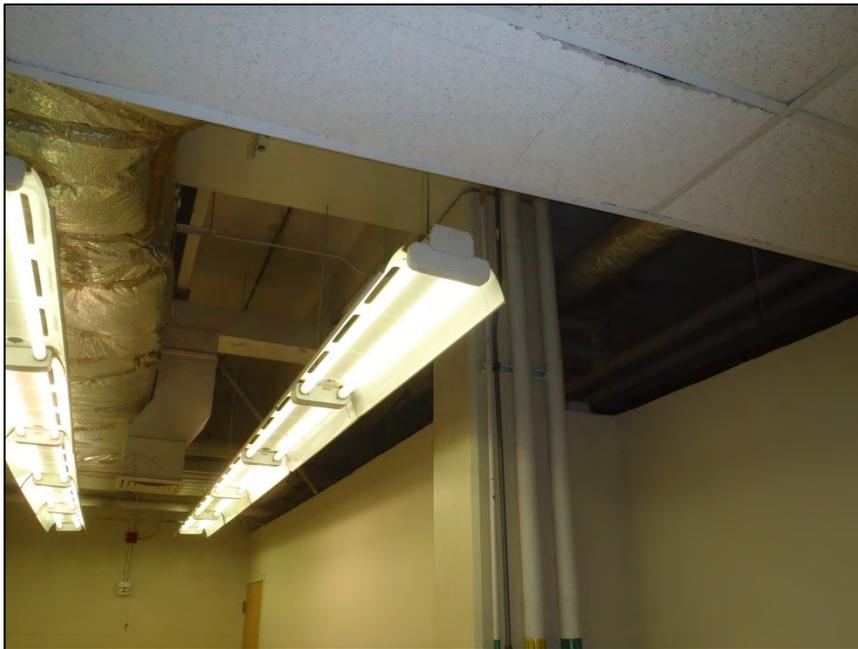
NO. 134 – SECOND FLOOR
GENERAL CHEMISTRY
LABORATORY 207 – MISSING
CEILING TILES

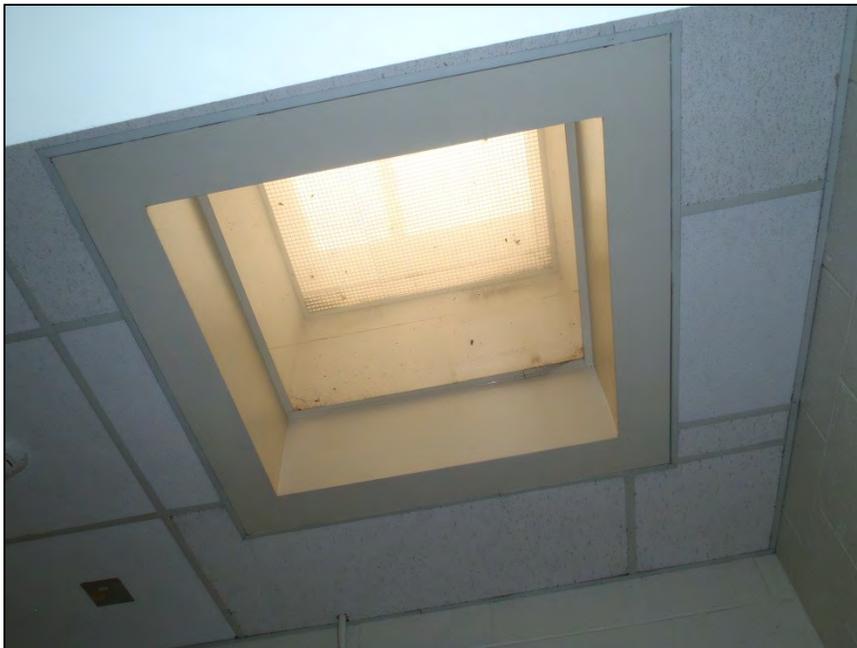
NO. 135 – SECOND FLOOR
CORRIDOR – DAMAGED
CEILING TILES FROM WATER
INFILTRATION

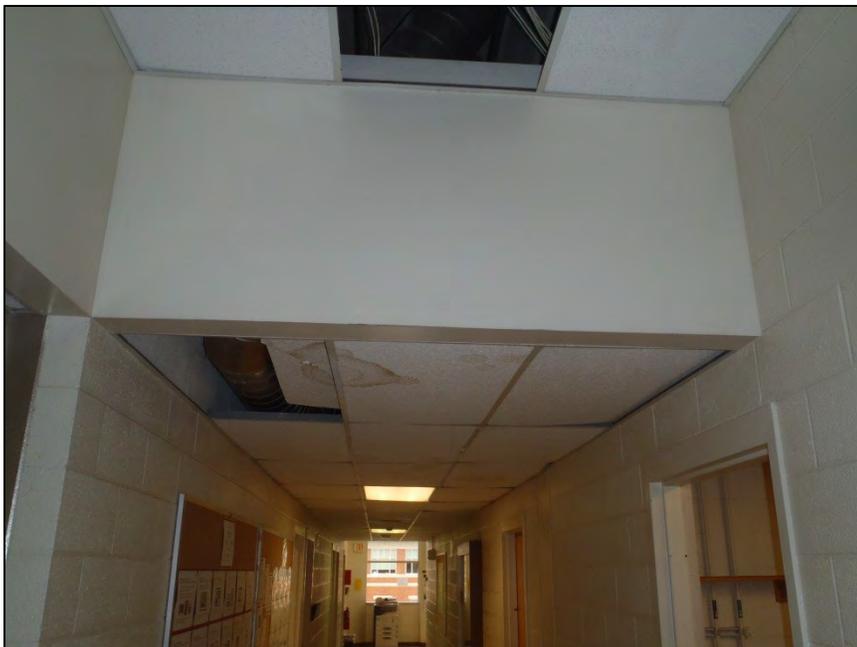
NO. 136 – SECOND FLOOR
CORRIDOR – DAMAGED
CEILING TILES FROM WATER
INFILTRATION

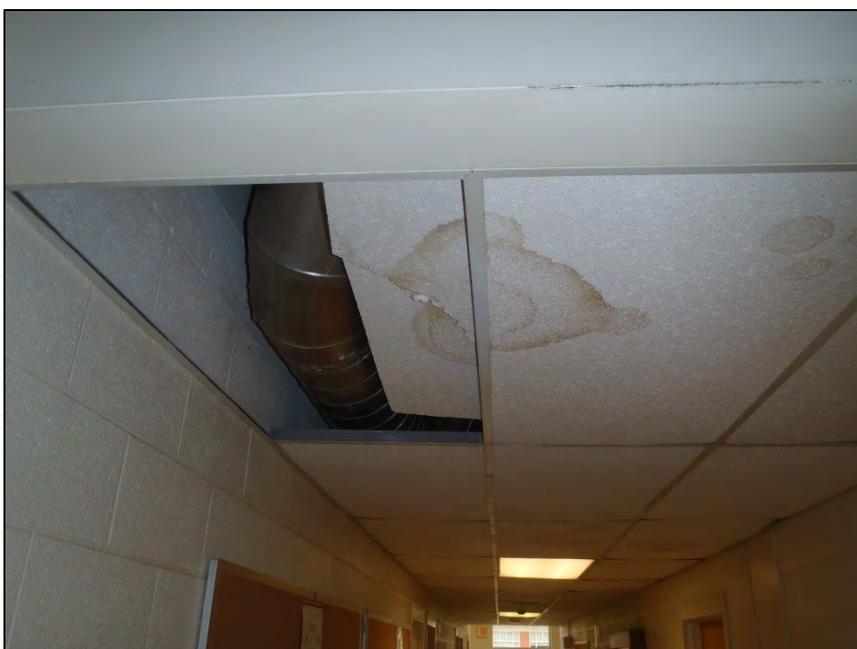
NO. 137 – SECOND FLOOR
CORRIDOR – DAMAGED
CEILING TILES FROM WATER
INFILTRATION

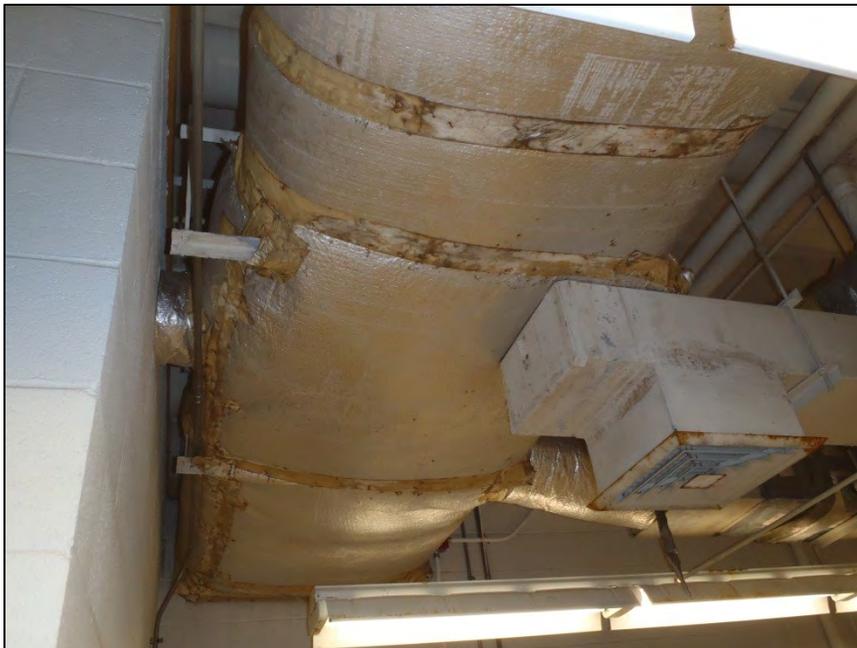
NO. 138 – SECOND FLOOR
ROOM 241 – WATER STAINED
DUCT WORK FROM WATER
INFILTRATION AND/OR
CONDENSATION

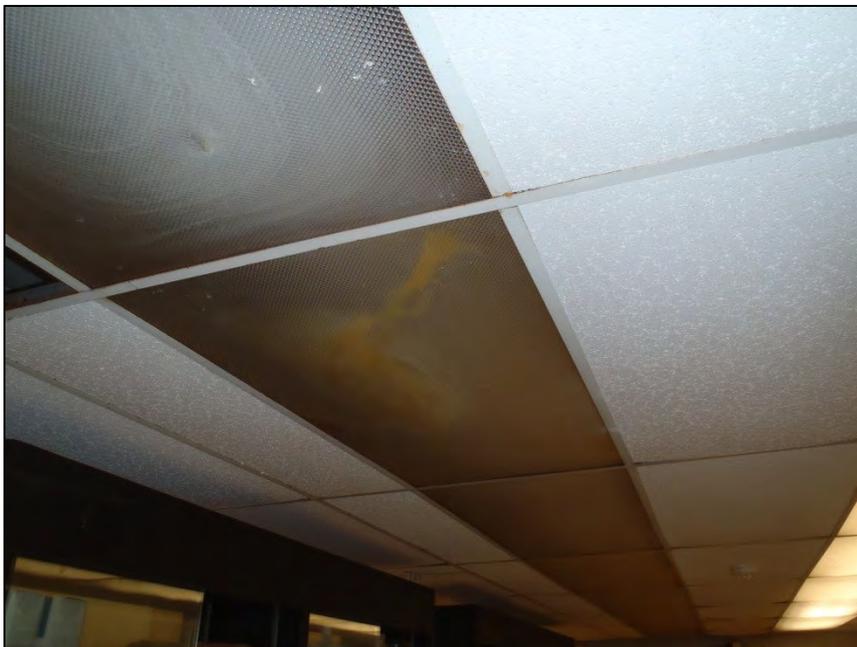
NO. 139 – SECOND FLOOR
ROOM 243 – STAINED LIGHT
FIXTURE DUE TO WATER
INFILTRATION

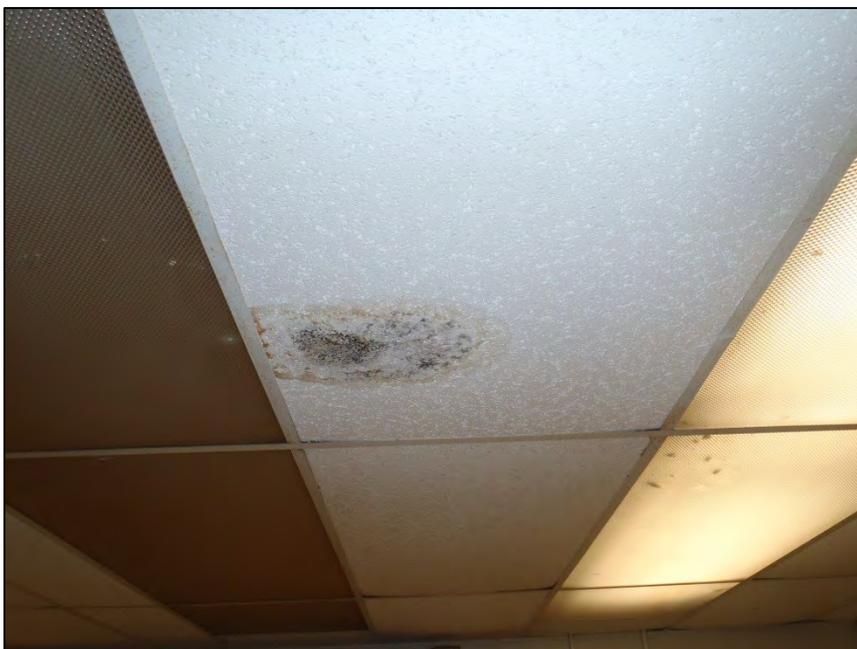
NO. 140 – SECOND FLOOR
ROOM 243 – DAMAGED
CEILING TILES FROM WATER
INFILTRATION

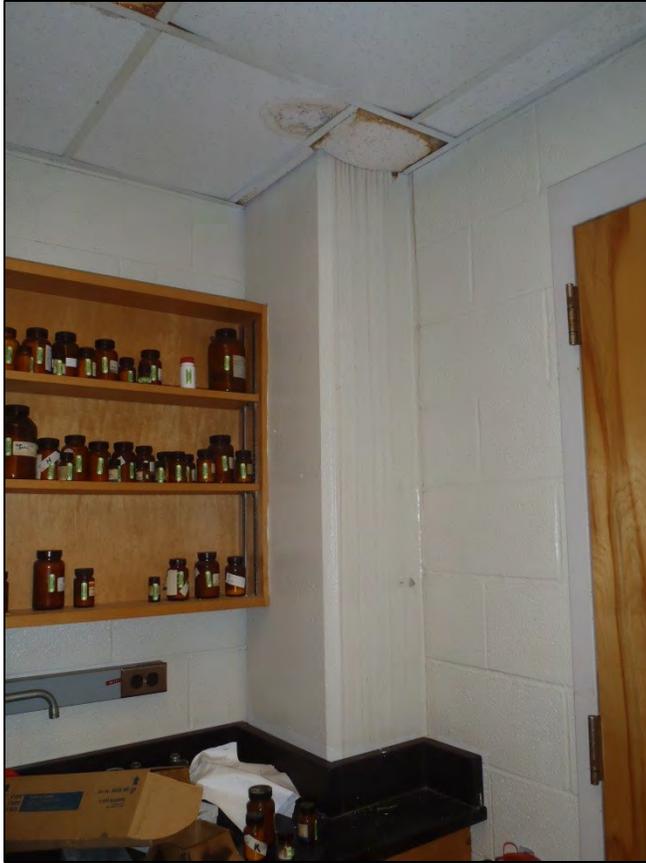
NO. 141 – SECOND FLOOR ROOM 243 – DAMAGED CEILING TILES FROM WATER INFILTRATION

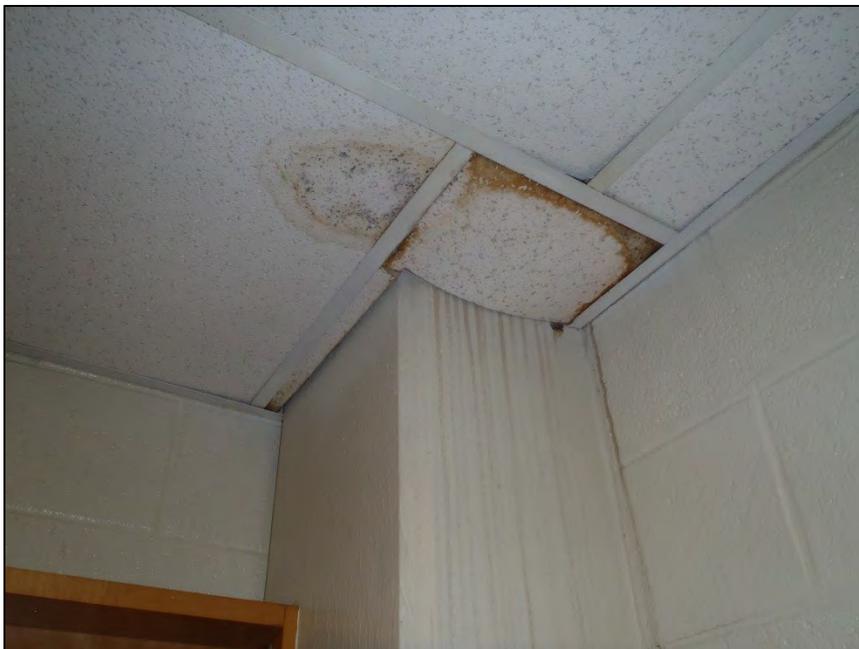
NO. 142 – SECOND FLOOR ROOM 243 – DAMAGED CEILING TILES FROM WATER INFILTRATION

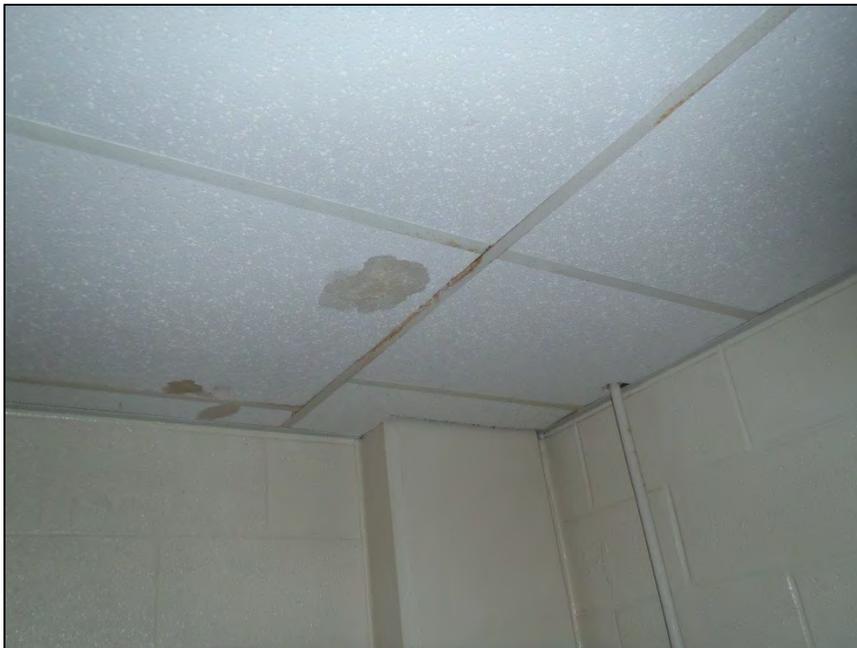
NO. 143 – SECOND FLOOR
ROOM 243 – DAMAGED
CEILING TILES FROM WATER
INFILTRATION

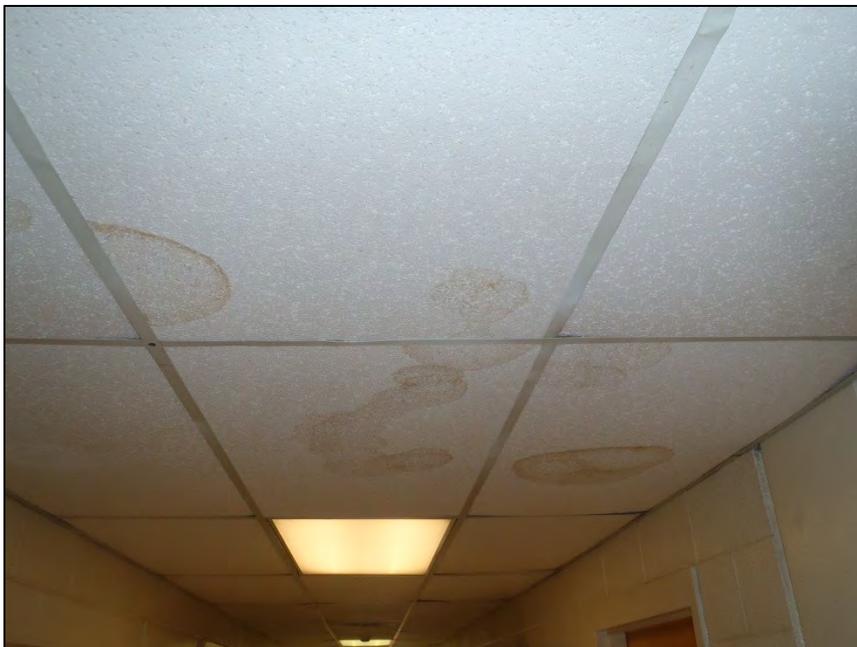
NO. 144 – SECOND FLOOR
CORRIDOR – DAMAGED
CEILING TILES FROM WATER
INFILTRATION

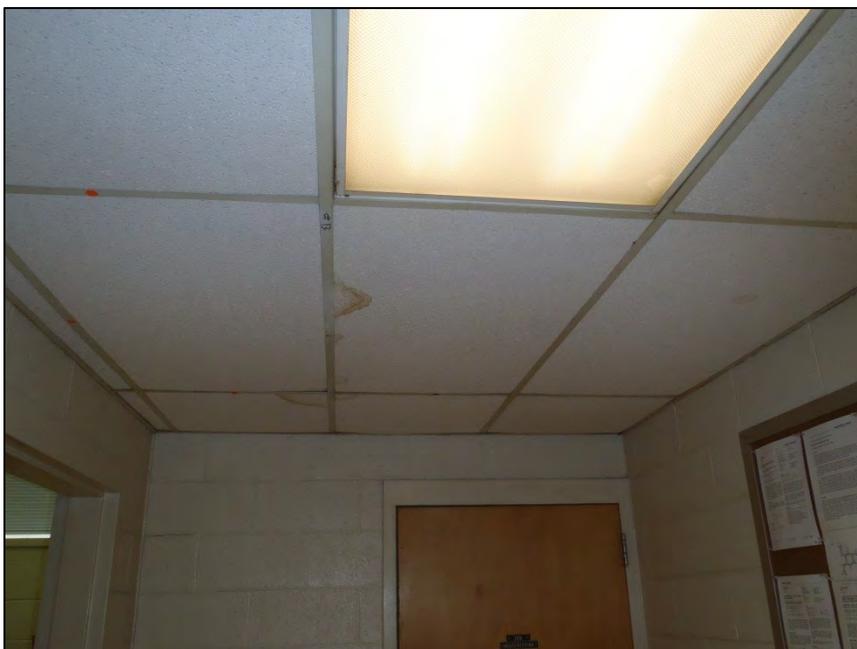
NO. 145 – SECOND FLOOR
CORRIDOR – DAMAGED
CEILING TILES FROM WATER
INFILTRATION

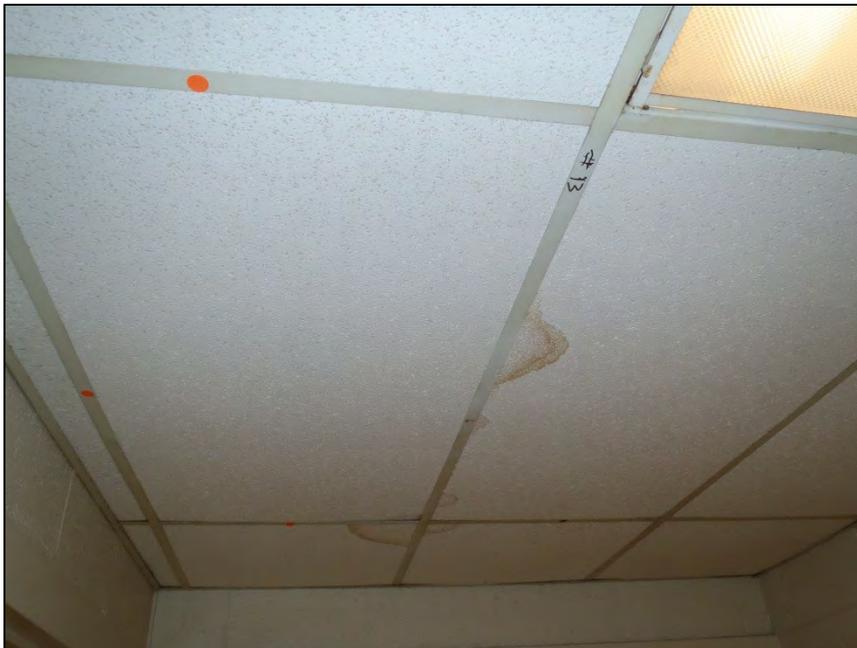
NO. 146 – SECOND FLOOR
CORRIDOR – DAMAGED
CEILING TILES FROM WATER
INFILTRATION

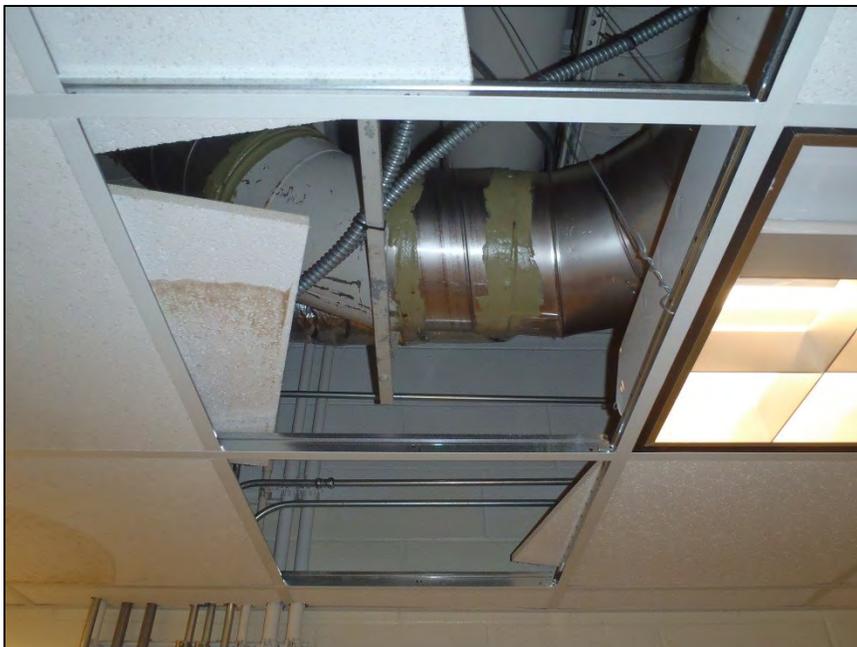
NO. 147 – SECOND FLOOR
ROOM 274 RESEARCH
LABORATORY – DAMAGED
CEILING TILES FROM WATER
INFILTRATION

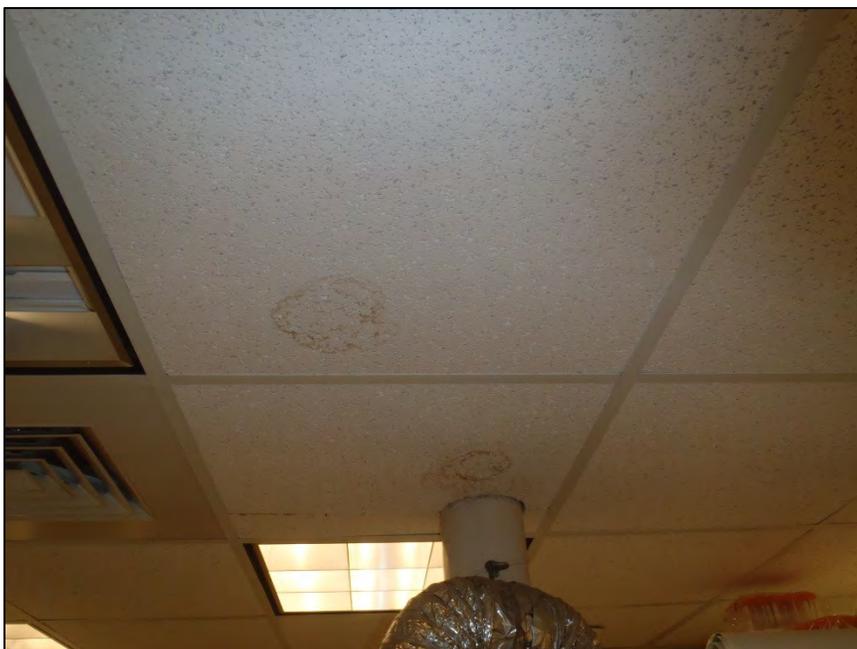
NO. 148 – SECOND FLOOR
ROOM 274 RESEARCH
LABORATORY – DAMAGED
CEILING TILES FROM WATER
INFILTRATION

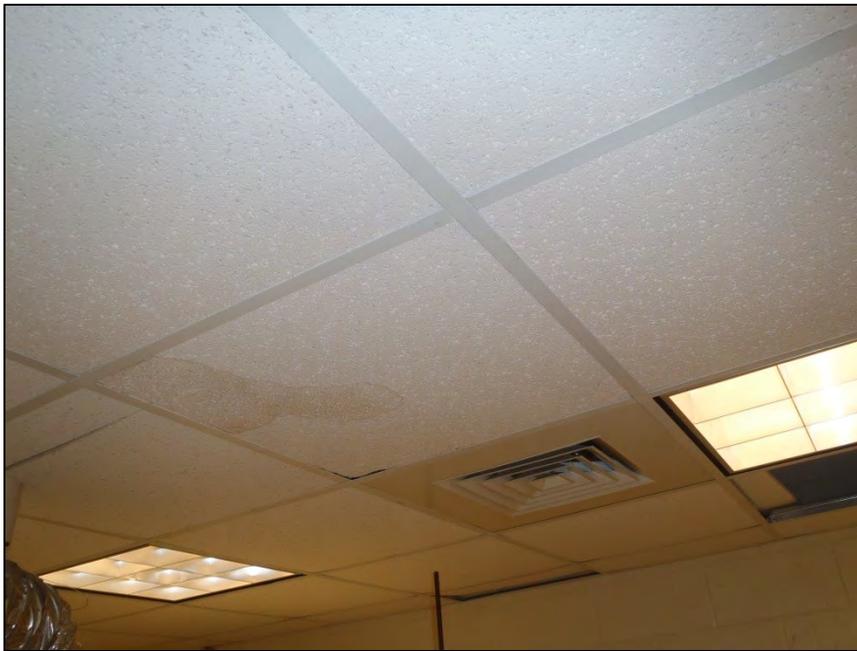
NO. 149 – SECOND FLOOR
ROOM 274 RESEARCH
LABORATORY – DAMAGED
CEILING TILES FROM WATER
INFILTRATION

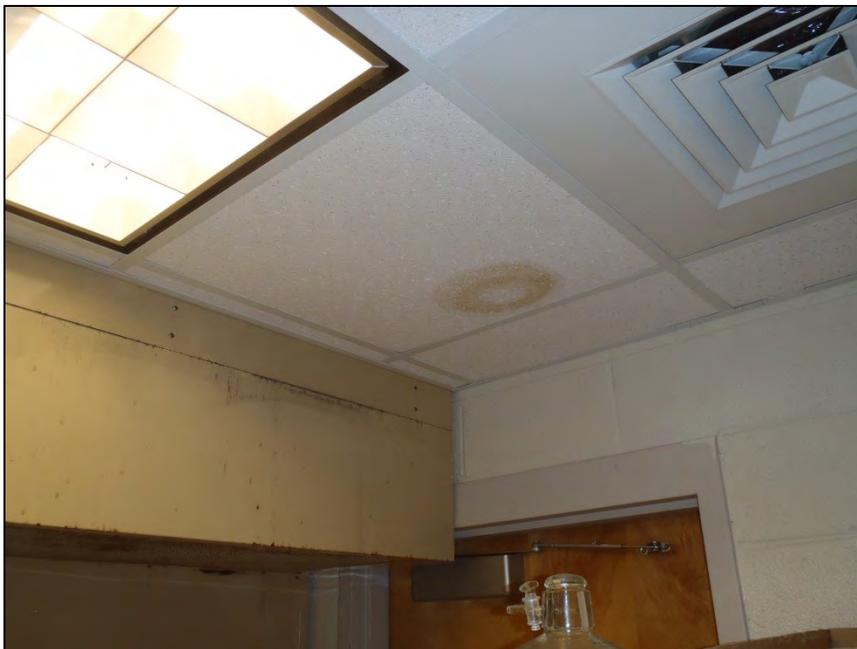
NO. 150 – SECOND FLOOR
ROOM 274 RESEARCH
LABORATORY – DAMAGED
CEILING TILES FROM WATER
INFILTRATION
