UNIVERSITY OF NORTH CAROLINA at CHARLOTTE

Burson Building Feasibility Study

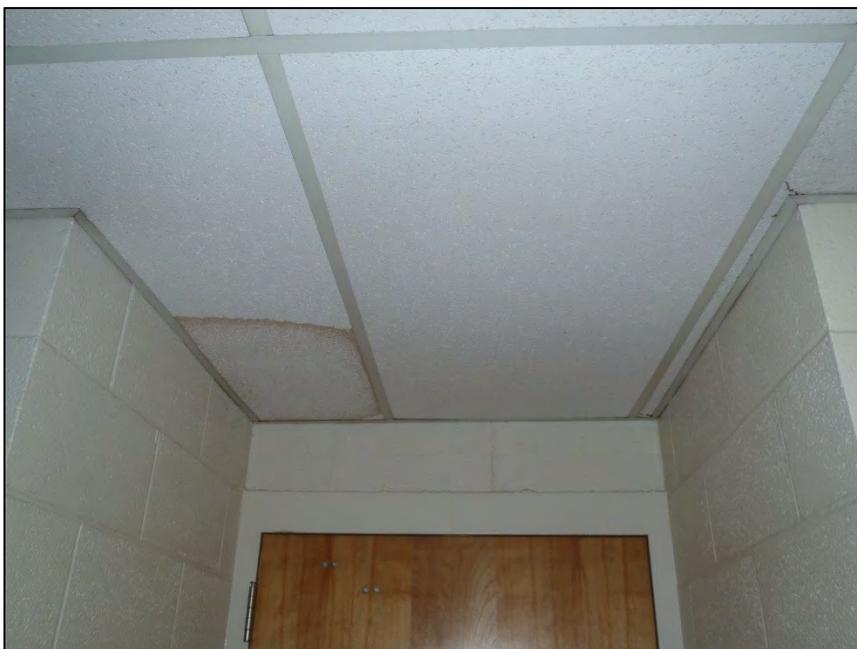
NO. 151 – SECOND FLOOR
CORRIDOR – DAMAGED
CEILING TILES FROM WATER
INFILTRATION

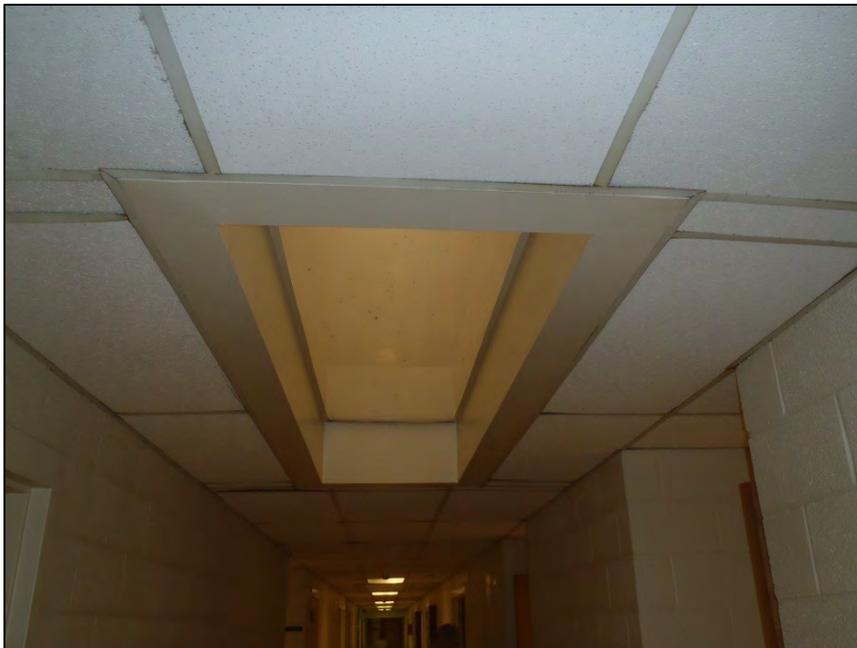
NO. 152 – SECOND FLOOR
CORRIDOR – WATER STAINED
SKYLIGHT DUE TO WATER
INFILTRATION

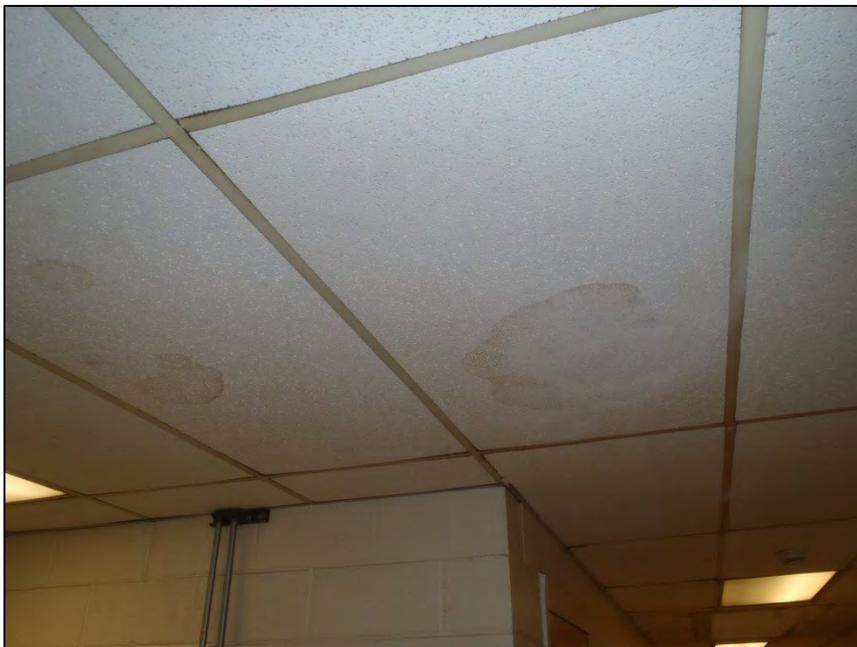
NO. 153 – SECOND FLOOR
CORRIDOR – WATER DAMAGED
CEILING TILES FROM WATER
INFILTRATION

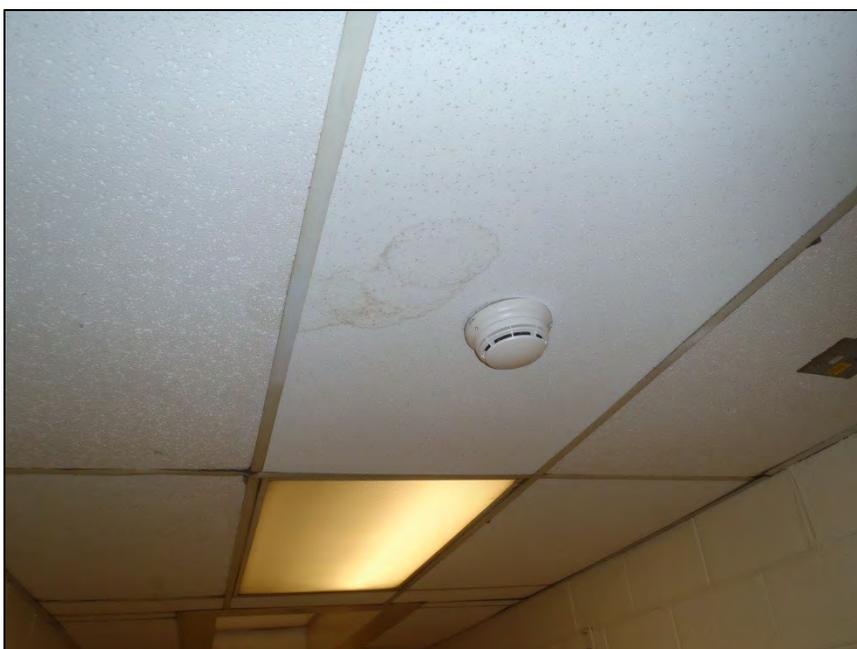
NO. 154 – SECOND FLOOR
CORRIDOR – WATER DAMAGED
CEILING TILES FROM WATER
INFILTRATION

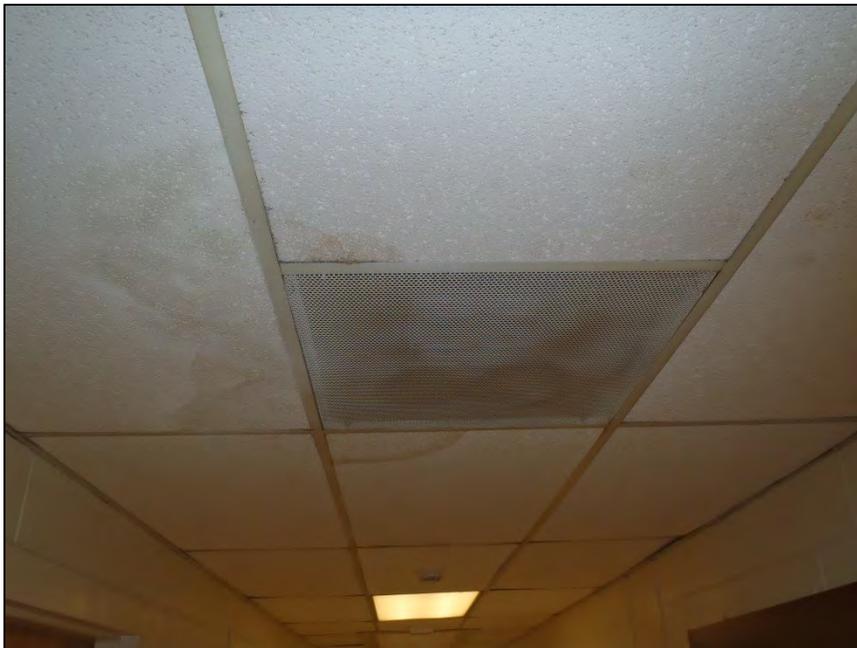
NO. 155 – SECOND FLOOR
CORRIDOR – WATER DAMAGED
CEILING TILES FROM WATER
INFILTRATION

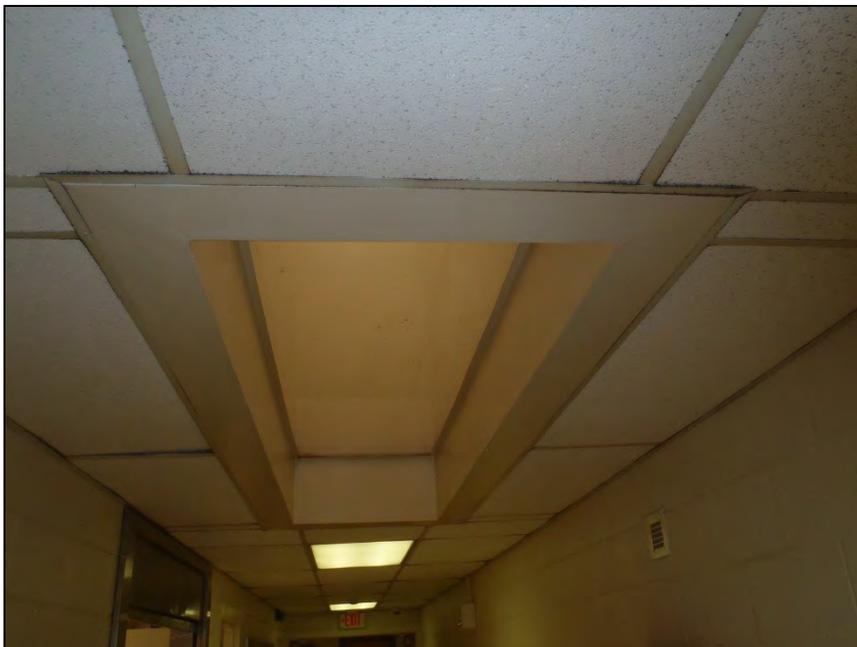
NO. 156 – SECOND FLOOR
CORRIDOR – WATER STAINED
SKYLIGHT DUE TO WATER
INFILTRATION

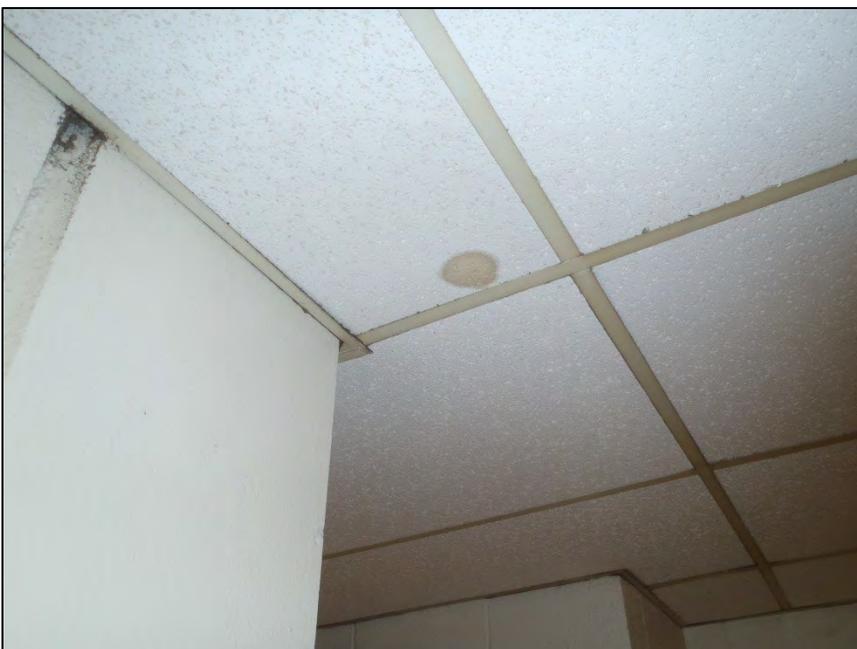
NO. 157 – SECOND FLOOR
CORRIDOR – WATER DAMAGED
CEILING TILES FROM WATER
INFILTRATION

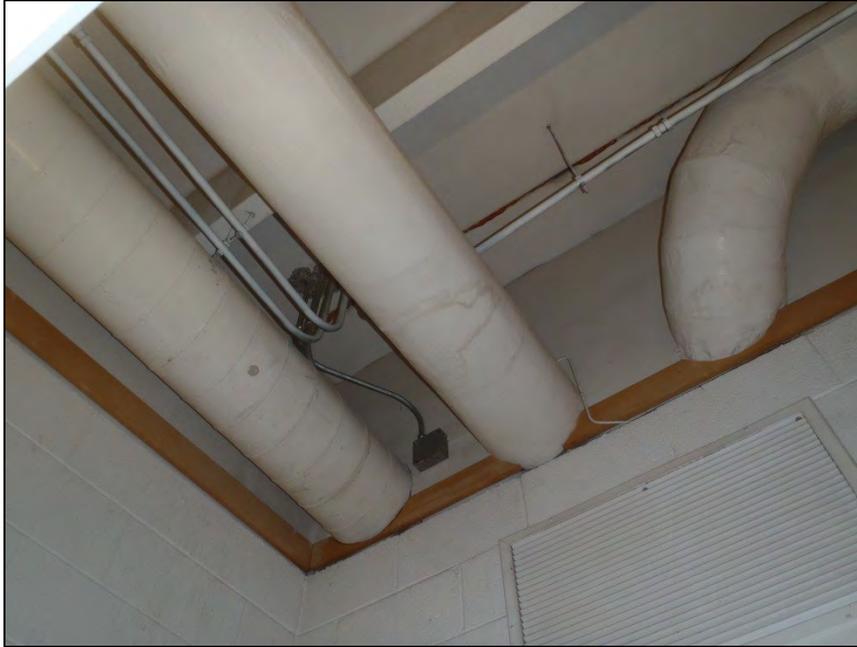
NO. 158 – SECOND FLOOR
ROOM 221 – WATER STAINED
DUCT WORK FROM WATER
INFILTRATION AND/OR
CONDENSATION

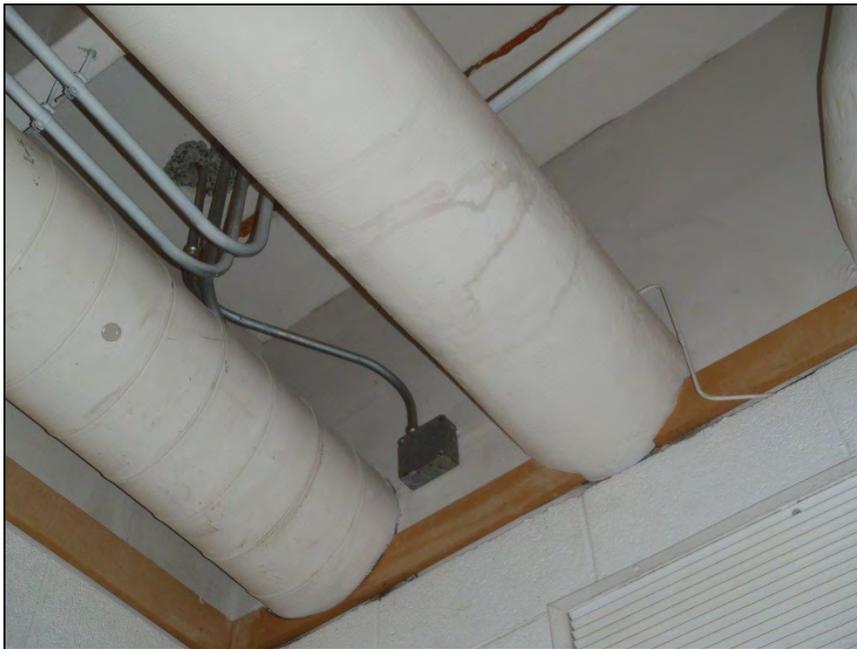
NO. 159 – SECOND FLOOR
ROOM 221 – WATER STAINED
DUCT WORK FROM WATER
INFILTRATION AND/OR
CONDENSATION

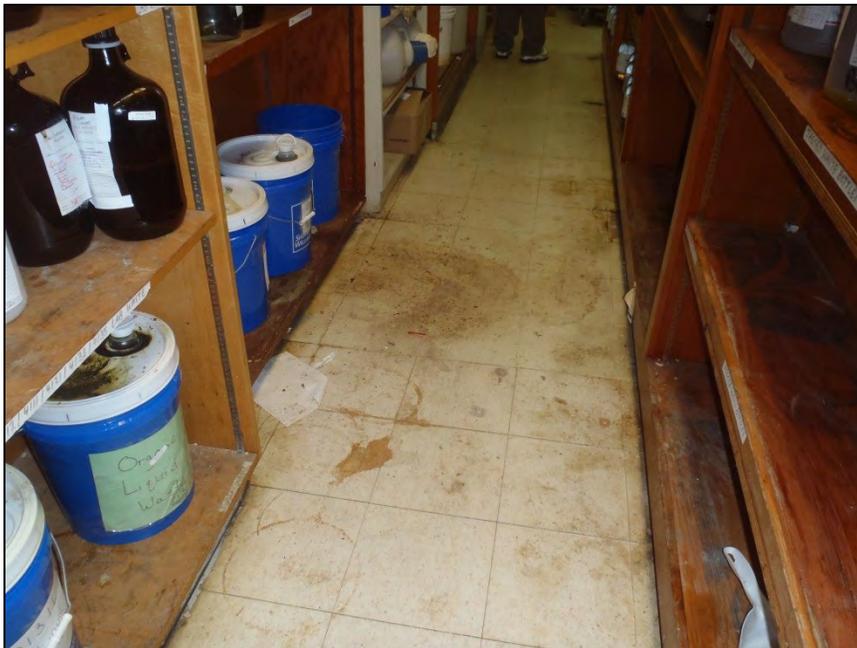
NO. 160 – SECOND FLOOR
ROOM 225A – CHEMICALLY
STAINED FURNITURE AND
FLOOR FINISHES

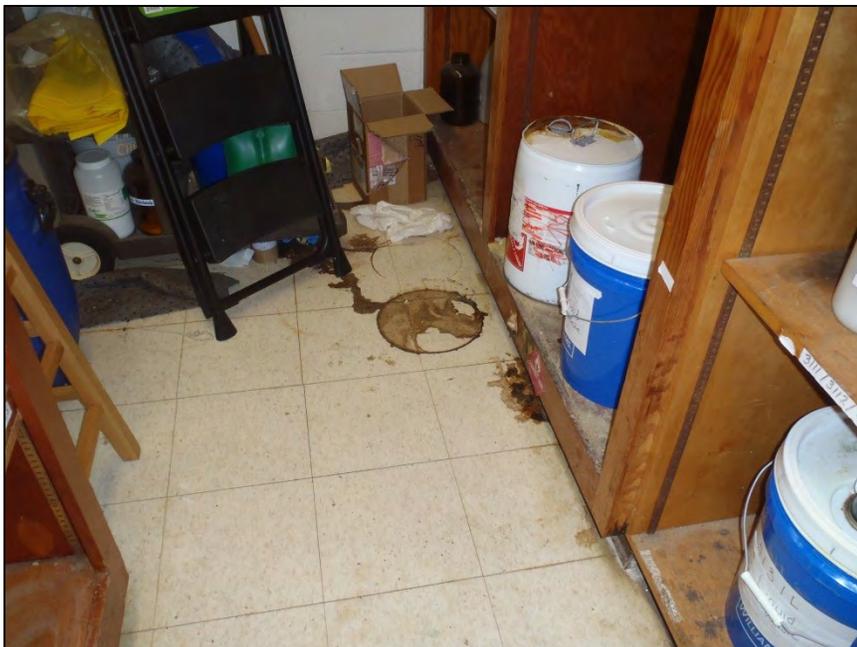
NO. 161 – SECOND FLOOR
ROOM 225A – CHEMICALLY
STAINED FURNITURE AND
FLOOR FINISHES

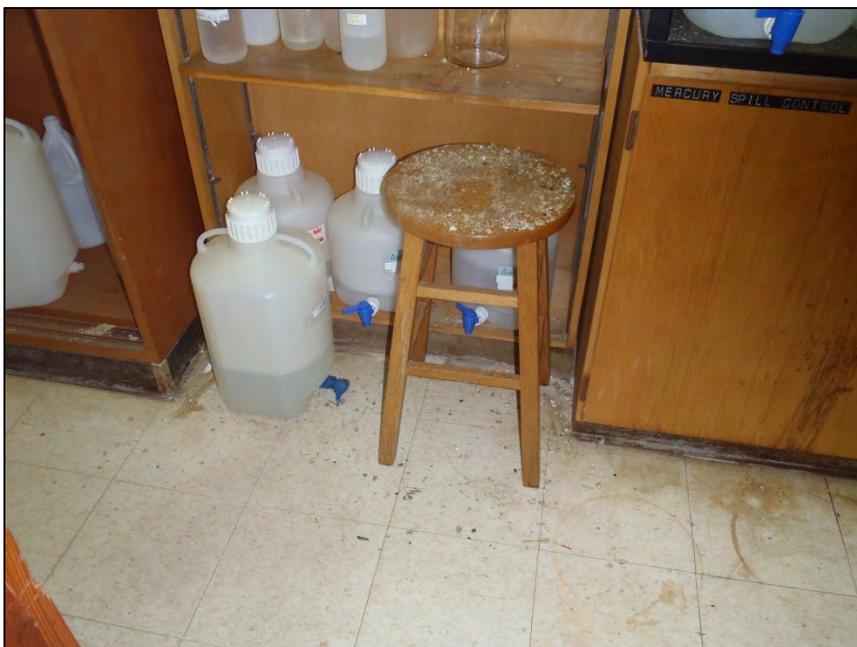
NO. 162 – SECOND FLOOR
ROOM 225A – CHEMICALLY
STAINED FURNITURE AND
FLOOR FINISHES

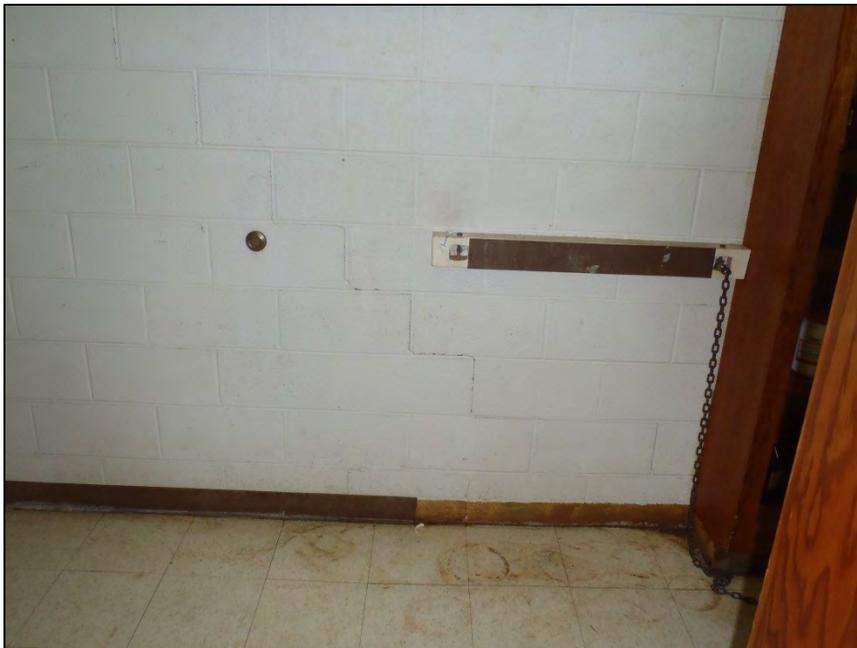
NO. 163 – SECOND FLOOR
ROOM 225 – CRACKED INTERIOR
CONCRETE MASONRY WALL

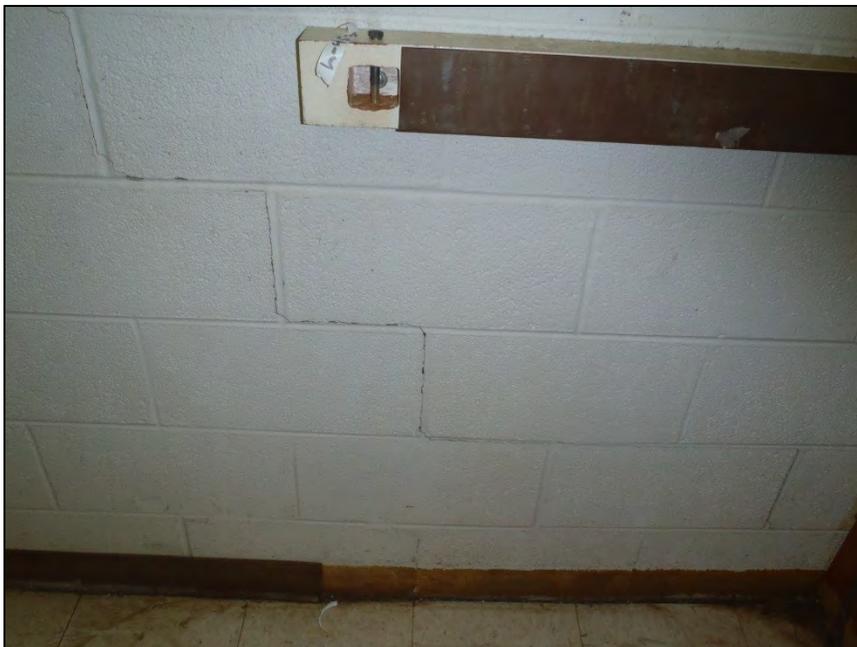
NO. 164 – SECOND FLOOR
ROOM 225 – CRACKED INTERIOR
CONCRETE MASONRY WALL

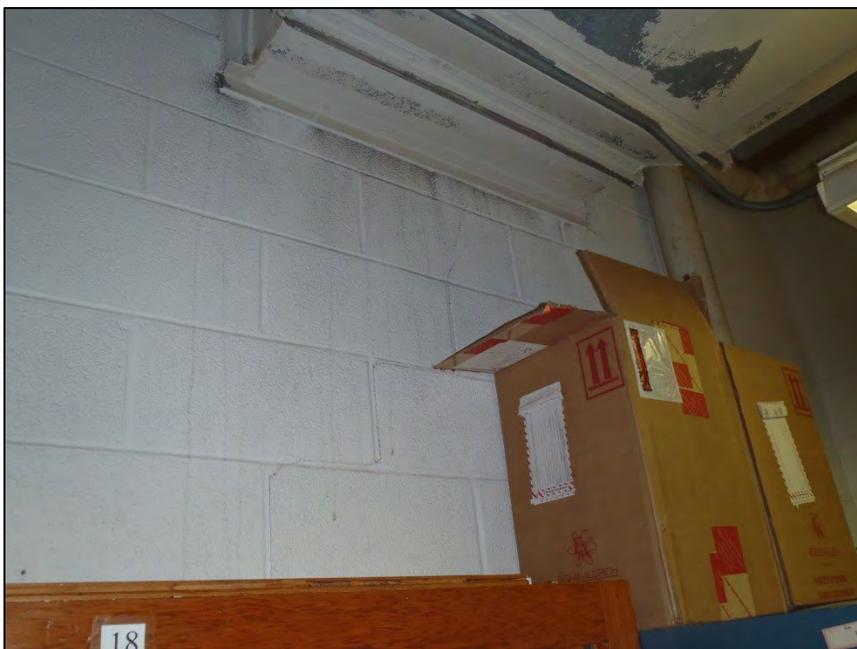
NO. 165 – SECOND FLOOR
ROOM 225 – CRACKED INTERIOR
CONCRETE MASONRY WALL

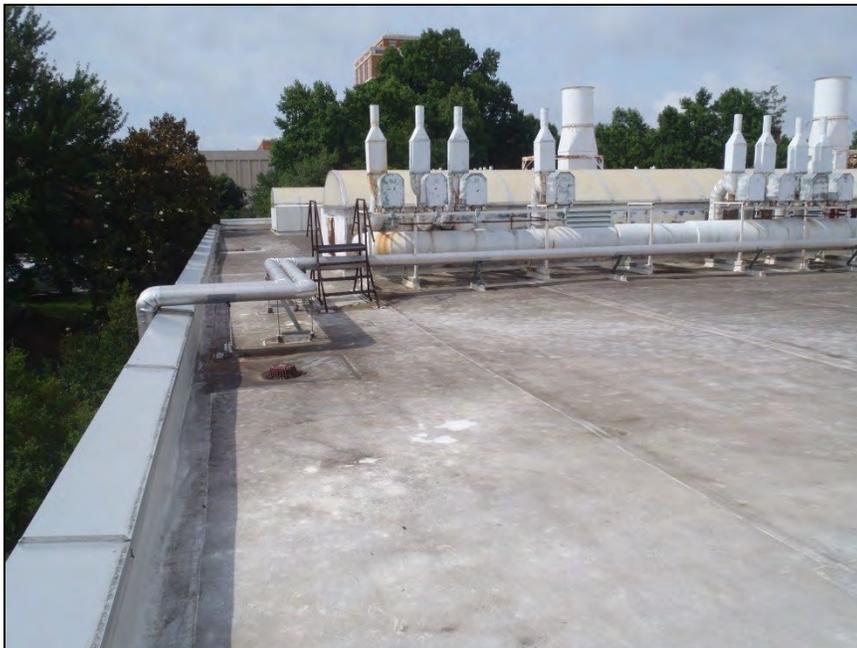
NO. 166 – ROOF VIEWS FROM THE NORTHEAST CORNER

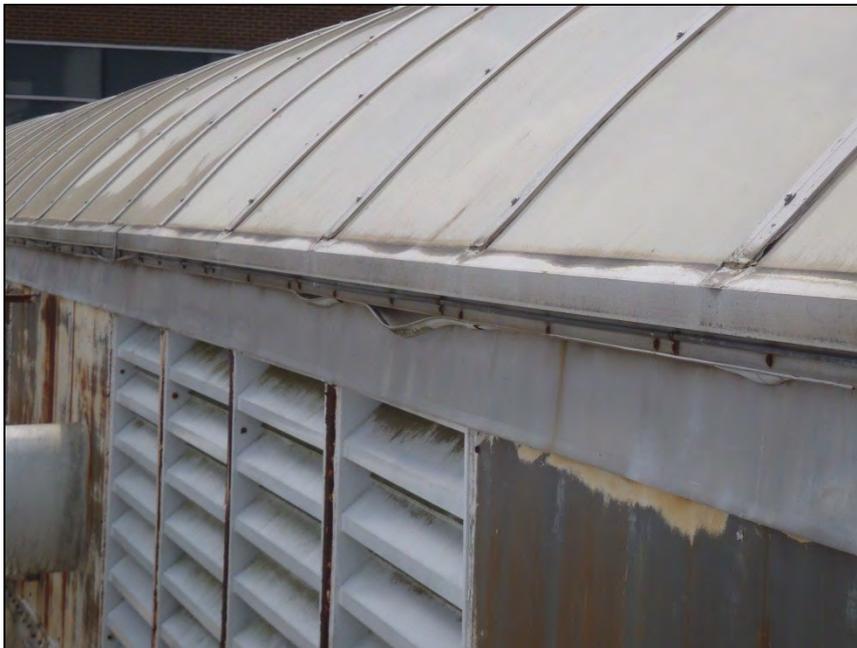
NO. 204 – ROOF
SKYLIGHT/MECHANICAL
ENCLOSURE – DETERIORATED
JOINT SEALANTS ALLOWING
WATER INFILTRATION

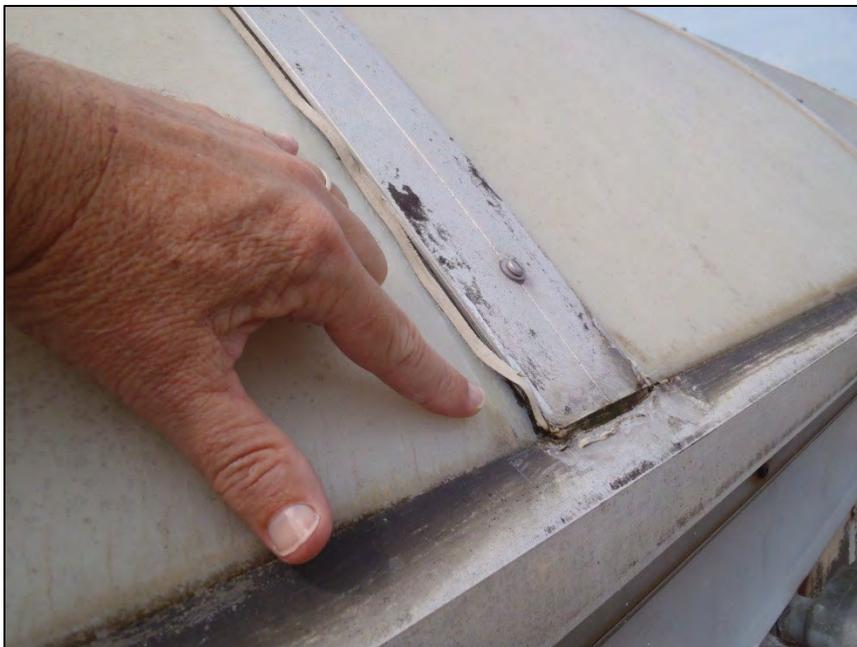
NO. 205 – ROOF
SKYLIGHT/MECHANICAL
ENCLOSURE – DETERIORATED
JOINT SEALANTS ALLOWING
WATER INFILTRATION

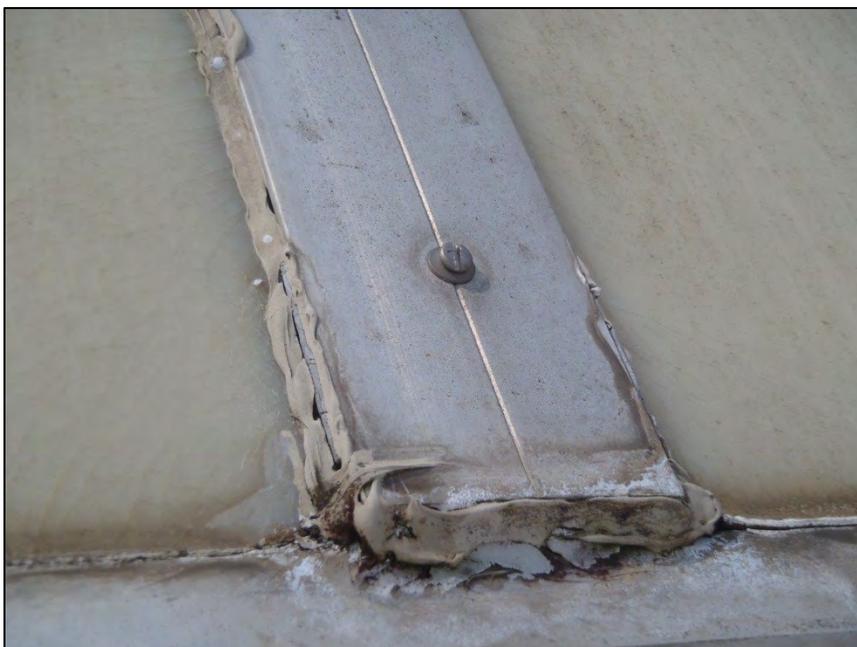
NO. 206 – ROOF
SKYLIGHT/MECHANICAL
ENCLOSURE – DETERIORATED
JOINT SEALANTS ALLOWING
WATER INFILTRATION

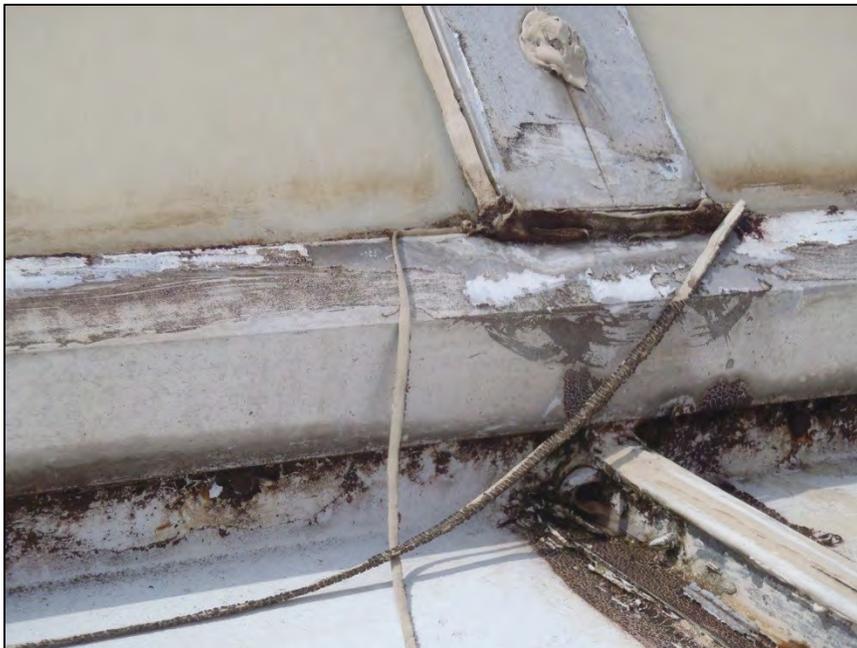
NO. 207 – ROOF
SKYLIGHT/MECHANICAL
ENCLOSURE – DETERIORATED
JOINT SEALANTS ALLOWING
WATER INFILTRATION

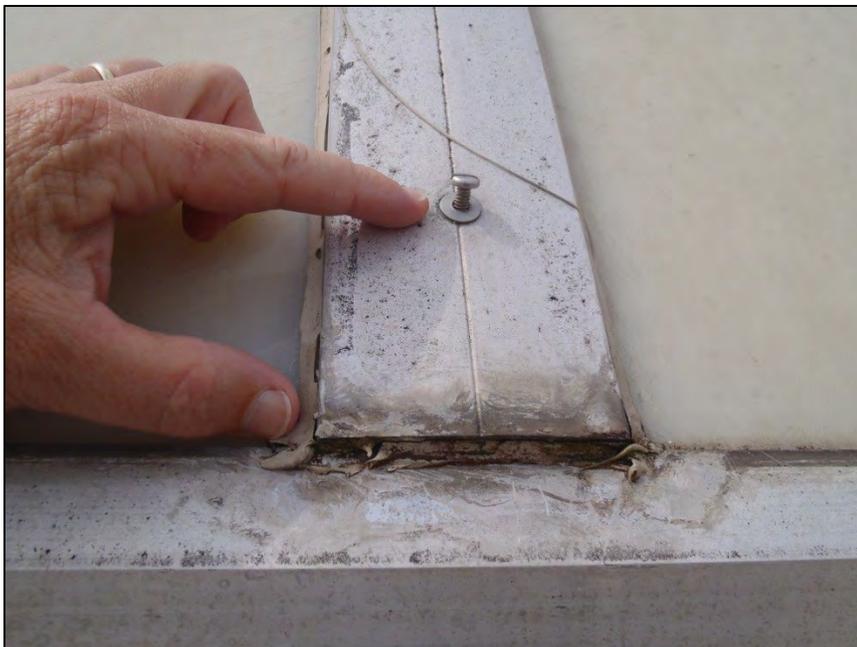
NO. 208 – ROOF
SKYLIGHT/MECHANICAL
ENCLOSURE – LOOSE FRAMING
ALLOWING WATER INFILTRATION

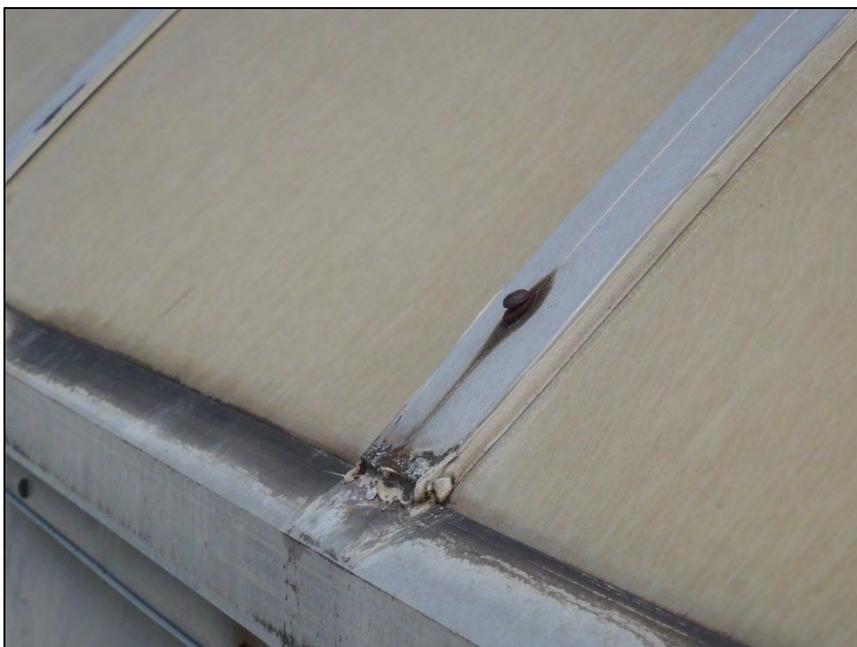
NO. 209 – ROOF
SKYLIGHT/MECHANICAL
ENCLOSURE – LOOSE FRAMING
ALLOWING WATER INFILTRATION

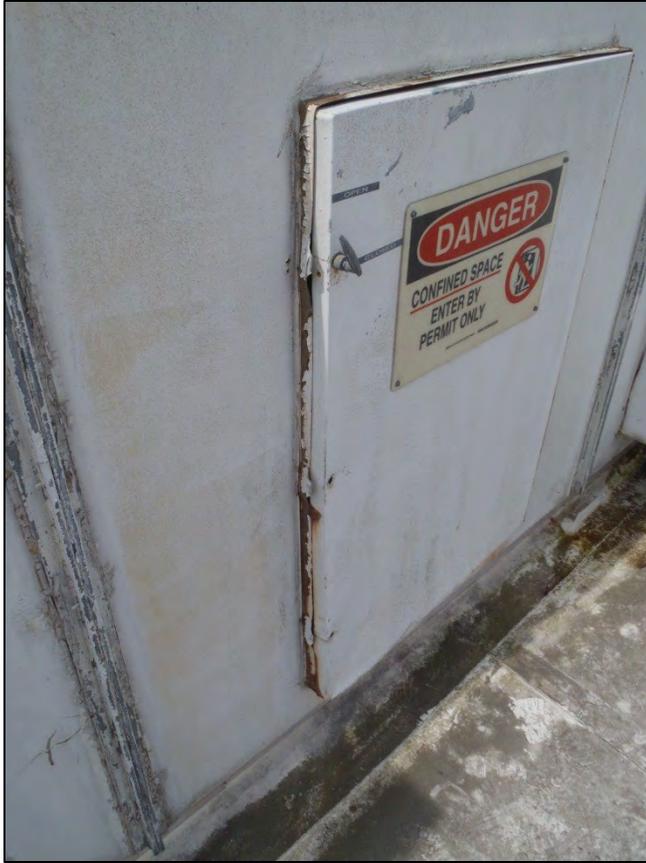
NO. 210 – ROOF SKYLIGHT/MECHANICAL ENCLOSURE – TYPICAL CONFINED SPACE ACCESS

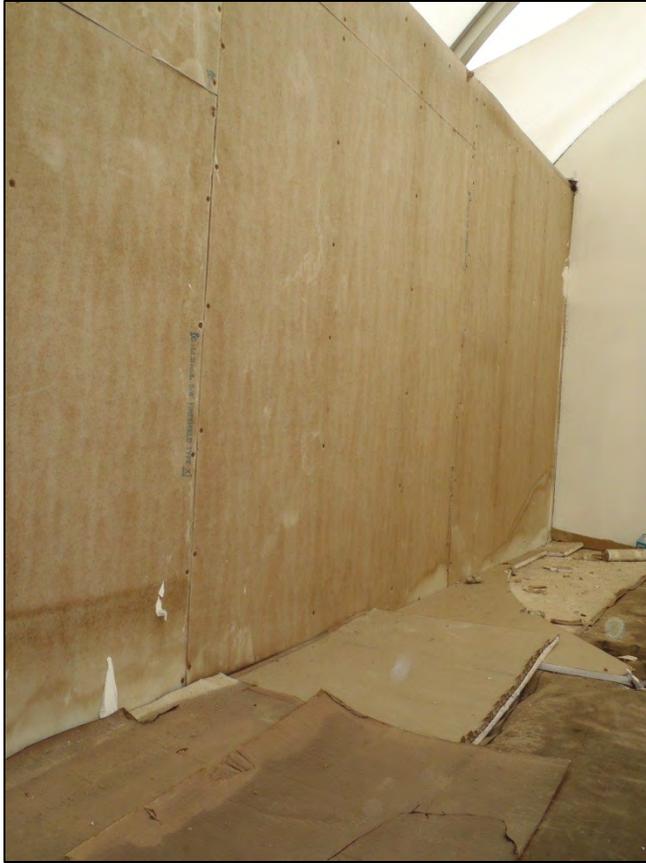
NO. 212 – ROOF SKYLIGHT/MECHANICAL ENCLOSURE – WATER DAMAGED INTERIOR FINISHES

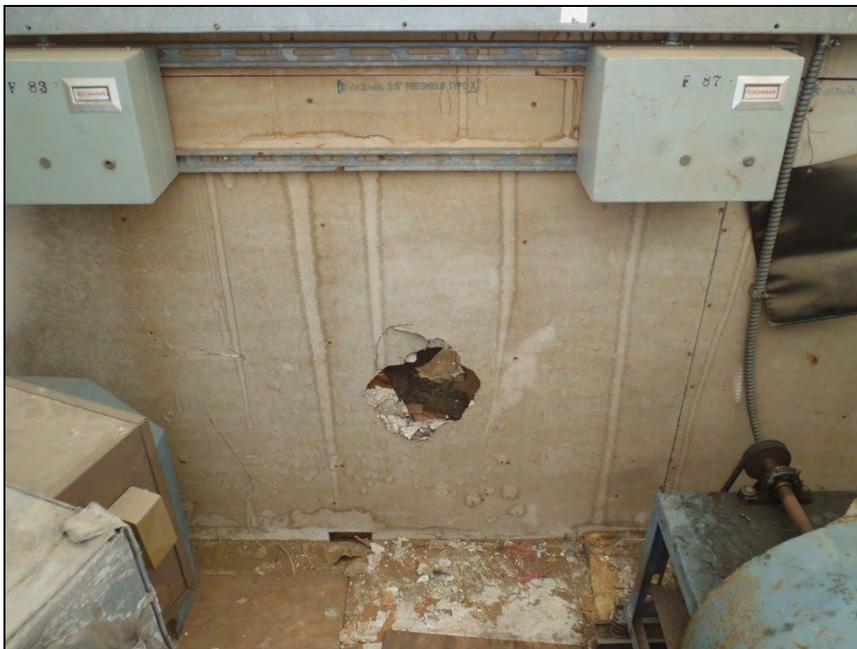
NO. 213 – ROOF SKYLIGHT/MECHANICAL ENCLOSURE – WATER DAMAGED INTERIOR FINISHES

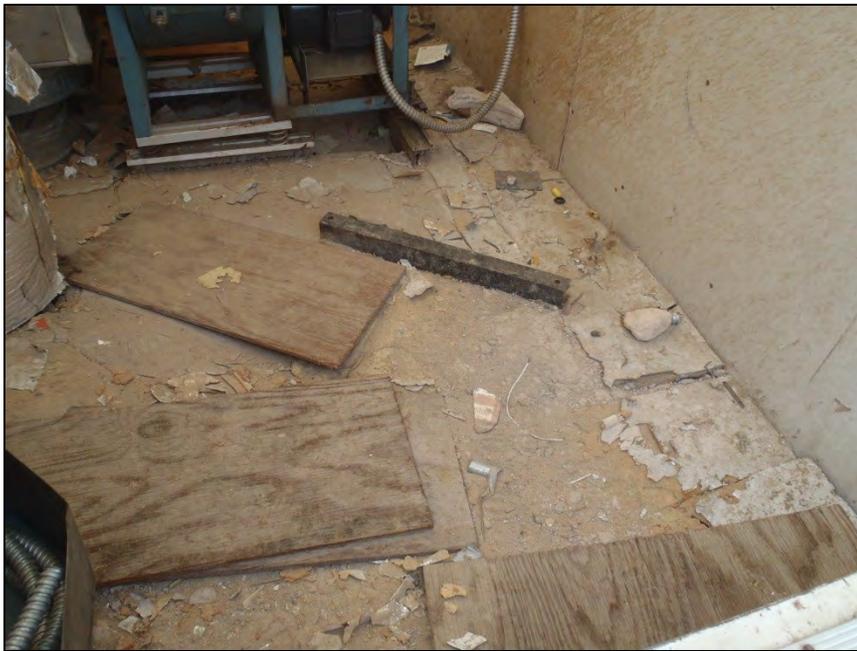
NO. 214 – ROOF
SKYLIGHT/MECHANICAL
ENCLOSURE – WATER DAMAGED
INTERIOR FINISHES

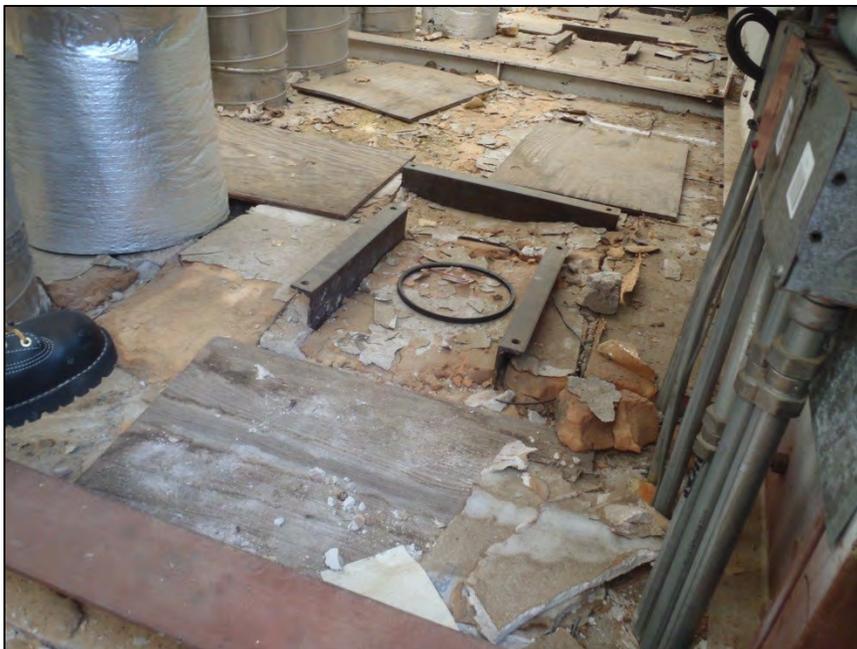
NO. 215 – ROOF
SKYLIGHT/MECHANICAL
ENCLOSURE – WATER DAMAGED
INTERIOR FINISHES

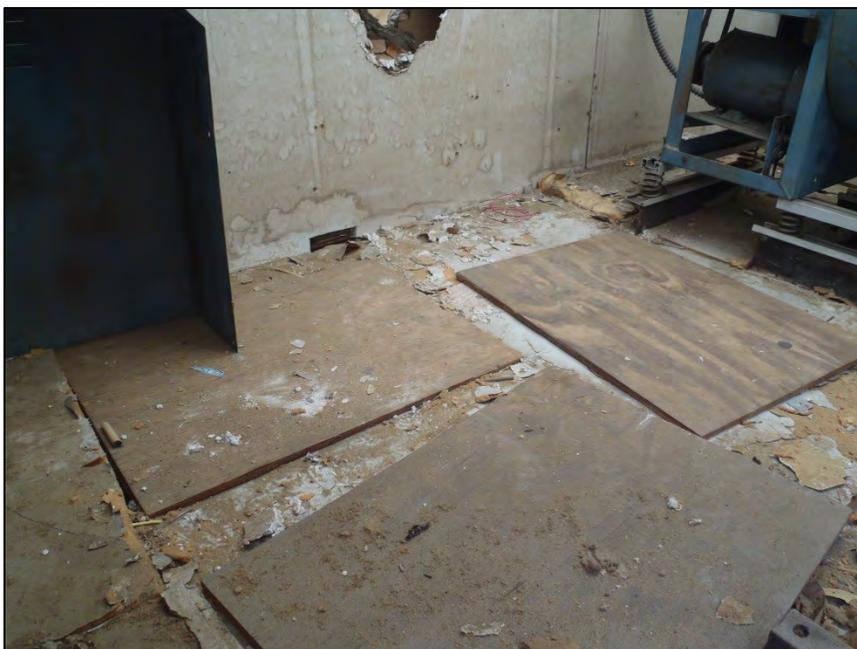
NO. 216 – ROOF
SKYLIGHT/MECHANICAL
ENCLOSURE – WATER DAMAGED
INTERIOR FINISHES
